BOROUGH OF QUEENSCLIFFE
Quantified Tree Risk Assessment

Selected Trees in Princess, Citizens and
Victoria Parks, Queenscliff

25 September 2009

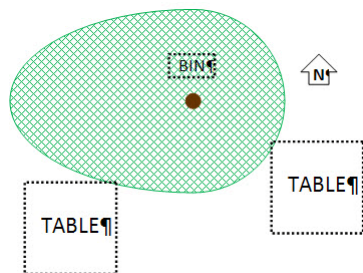
Tree 10

Species	<i>Pinus pinea</i> (Stone Pine)	
DBH (cm)	66	
Height (m)	13.2	
Canopy Spread (m)	N	4
	S	4
	E	4
	W	8
Target Potential	1/20	
Impact Potential	1/8	
Probability of Failure	1/1,000	
Risk of Harm	1/174,397	
Risk Rating	Low

To prevent further decline in tree health that can contribute to the tree's risk by increasing the Probability of Failure it is recommended that establishment of a mulched garden bed be completed and investigation into the viability of supplying additional water to the trees be conducted.

Whilst not an immediate recommendation, the establishment of the mulched garden bed will also have an impact on the Target Potential resulting in a decreased Risk of Harm. This impact can be increased by moving park furniture out from underneath the canopy of the tree further reducing the Risk of Harm.

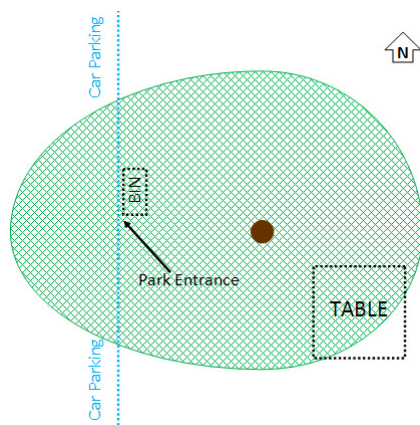
Tree 29

Species		<i>Pinus pinea</i> (Stone Pine)
DBH (cm)		98
Height (m)		16.1
Canopy Spread (m)	N	7
	S	6
	E	7
	W	11
Target Potential		1/6
Impact Potential		1/81
Probability of Failure		1/1,000
Risk of Harm		1/446,457
Risk Rating		Low

To prevent further decline in tree health that can contribute to the tree's risk by increasing the Probability of Failure it is recommended that establishment of a mulched garden bed be completed and investigation into the viability of supplying additional water to the trees be conducted.

Whilst not an immediate recommendation, the establishment of the mulched garden bed will also have an impact on the Target Potential resulting in a decreased Risk of Harm. This impact can be increased by moving park furniture out from underneath the canopy of the tree further reducing the Risk of Harm.

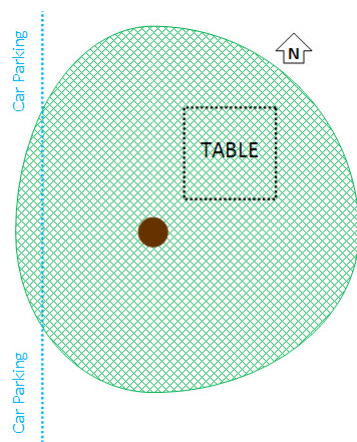
Tree 30

Species	<i>Cupressus macrocarpa</i> (Monterey Cypress)	
DBH (cm)	128	
Height (m)	16.5	
Canopy Spread (m)	N	9
	S	7
	E	9
	W	6
Target Potential	1/6	
Impact Potential	1/81	
Probability of Failure	1/50	
Risk of Harm	1/24,506	
Risk Rating	Medium

While not currently considered a High risk, it is close enough to the threshold where minor changes in weather patterns and/or tree health can affect the Probability of Failure to an extent where this tree could become a High risk.

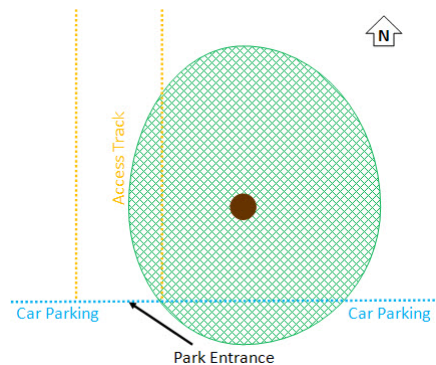
Tree 41

Species	<i>Cupressus macrocarpa</i> (Monterey Cypress)	
DBH (cm)	112	
Height (m)	16.5	
Canopy Spread (m)	N	7
	S	6
	E	6
	W	5
Target Potential	1/13	
Impact Potential	1/81	
Probability of Failure	1/50	
Risk of Harm	1/54,553	
Risk Rating	Medium

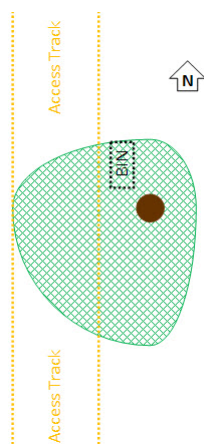
Tree 42

Species	<i>Cupressus macrocarpa</i> (Monterey Cypress)	
DBH (cm)	120	
Height (m)	18.3	
Canopy Spread (m)	N	3
	S	6
	E	2
	W	6
Target Potential	1/4	
Impact Potential	1/81	
Probability of Failure	1/50	
Risk of Harm	1/16,658	
Risk Rating	Medium

While not currently considered a High risk, it is close enough to the threshold where minor changes in weather patterns and/or tree health can affect the Probability of Failure to an extent where this tree could become a High risk.

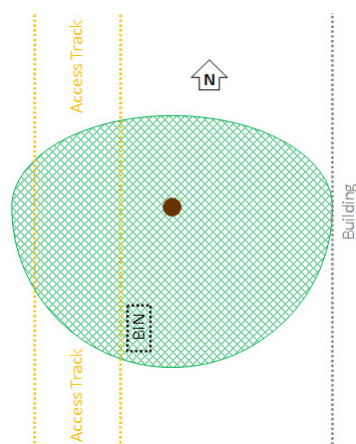
Tree 44

Species	<i>Cupressus macrocarpa</i> (Monterey Cypress)	
DBH (cm)	78	
Height (m)	16.7	
Canopy Spread (m)	N	4
	S	7
	E	7
	W	7
Target Potential	1/3	
Impact Potential	1/81	
Probability of Failure	1/50	
Risk of Harm	1/13,436	
Risk Rating	Medium

While not currently considered a High risk, it is close enough to the threshold where minor changes in weather patterns and/or tree health can affect the Probability of Failure to an extent where this tree could become a High risk.

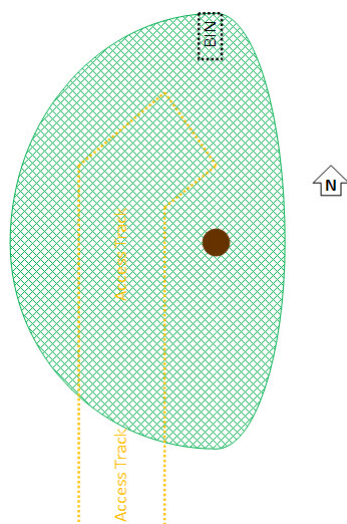
Tree 45

Species	<i>Cupressus macrocarpa</i> (Monterey Cypress)	
DBH (cm)	117	
Height (m)	14.1	
Canopy Spread (m)	N	10
	S	9
	E	3
	W	9
Target Potential	1/3	
Impact Potential	1/81	
Probability of Failure	1/50	
Risk of Harm	1/12,443	
Risk Rating	Medium

While not currently considered a High risk, it is close enough to the threshold where minor changes in weather patterns and/or tree health can affect the Probability of Failure to an extent where this tree could become a High risk.

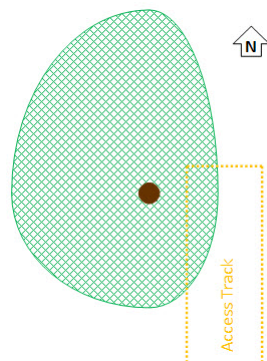
Tree 46

Species	<i>Cupressus macrocarpa</i> (Monterey Cypress)	
DBH (cm)	90	
Height (m)	13.2	
Canopy Spread (m)	N	8
	S	5
	E	3
	W	6
Target Potential	1/17	
Impact Potential	1/81	
Probability of Failure	1/50	
Risk of Harm	1/67,875	
Risk Rating	Medium

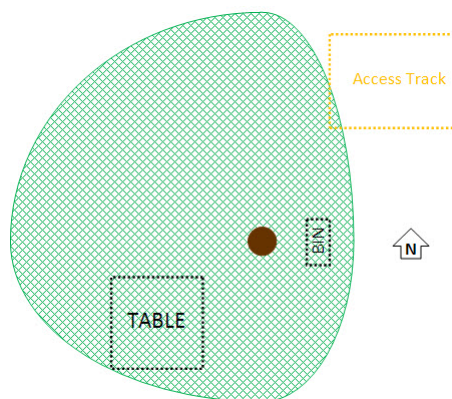
Tree 47

Species	<i>Cupressus macrocarpa</i> (Monterey Cypress)	
DBH (cm)	124	
Height (m)	19.1	
Canopy Spread (m)	N	10
	S	7
	E	4
	W	11
Target Potential	1/5	
Impact Potential	1/81	
Probability of Failure	1/50	
Risk of Harm	1/20,274	
Risk Rating	Medium

While not currently considered a High risk, it is close enough to the threshold where minor changes in weather patterns and/or tree health can affect the Probability of Failure to an extent where this tree could become a High risk.

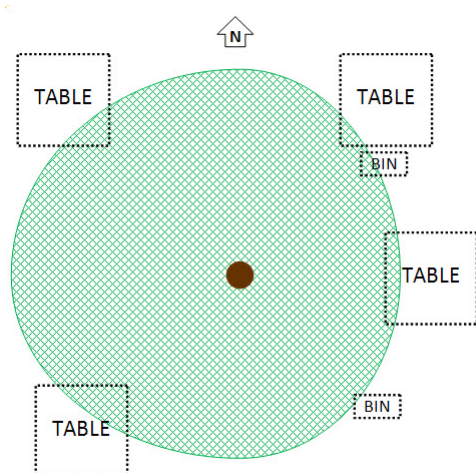
Tree 48

Species	<i>Cupressus macrocarpa</i> (Monterey Cypress)	
DBH (cm)	117	
Height (m)	18.7	
Canopy Spread (m)	N	9
	S	8
	E	7
	W	10
Target Potential	1/4	
Impact Potential	1/81	
Probability of Failure	1/50	
Risk of Harm	1/17,959	
Risk Rating	Medium

While not currently considered a High risk, it is close enough to the threshold where minor changes in weather patterns and/or tree health can affect the Probability of Failure to an extent where this tree could become a High risk.

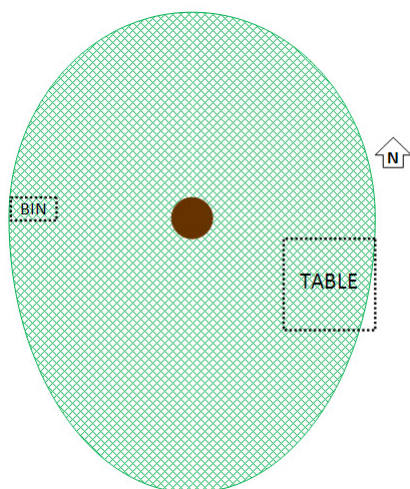
Tree 68

Species	<i>Cupressus macrocarpa</i> (Monterey Cypress)	
DBH (cm)	180	
Height (m)	20.7	
Canopy Spread (m)	N	9
	S	12
	E	8
	W	8
Target Potential	1/4	
Impact Potential	1/81	
Probability of Failure	1/50	
Risk of Harm	1/17,783	
Risk Rating	Medium

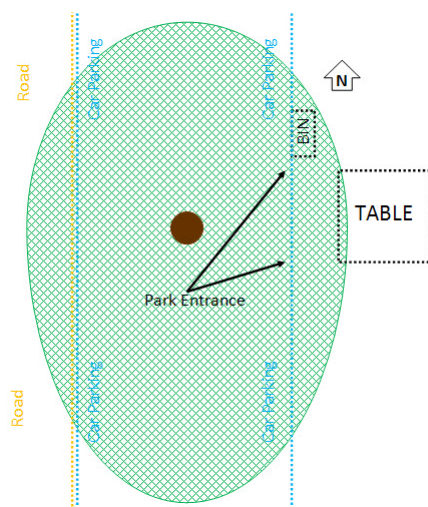
Tree 69

Species	<i>Cupressus macrocarpa</i> (Monterey Cypress)	
DBH (cm)	141	
Height (m)	17.0	
Canopy Spread (m)	N	9
	S	12
	E	7
	W	7
Target Potential	1/3	
Impact Potential	1/81	
Probability of Failure	1/50	
Risk of Harm	1/11,475	
Risk Rating	Medium

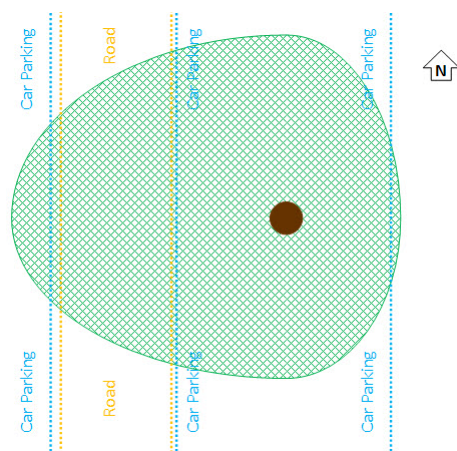
Tree 70

Species	<i>Cupressus macrocarpa</i> (Monterey Cypress)	
DBH (cm)	142	
Height (m)	19.7	
Canopy Spread (m)	N	8
	S	7
	E	5
	W	12
Target Potential	1/2	
Impact Potential	1/81	
Probability of Failure	1/50	
Risk of Harm	1/7,855	
Risk Rating	High

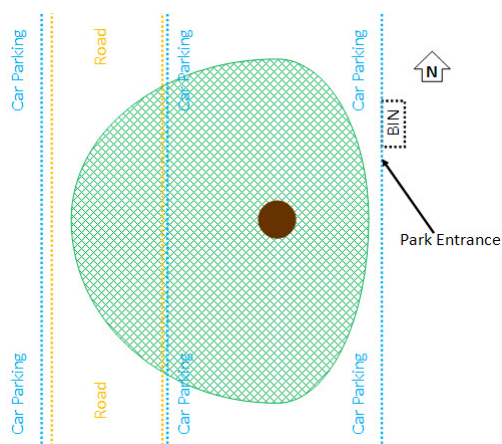
Tree 71

Species	<i>Cupressus macrocarpa</i> (Monterey Cypress)	
DBH (cm)	163	
Height (m)	20.7	
Canopy Spread (m)	N	7
	S	8
	E	4
	W	9
Target Potential	1/3	
Impact Potential	1/81	
Probability of Failure	1/50	
Risk of Harm	1/11,924	
Risk Rating	Medium

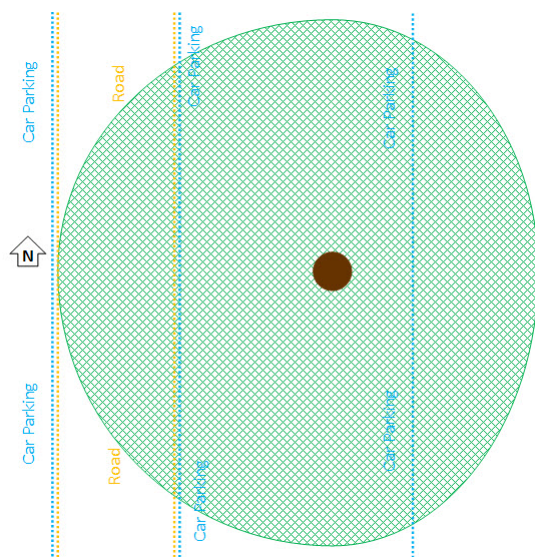
Tree 155

Species	<i>Cupressus macrocarpa</i> (Monterey Cypress)	
DBH (cm)	168	
Height (m)	17.4	
Canopy Spread (m)	N	11
	S	12
	E	9
	W	12
Target Potential	1/2	
Impact Potential	1/81	
Probability of Failure	1/100	
Risk of Harm	1/19,342	
Risk Rating	Medium

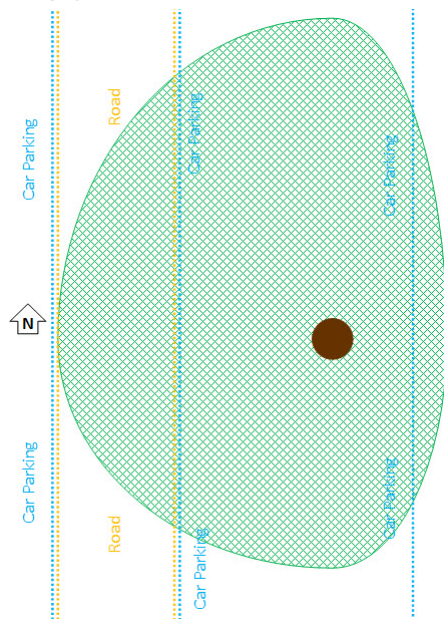
Tree 156

Species		<i>Cupressus macrocarpa</i> (Monterey Cypress)
DBH (cm)		178
Height (m)		14.3
Canopy Spread (m)	N	14
	S	10
	E	5
	W	12
Target Potential		1/3
Impact Potential		1/81
Probability of Failure		1/100
Risk of Harm		1/21,970
Risk Rating		Medium

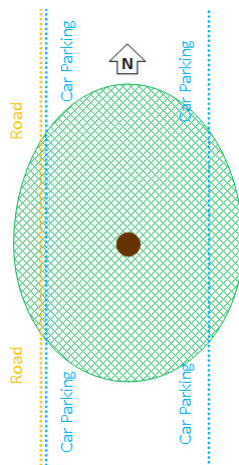
Tree 161

Species	<i>Allocasuarina verticillata</i> (Drooping She-oak)	
DBH (cm)	102	
Height (m)	10	
Canopy Spread (m)	N	7
	S	6
	E	5
	W	5
Target Potential	1/13	
Impact Potential	1/5	
Probability of Failure	1/10	
Risk of Harm	1/628	
Risk Rating	High

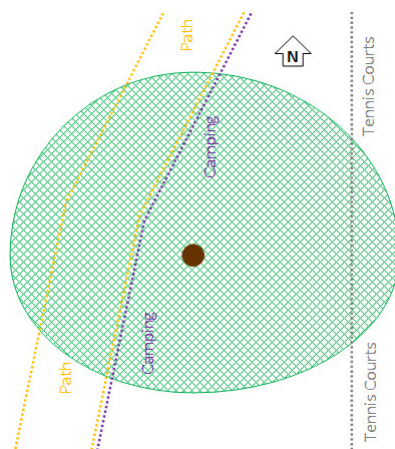
Tree 16

Species	<i>Cupressus macrocarpa</i> (Monterey Cypress)	
DBH (cm)	95	
Height (m)	17.3	
Canopy Spread (m)	N	8
	S	6
	E	9
	W	8
Target Potential	1/2	
Impact Potential	1/81	
Probability of Failure	1/100	
Risk of Harm	1/14,557	
Risk Rating	Medium

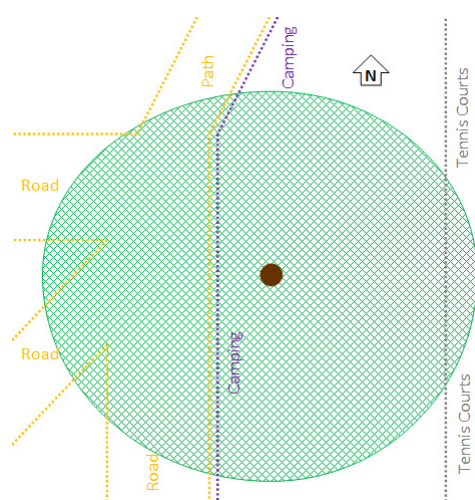
Tree 17

Species	<i>Cupressus macrocarpa</i> (Monterey Cypress)	
DBH (cm)	96	
Height (m)	16.3	
Canopy Spread (m)	N	8
	S	9
	E	9
	W	10
Target Potential	1/1.3	
Impact Potential	1/81	
Probability of Failure	1/100	
Risk of Harm	1/10,723	
Risk Rating	Medium

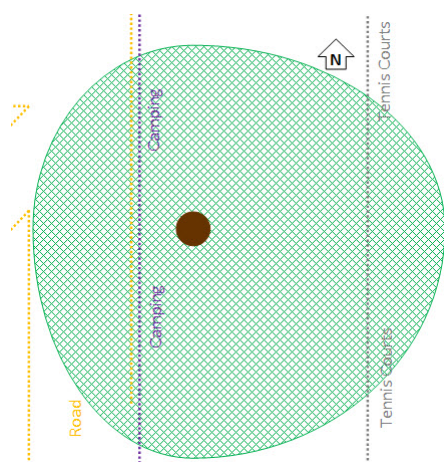
Tree 18

Species	<i>Cupressus macrocarpa</i> (Monterey Cypress)	
DBH (cm)	148	
Height (m)	15.3	
Canopy Spread (m)	N	8
	S	10
	E	11
	W	7
Target Potential	1/1.2	
Impact Potential	1/81	
Probability of Failure	1/100	
Risk of Harm	1/10,093	
Risk Rating	Medium

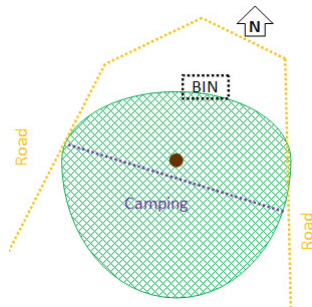
Tree 19

Species	<i>Melaleuca lanceolata</i> (Moonah)	
DBH (cm)	57	
Height (m)	11.8	
Canopy Spread (m)	N	3
	S	6
	E	5
	W	5
Target Potential	1/6	
Impact Potential	1/450	
Probability of Failure	1/1,000	
Risk of Harm	1/2,892,396	
Risk Rating	Very Low

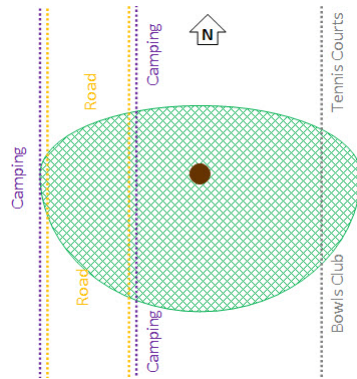
Tree 20

Species		<i>Melaleuca lanceolata</i> (Moonah)
DBH (cm)		88
Height (m)		15.6
Canopy Spread (m)	N	3
	S	6
	E	7
	W	7
Target Potential		1/3
Impact Potential		1/450
Probability of Failure		1/1,000
Risk of Harm		1/1,373,743
Risk Rating		Very Low

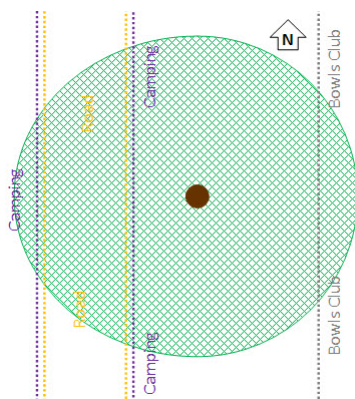
Tree 21

Species	<i>Cupressus macrocarpa</i> (Monterey Cypress)	
DBH (cm)	100	
Height (m)	16.3	
Canopy Spread (m)	N	7
	S	7
	E	7
	W	8
Target Potential	1/2	
Impact Potential	1/81	
Probability of Failure	1/100	
Risk of Harm	1/15,554	
Risk Rating	Medium

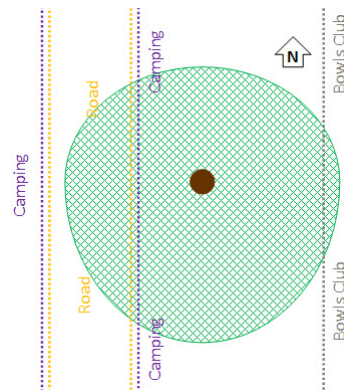
Tree 23

Species	<i>Melaleuca lanceolata</i> (Moonah)	
DBH (cm)	106	
Height (m)	10.4	
Canopy Spread (m)	N	5
	S	7
	E	6
	W	6
Target Potential	1/3	
Impact Potential	1/450	
Probability of Failure	1/1,000	
Risk of Harm	1/1,394,034	
Risk Rating	Very Low

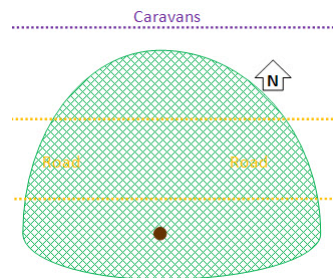
Tree 41

Species	<i>Melaleuca lanceolata</i> (Moonah)	
DBH (cm)	55	
Height (m)	8.4	
Canopy Spread (m)	N	8
	S	2
	E	7
	W	6
Target Potential	1/2	
Impact Potential	1/450	
Probability of Failure	1/1,000	
Risk of Harm	1/799,599	
Risk Rating	Low

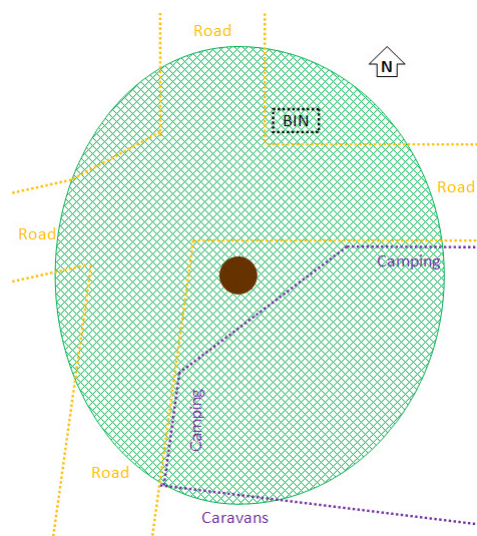
Tree 49

Species	<i>Cupressus macrocarpa</i> (Monterey Cypress)	
DBH (cm)	162	
Height (m)	20.0	
Canopy Spread (m)	N	10
	S	10
	E	9
	W	8
Target Potential	1/1.4	
Impact Potential	1/81	
Probability of Failure	1/100	
Risk of Harm	1/11,165	
Risk Rating	Medium

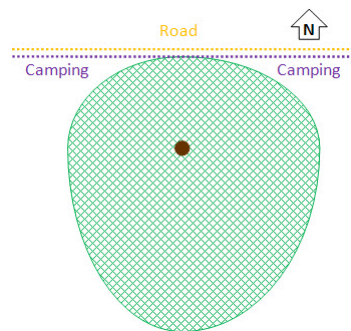
Tree 51

Species		<i>Melaleuca lanceolata</i> (Moonah)
DBH (cm)		63
Height (m)		12.8
Canopy Spread (m)	N	4
	S	8
	E	6
	W	5
Target Potential		1/11
Impact Potential		1/450
Probability of Failure		1/1,000
Risk of Harm		1/4,917,256
Risk Rating		Very Low

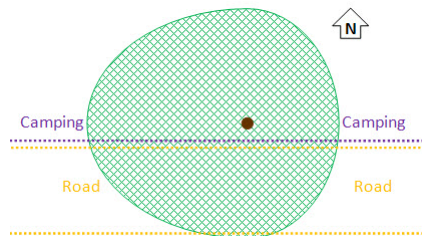
Tree 52

Species	<i>Melaleuca lanceolata</i> (Moonah)	
DBH (cm)	60	
Height (m)	9.8	
Canopy Spread (m)	N	5
	S	5
	E	4
	W	7
Target Potential	1/3	
Impact Potential	1/450	
Probability of Failure	1/1,000	
Risk of Harm	1/1,203,961	
Risk Rating	Very Low

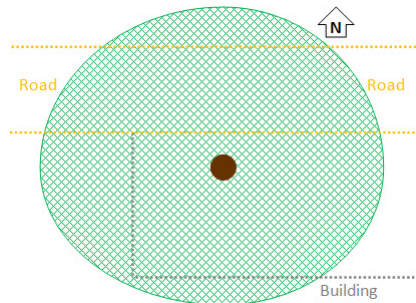
Tree 53

Species	<i>Melaleuca lanceolata</i> (Moonah)	
DBH (cm)	110	
Height (m)	12.4	
Canopy Spread (m)	N	7
	S	6
	E	7
	W	8
Target Potential	1/1.3	
Impact Potential	1/450	
Probability of Failure	1/1,000	
Risk of Harm	1/599,774	
Risk Rating	Low

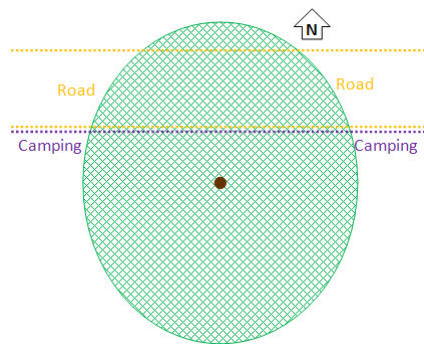
Tree 64

Species	<i>Melaleuca lanceolata</i> (Moonah)	
DBH (cm)	Multi-Stem	
Height (m)	7.0	
Canopy Spread (m)	N	7
	S	7
	E	6
	W	6
Target Potential	1/2	
Impact Potential	1/450	
Probability of Failure	1/1,000	
Risk of Harm	1/1,079,833	
Risk Rating	Very Low

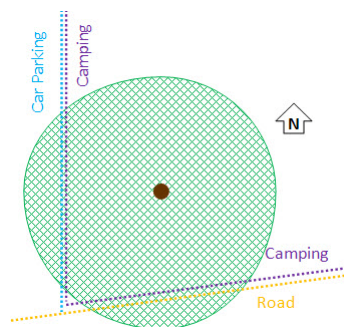
Tree 66

Species	<i>Melaleuca lanceolata</i> (Moonah)	
DBH (cm)	60	
Height (m)	8.3	
Canopy Spread (m)	N	5
	S	6
	E	5
	W	6
Target Potential	1/7	
Impact Potential	1/450	
Probability of Failure	1/1,000	
Risk of Harm	1/3,111,762	
Risk Rating	Very Low

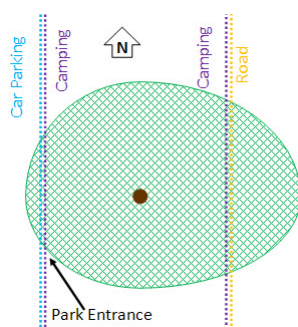
Tree 70

Species		<i>Melaleuca lanceolata</i> (Moonah)
DBH (cm)		62
Height (m)		9.1
Canopy Spread (m)	N	5
	S	4
	E	7
	W	5
Target Potential		1/6
Impact Potential		1/450
Probability of Failure		1/1,000
Risk of Harm		1/2,751,908
Risk Rating		Very Low

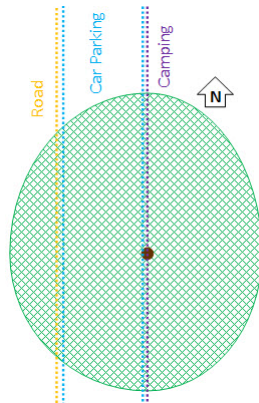
Tree 77

Species	<i>Melaleuca lanceolata</i> (Moonah)	
DBH (cm)	Multi-Stem	
Height (m)	9.8	
Canopy Spread (m)	N	7
	S	6
	E	5
	W	6
Target Potential	1/5	
Impact Potential	1/450	
Probability of Failure	1/1,000	
Risk of Harm	1/2,305,346	
Risk Rating	Very Low

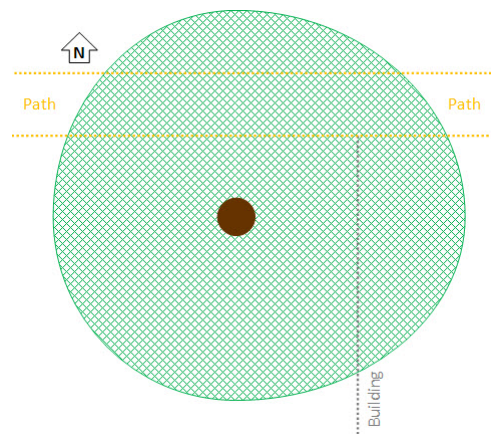
Tree 81

Species	<i>Cupressus macrocarpa</i> (Monterey Cypress)	
DBH (cm)	164	
Height (m)	17.1	
Canopy Spread (m)	N	9
	S	8
	E	10
	W	8
Target Potential	1/2	
Impact Potential	1/81	
Probability of Failure	1/100	
Risk of Harm	1/17,413	
Risk Rating	Medium

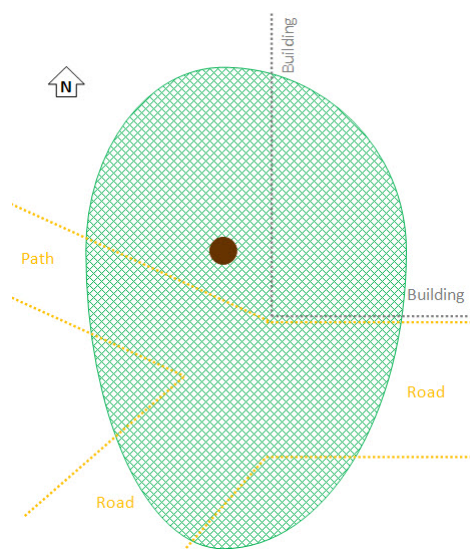
Tree 82

Species	<i>Cupressus macrocarpa</i> (Monterey Cypress)	
DBH (cm)	118	
Height (m)	17.9	
Canopy Spread (m)	N	8
	S	13
	E	8
	W	6
Target Potential	1/2	
Impact Potential	1/81	
Probability of Failure	1/100	
Risk of Harm	1/17,250	
Risk Rating	Medium

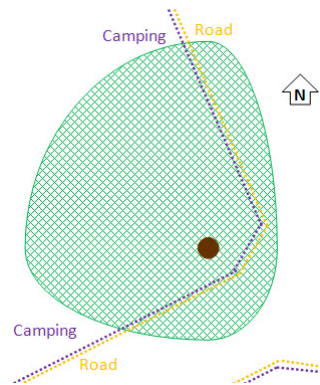
Tree 93

Species		<i>Melaleuca lanceolata</i> (Moonah)
DBH (cm)		91
Height (m)		12.6
Canopy Spread (m)	N	9
	S	4
	E	3
	W	8
Target Potential		1/3
Impact Potential		1/450
Probability of Failure		1/1,000
Risk of Harm		1/1,531,056
Risk Rating		Very Low

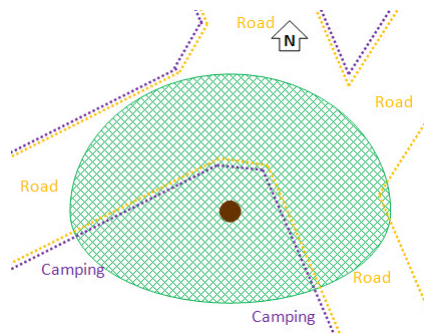
Tree 94

Species		<i>Melaleuca lanceolata</i> (Moonah)
DBH (cm)		Multi-Stem
Height (m)		14.0
Canopy Spread (m)	N	6
	S	4
	E	7
	W	7
Target Potential		1/2
Impact Potential		1/450
Probability of Failure		1/1,000
Risk of Harm		1/921,783
Risk Rating		Low

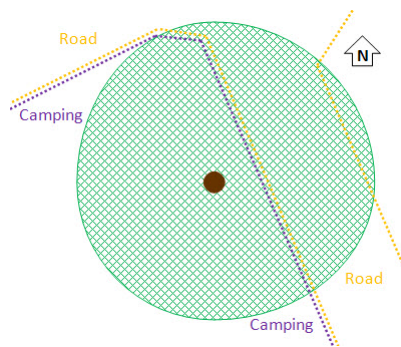
Tree 95

Species	<i>Melaleuca lanceolata</i> (Moonah)	
DBH (cm)	Multi-Stem	
Height (m)	14.4	
Canopy Spread (m)	N	7
	S	6
	E	7
	W	6
Target Potential	1/2	
Impact Potential	1/450	
Probability of Failure	1/1,000	
Risk of Harm	1/934,114	
Risk Rating	Low

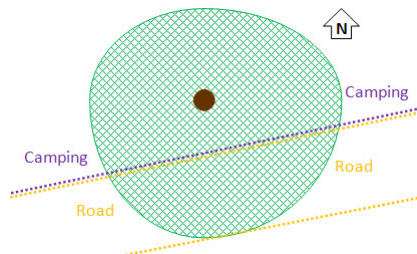
Tree 102

Species	<i>Melaleuca lanceolata</i> (Moonah)	
DBH (cm)	Multi-Stem	
Height (m)	10.4	
Canopy Spread (m)	N	4
	S	6
	E	6
	W	5
Target Potential	1/3	
Impact Potential	1/81	
Probability of Failure	1/1,000	
Risk of Harm	1/257,739	
Risk Rating	Low

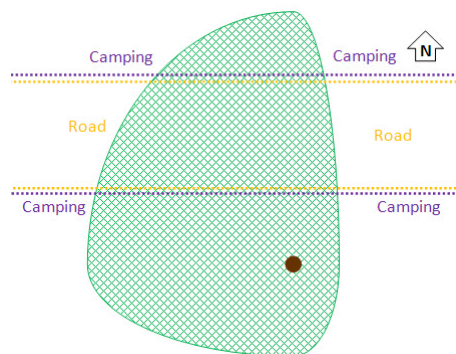
Tree 107

Species	<i>Melaleuca lanceolata</i> (Moonah)	
DBH (cm)	69	
Height (m)	16.5	
Canopy Spread (m)	N	11
	S	4
	E	2
	W	9
Target Potential	1/2	
Impact Potential	1/5	
Probability of Failure	1/10	
Risk of Harm	1/105	
Risk Rating	High

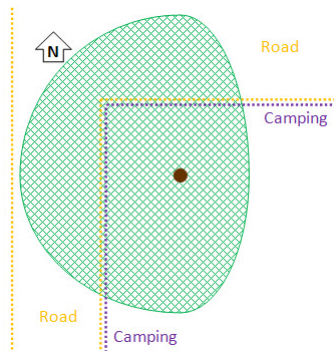
Tree 109

Species	<i>Eucalyptus gomphocephala</i> (Tuart)	
DBH (cm)	58	
Height (m)	12.4	
Canopy Spread (m)	N	7
	S	6
	E	3
	W	7
Target Potential	1/3	
Impact Potential	1/450	
Probability of Failure	1/100	
Risk of Harm	1/137,990	
Risk Rating	Low

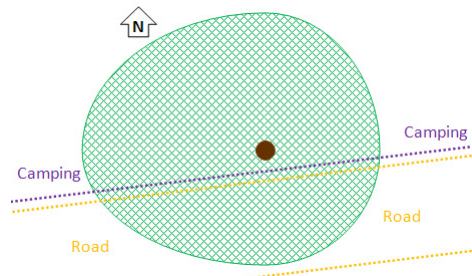
Tree 113

Species	<i>Melaleuca lanceolata</i> (Moonah)	
DBH (cm)	82	
Height (m)	11.3	
Canopy Spread (m)	N	6
	S	5
	E	5
	W	8
Target Potential	1/2	
Impact Potential	1/450	
Probability of Failure	1/1,000	
Risk of Harm	1/1,001,490	
Risk Rating	Very Low

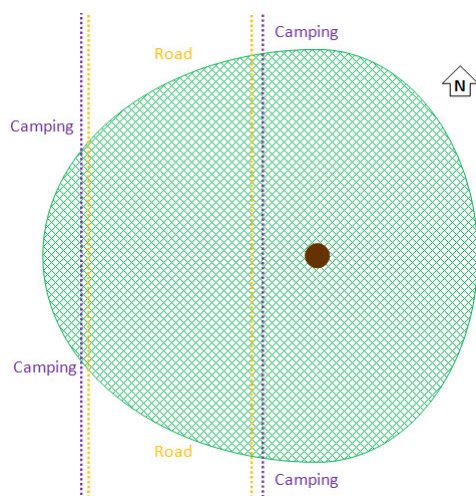
Tree 120

Species	<i>Cupressus macrocarpa</i> (Monterey Cypress)	
DBH (cm)	105	
Height (m)	16.7	
Canopy Spread (m)	N	9
	S	9
	E	7
	W	12
Target Potential	1/2	
Impact Potential	1/81	
Probability of Failure	1/100	
Risk of Harm	1/16,605	
Risk Rating	Medium
