TREE MANAGEMENT, REMOVAL AND REPLACEMENT STRATEGY FOR PRINCESS, CITIZENS AND VICTORIA PARKS BOROUGH OF QUEENSLIFFE

SEPTEMBER 2009

Produced By:

JOHN PATRICK PTY LTD

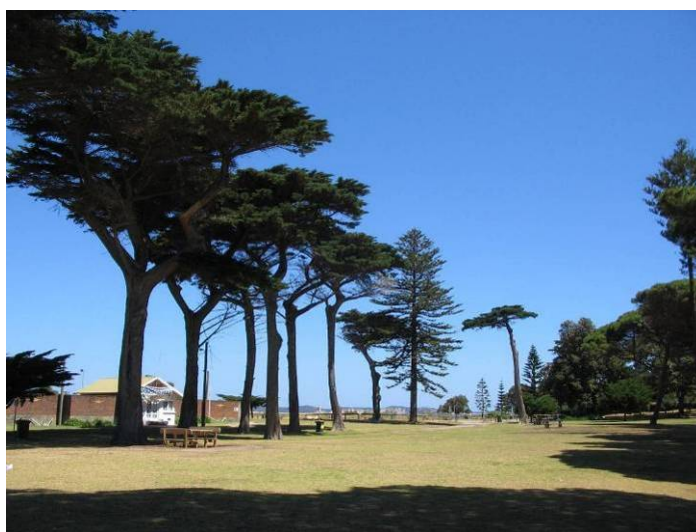
Monterey Cypress have a finite lifespan in Victoria, usually of around 80 to 100 years. Towards the end of their lives these trees tend to start breaking apart with structural defects such as poor branch attachment and trunk decay being common. Generally speaking, old trees are at increased risk of failure due to reduced wood quality and a decreased capacity to prevent the spread of decay.

Figure 4: Over-mature Monterey Cypress within Princess Park

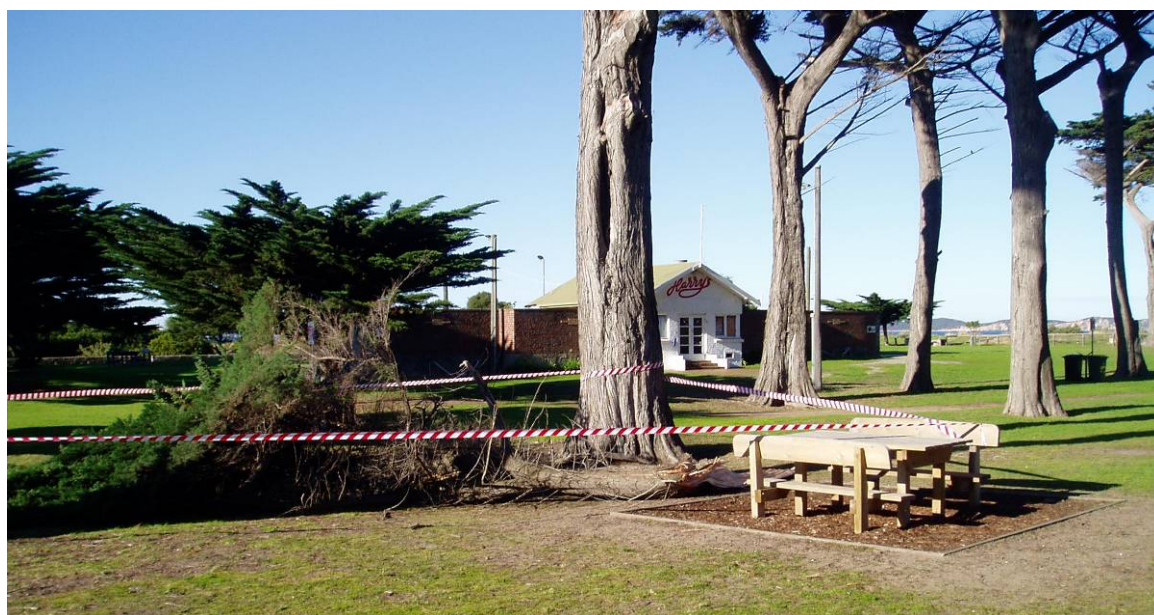
Figure 8: Failed branch from a Princess Park Monterey Cypress (branch failed on or around June 21st 2009). Source: John Henderson, Borough of Queenscliff

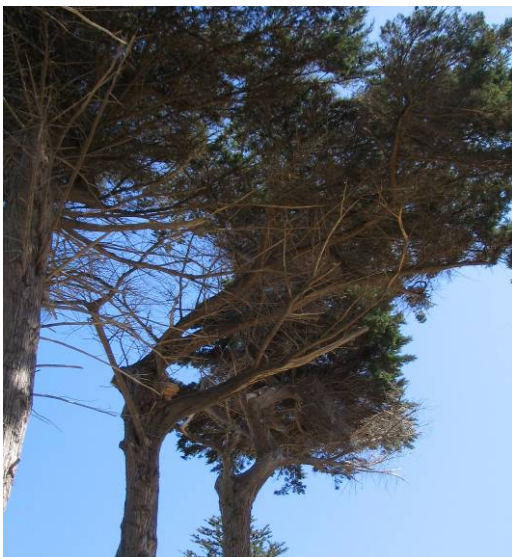
Figure 9: These Monterey Cypress in Princess Park are at the end of their lives. Maintenance would be expensive and provide no long term benefit.

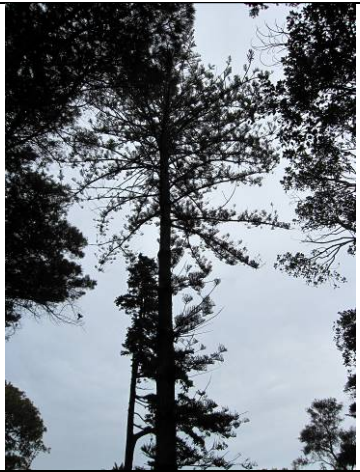
<p>Tree No. 5 <i>Araucaria heterophylla</i>, Norfolk Island Pine Condition: Fair-poor health (reduced canopy) but may improve in health if competition is removed. Recommend stress mitigation works be carried out. Removal Timeframe: 10 years plus</p>

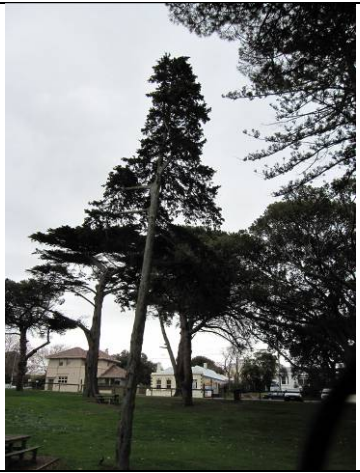
<p>Tree No. 6 <i>Cupressus torulosa</i>, Bhutan Cypress Condition: A spindly tree, but only minor structural defects (damage limbs high). Recommend ongoing inspections and management works to manage risk. Removal Timeframe: 10 years plus</p>

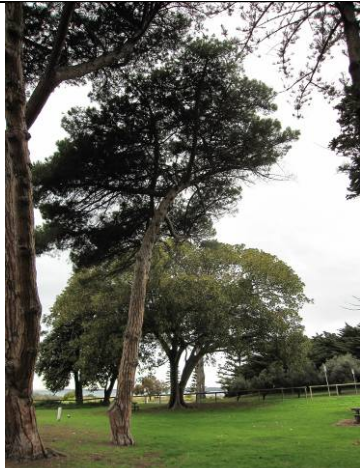
<p>Tree No. 7 <i>Pinus pinea</i>, Stone Pine Condition: One leader remaining of what was once a two leadered tree. Lop sided canopy, but tree is in reasonably good condition. Recommend an aerial examination by an experienced arborist to more fully determine the structural integrity of the tree. Recommend ongoing inspections and maintenance work to aid tree retention and manage risk. Retain only while safe to do so. Retention of the tree should be reconsidered if Tree 8 is removed. Removal Timeframe: 10 years plus</p>

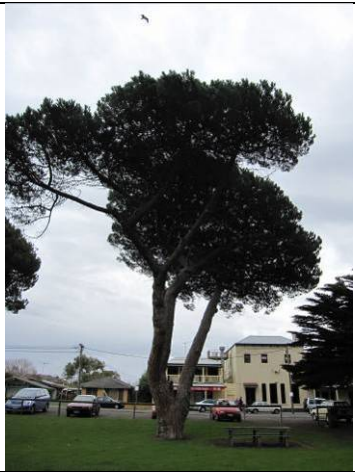
<p>Tree No. 64 <i>Pinus pinea</i>, Stone Pine</p> <p>Condition: A very handsome specimen but must be carefully managed. It is recommended that an urgent aerial inspection of the tree be carried out, including review of the strength of the tree at the deadwood stump at the base. It is recommended that the tree be assessed for the feasibility of cables to aid tree retention. Recommend ongoing inspections and maintenance work to aid tree retention and manage risk. Retain only while safe to do so.</p> <p>Removal Timeframe: 10 years plus (depending on outcome of examination)</p>

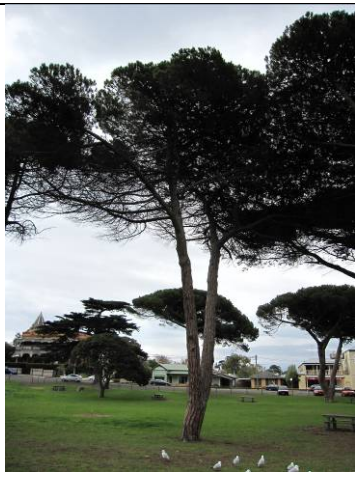
<p>Tree No. 65 <i>Pinus pinea</i>, Stone Pine</p> <p>Condition: Possible cavity in the union of the bifurcation. Recommend urgent investigation of the strength of this union. Bifurcated, but without included bark and tree is relatively healthy. Better than many of the Stone Pines with the exception of the possibly issue with the cavity in the bifurcation. South-west side of the canopy has died back due to previous shading. Recommend an aerial examination by an experienced arborist to more fully determine the structural integrity of the tree. Recommend ongoing inspections and maintenance work to aid tree retention and manage risk. Retain only while safe to do so.</p> <p>Removal Timeframe: 10 years plus</p>

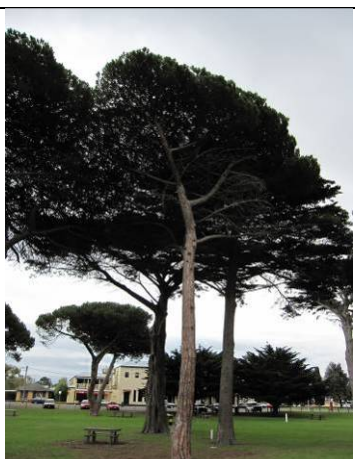
<p>Tree No. 66 <i>Pinus pinea</i>, Stone Pine</p> <p>Condition: One limb left. Good canopy cover but large deadwood present. Recommend an aerial examination by an experienced arborist to more fully determine the structural integrity of the tree. Recommend ongoing inspections and maintenance work to aid tree retention and manage risk. Retain only while safe to do so.</p> <p>Removal Timeframe: 10 years plus</p>

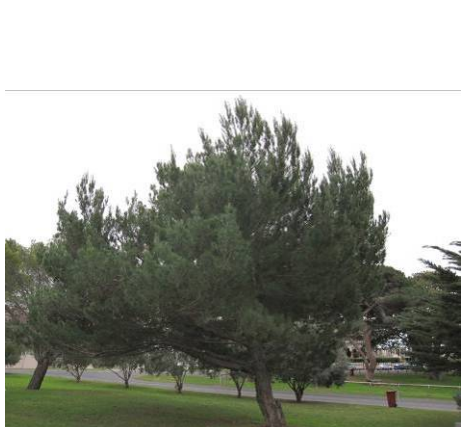
<p>Tree No. 80 Species: <i>Pinus halepensis</i>, Aleppo Pine Condition: A relatively small tree with not especially high amenity value and not a traditional species for this park. Extensive decay present, nearly reaching the root crown. Recommend removal as tree won't develop well and will become increasingly unsound structurally if retained. It is recommend that regular inspections and maintenance work be carried out to manage the stability of the tree leading up to removal. Tree should be removed if inspections indicate it poses an unacceptable risk to the public; even if within the 2-3 year retention period. Removal Timeframe: 2-3 years</p>

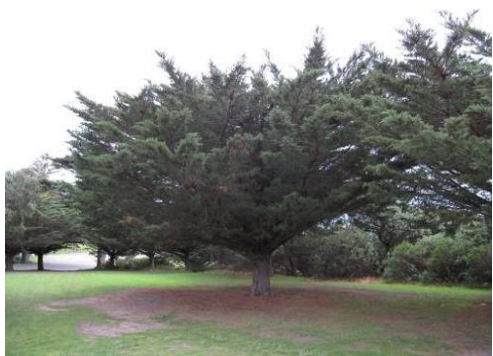
<p>Tree No. 87 <i>Cupressus macrocarpa</i>, Monterey Cypress Condition: A healthy young tree but with a branching structure that may not develop well and may be problematic in the future. Recommend managing the tree to aid retention but also installing replacement planting. Removal Timeframe: 10 years plus</p>

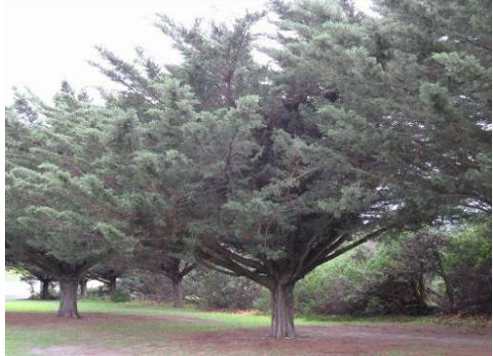
<p>Tree No. 88 <i>Cupressus macrocarpa</i>, Monterey Cypress Condition: A healthy young tree but with a branching structure that may not develop well and may be problematic in the future. Recommend managing the tree to aid retention but also installing replacement planting. Recommend monitoring or removing the low limb to the west with the twisted structure. Removal Timeframe: 10 years plus</p>
 	<p>Tree No. 89 <i>Cupressus macrocarpa</i>, Monterey Cypress Condition: A healthy young tree but with a branching structure that may not develop well and may be problematic in the future. Recommend managing the tree to aid retention but also installing replacement planting. Removal Timeframe: 10 years plus</p>

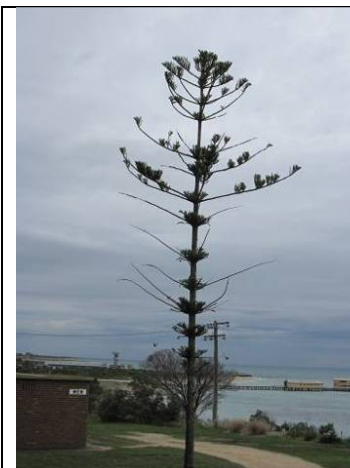
<p>Tree No. 101 <i>Araucaria heterophylla</i>, Norfolk Island Pine Condition: Very poor condition and gash in trunk. Marked as a commemorative tree (1968), but likely to be a replacement planting. Recommend removal and replacement since tree is unlikely to be original. Removal Timeframe: 2-3 years</p>

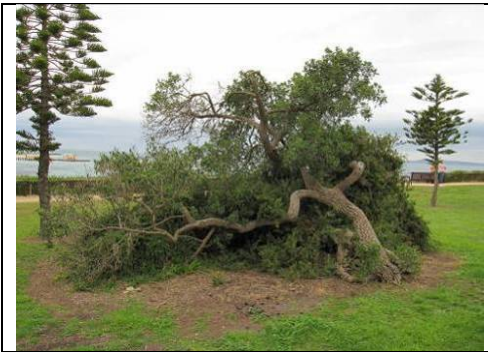
<p>Tree No. 120 <i>Myoporum insulare</i>, Boobialla</p> <p>Condition: Specimen has already collapsed and is unsightly but not dangerous. Excessive growth present. Tree is structurally unsound but is in a mass, and therefore is unlikely to cause damage if it were to fail.</p> <p>Removal Timeframe: 2-3 years.</p>

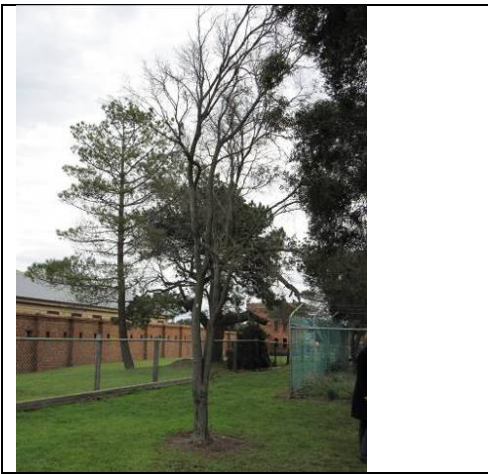
<p>Tree No. 121 <i>Agonis flexuosa</i>, Willow Myrtle</p> <p>Condition: Bifurcated with included bark and dieback in the upper canopy. No development potential and unsightly, but not dangerous.</p> <p>Removal Timeframe: 2-3 years</p>
 	<p>Tree No. 122 <i>Melaleuca lanceolata</i>, Moonah</p> <p>Condition: Handsome, mature twisted tree. Manage in accordance with Section 4.3</p> <p>Coppice Timeframe: 10 years plus</p>

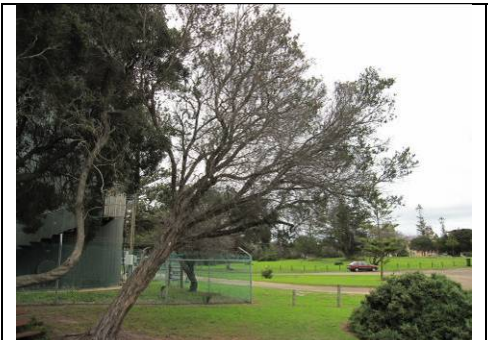
<p>Tree No. 123 <i>Leptospermum laevigatum</i>, Coast Tea-tree</p> <p>Condition: Species falls apart with age, and as this specimen is dieing it may start to collapse. Remove</p> <p>Removal Timeframe: Before next summer.</p>

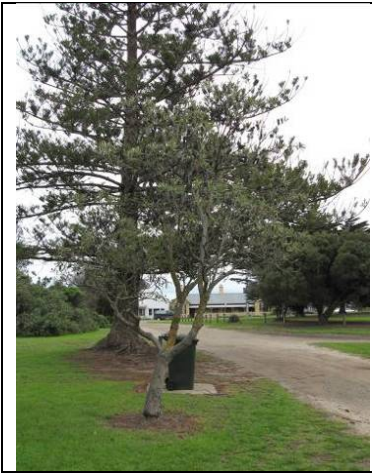
<p>Tree No. 124 <i>Banksia integrifolia</i>, Coast Banksia Condition: Young tree in fair health. No long term viability due to serious damage to the base of the tree. Removal Timeframe: 2-3 years</p>

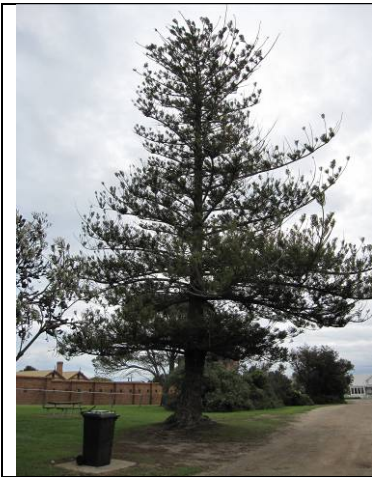
<p>Tree No. 125 <i>Araucaria heterophylla</i>, Norfolk Island Pine Condition: Aerial girdling roots. Large tree in fair health. Young tree. Manage in accordance with Section 4.3. Removal Timeframe: 10 years plus</p>

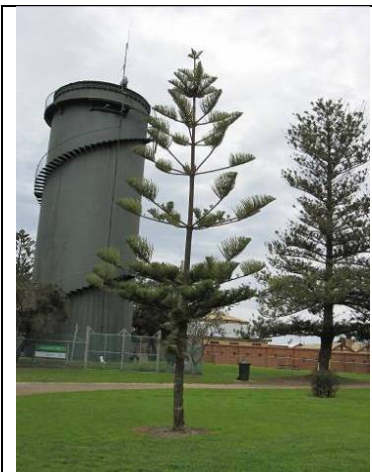
<p>Tree No. 126 <i>Araucaria heterophylla</i>, Norfolk Island Pine Condition: Tree in fair health. Stress mitigation works such as mulch, irrigation and an application of seaweed fertiliser are recommended. Removal Timeframe: 10 years plus</p>

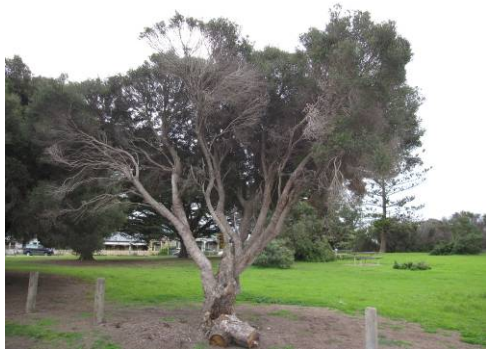
<p>Tree No. 129 <i>Melaleuca lanceolata</i>, Moonah</p> <p>Condition: Has lost a large part of the tree from the base, resulting in half the trunk being missing and severely compromising the tree's longevity. It is recommend that regular inspections and maintenance work be carried out to manage the stability of the tree leading up to removal. Tree should be coppiced if inspections indicate it poses an unacceptable risk to the public; even if within the 2-3 year retention period.</p> <p>Coppice Timeframe: 2-3 years</p>

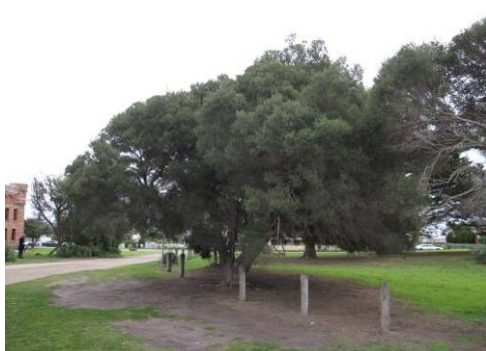
<p>Tree No. 130 <i>Melaleuca lanceolata</i>, Moonah</p> <p>Condition: Young tree with a large number of "witches' brooms". Manage in accordance with Section 4.3</p> <p>Coppice Timeframe: 10 years plus</p>

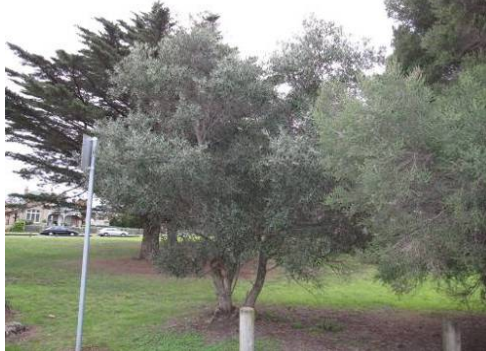
<p>Tree No. 131 <i>Olea europaea</i>, Olive</p> <p>Condition: Young tree. This tree may require removal on environmental grounds (Olives are self seeding into Swan Bay). It is recommended that the Borough assess this and make a decision on retaining or replacing this tree as appropriate. The listed removal time frame does not consider the weed issue, as there was insufficient information available to make a decision.</p> <p>Removal Timeframe: 10 years plus</p>

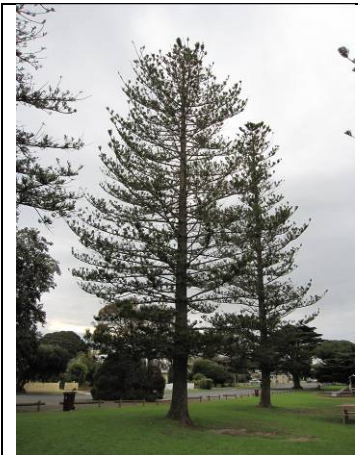
<p>Tree No. 158 <i>Araucaria heterophylla</i>, Norfolk Island Pine Condition: Tree in fair health. Stress mitigation works such as mulch, irrigation and an application of seaweed fertiliser are recommended. Removal Timeframe: 10 years plus</p>

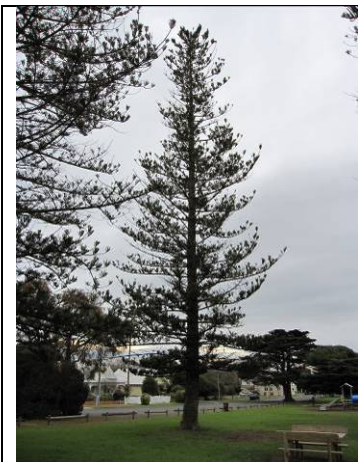
<p>Tree No. 159 <i>Araucaria heterophylla</i>, Norfolk Island Pine Condition: Tree in fair health. Stress mitigation works such as mulch, irrigation and an application of seaweed fertiliser are recommended. Removal Timeframe: 10 years plus</p>

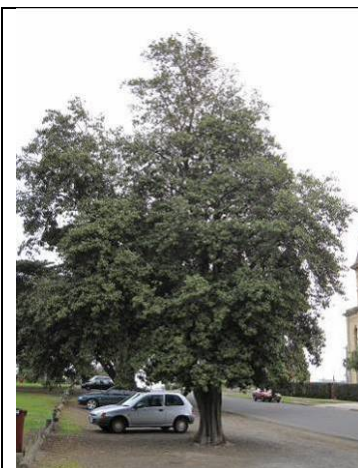
<p>Tree No. 160 <i>Lagunaria patersonia</i>, Norfolk Island Hibiscus Condition: Tree is bifurcated, but this appears to be solid. The fruit of this species has irritant fibres within the seed pods which can cause allergic reactions in some people and are an occupational health and safety concern for tree pruners due to irritation caused by contact with the skin during tree works. It is recommended that council decide whether they are willing to manage and retain this species of tree within their public parks. Removal Timeframe: 10 years plus</p>

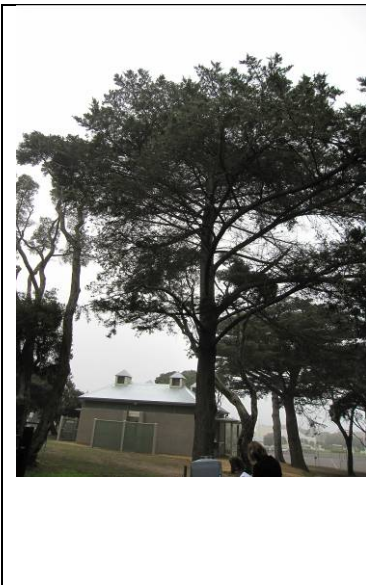
<p>Tree No. 5 <i>Cupressus macrocarpa</i>, Monterey Cypress</p> <p>Condition: Extensive ground disturbance from new tap with subsequent root loss. Recommend that the location of the service is determined and that if this falls within the structural root zone then hand excavation be carried out by an arborist to determine whether root loss has destabilised the tree. If it were not for the potentially compromising root loss then this tree would have good potential longevity. <i>Recommend removal immediately of large, recently failed hanger in canopy.</i> It is recommend that regular inspections and maintenance work be carried out to aid retention of the tree and manage risk. Tree should be removed if inspections indicate it poses an unacceptable risk to the public; even if within the 10 year retention period – especially if root loss has compromised tree health and structure.</p> <p>Removal Timeframe: 10 years plus</p>

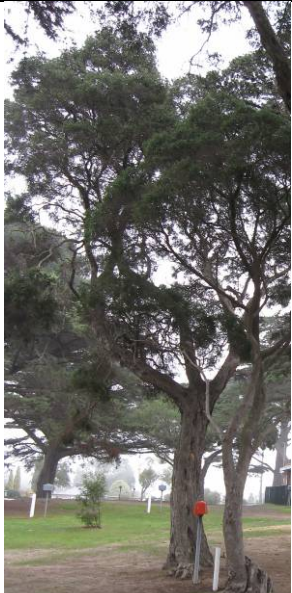
<p>Tree No. 15 <i>Melaleuca lanceolata</i>, Moonah (larger tree, on left of image)</p> <p>Condition: Large old tree. Hollow present and potential dieback in trunk. It is recommend that regular inspections and maintenance work be carried out to aid retention of the tree and manage risk. Tree should be coppiced if inspections indicate it poses an unacceptable risk to the public; even if within the 10 year retention period.</p> <p>Coppice Timeframe: 10 years plus</p>

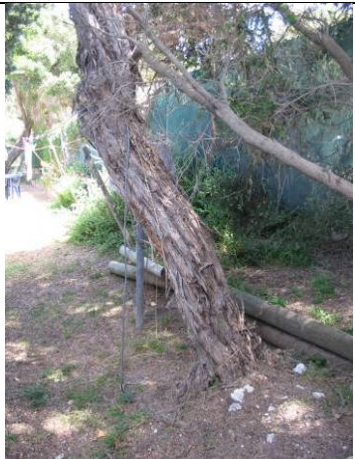
<p>Tree No. 28 <i>Leptospermum laevigatum</i>, Coast Tea-tree</p> <p>Condition: Recommend ongoing monitoring of the tree. Install replacement planting a suitable distance from tree 22.</p> <p>Removal Timeframe: 10 years plus</p>

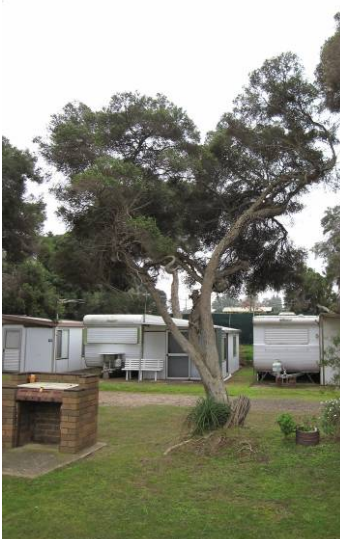
<p>Tree No. 37 <i>Melaleuca lanceolata</i>, Moonah</p> <p>Condition: It is recommend that regular inspections and maintenance work be carried out to manage the stability of the tree. Tree should be coppiced if inspections indicate it poses an unacceptable risk to the public; even if within the 10 year retention period.</p> <p><i>Before next summer it is recommended that:</i></p> <ul style="list-style-type: none"> <i>a) the deformed branch to the north be removed</i> <i>b) the lower limb to the east be removed and</i> <i>c) the feasibility of cabling/bracing the tree be investigated and that works subsequently be carried out if possible.</i> <p>Tree is located within a "Potential Moonah Reserve". If this reserve is adopted than the tree should be fenced rather than coppiced.</p> <p>Coppice Timeframe: 10 years plus or retain in "Moonah Reserve"</p>

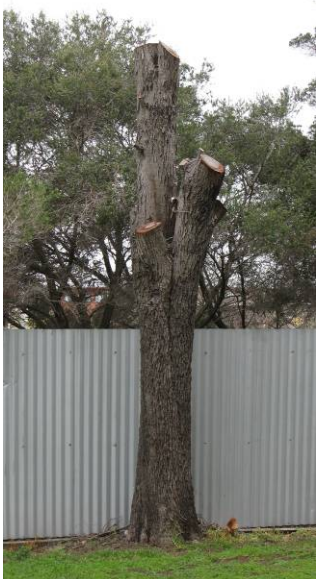
<p>Tree No. 58 Species: <i>Allocasuarina verticillata</i>, Drooping She-oak Condition: Tree was in very poor condition at the time of the first inspection. This failure risk has been partially mitigated by extensive pruning. <i>The tree has no viability and is recommended for outright removal before next summer.</i> Recommend replacement with a Moonah. Removal Timeframe: Before next summer</p>

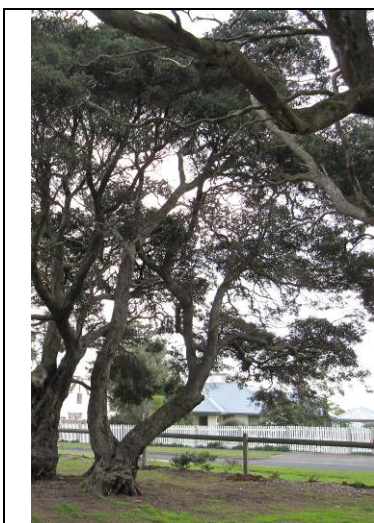
<p>Tree No. 71 <i>Melaleuca lanceolata</i>, Moonah</p> <p>Condition: Dieback in union of major limb. <i>Recommend fencing of the tree to exclude public access before next summer.</i> Tree is recommended for retention within a "Moonah Reserve" with management works to manage parts of the tree with a drop zone outside the fence.</p> <p>Coppice Timeframe: Retain in "Moonah Reserve"</p>

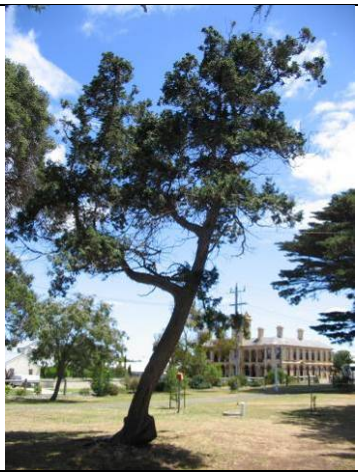
<p>Tree No. 85 <i>Cupressus lusitanica</i>, Mexican Cypress</p> <p>Condition: Structurally, the tree is comprised of one main limb originating from the main trunk which is growing horizontally, with the rest of the tree past this limb having been removed. This puts the tree at risk of failure, and given its presence in a camping ground and the tree's low amenity value retention is undesirable and it is recommended that the tree be removed and replaced in the short term. Removing arborists should be aware of nails in the trunk of the tree.</p> <p>Removal Timeframe: Before next summer</p>

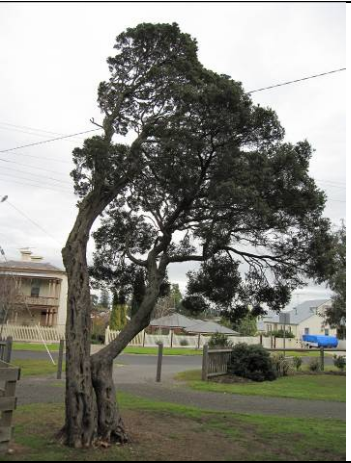
<p>Tree No. 86 <i>Melaleuca lanceolata</i>, Moonah</p> <p>Condition: Some fungal growth / decay present. Tree showing sign of basal line trimmer damage. It is recommend that regular inspections and maintenance work be carried out to aid retention of the tree and manage risk. Especially attention should be paid to monitoring the decay, especially the fungal growth in an elbow of one of the branches. This branch should be monitored carefully and removed when required. Tree should be coppiced if inspections indicate it poses an unacceptable risk to the public; even if within the 10 year retention period.</p> <p>Coppice Timeframe: 10 years plus</p>

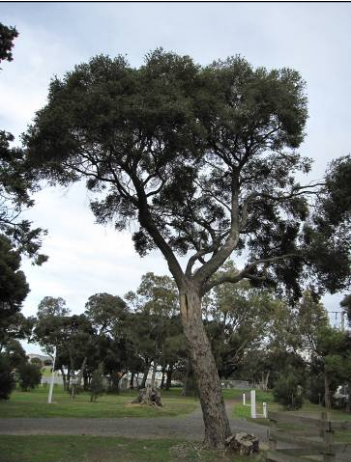
<p>Tree No. 87 <i>Melaleuca lanceolata</i>, Moonah</p> <p>Condition: <i>Remove damaged limb over path immediately.</i> This limb is damaged on top and bark is showing compression stress beneath. Hollow in trunk. It is recommend that regular inspections and maintenance work be carried out to manage the stability of the tree. Especial attention should be taken to the basal integrity of the tree. Tree should be coppiced if inspections indicate it poses an unacceptable risk to the public; even if within the 10year retention period. Extensive replanting which has taken place in the area is beneficial.</p> <p>Coppice Timeframe: 10 years plus</p>

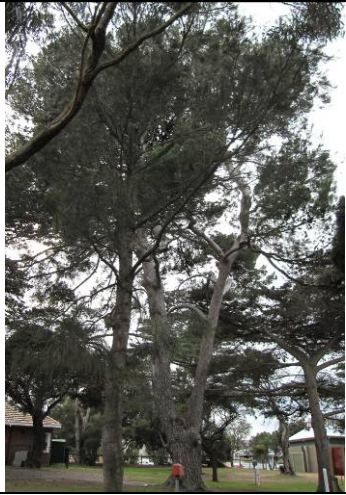
<p>Tree No. 90</p> <p>Species: <i>Allocasuarina sp.</i>, Sheoak</p> <p>Condition: A young tree suffering from competition with other specimens. Manage in accordance with section 4.3.2.</p> <p>Removal Timeframe: 10 years plus</p>
 	<p>Tree No. 91 <i>Melaleuca lanceolata</i>, Moonah</p> <p>Condition: Tree has a major basal wound, but has been propped to help support the tree. This reduces the risk of the tree failing and could be used elsewhere in the park. Props need ongoing monitoring. It may be beneficial to add asphalt packing between the limbs and the props.</p> <p>Coppice Timeframe: 10 years plus</p>

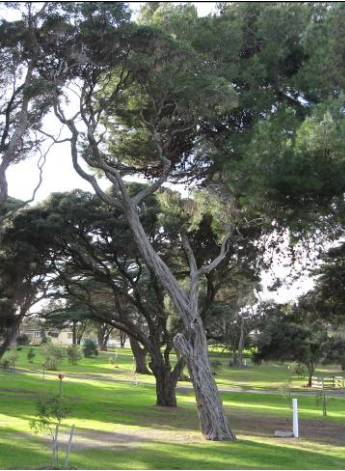
<p>Tree No. 105 <i>Melaleuca lanceolata</i>, Moonah</p> <p>Condition: Mature, bifurcated tree. One tract of decay. It is recommend that regular inspections and maintenance work be carried out to aid retention of the tree and manage risk. Particular attention should be paid to the decayed limb, with this being removed when inspections indicate it is necessary. Tree should be coppiced if inspections indicate it poses an unacceptable risk to the public; even if within the 10 year retention period.</p> <p>Tree is located within a "Potential Moonah Reserve". If this reserve is adopted than the tree should be fenced rather than coppiced.</p> <p>Coppice Timeframe: 10 years plus or retain in "Moonah Reserve"</p>

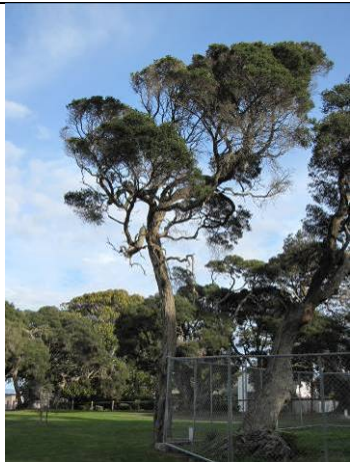
<p>Tree No. 114 <i>Melaleuca lanceolata</i>, Moonah</p> <p>Condition: Not an especially healthy tree and has limited viability. Tree may senesce within the 10 year timeframe, but given the species it is recommended for retention for as long as it is safe to do so.</p> <p>Coppice Timeframe: 10 years plus</p>

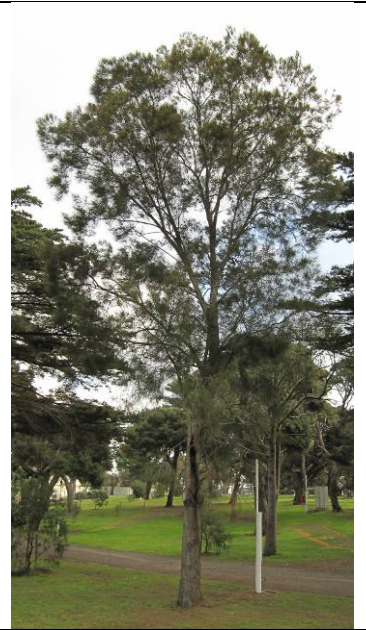
<p>Tree No. 121 <i>?Allocasuarina sp.</i>, Sheoak</p> <p>Condition: Tree has a major structural defect and is in a high target area adjacent to a tap.</p> <p>Removal Timeframe: Before next summer</p>

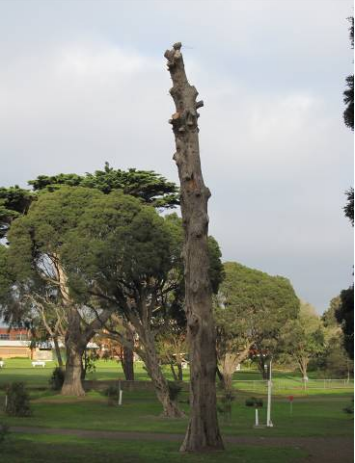
<p>Tree No. 124 <i>Cupressus macrocarpa</i>, Monterey Cypress</p> <p>Condition: Only trunk left (rest removed). Recommend completion of removal before next summer.</p> <p>Removal Timeframe: Before next summer</p>
