Health and Condition Report

Assessment of the Queenscliff Avenue of Honour.

Friday, 1 March 2024

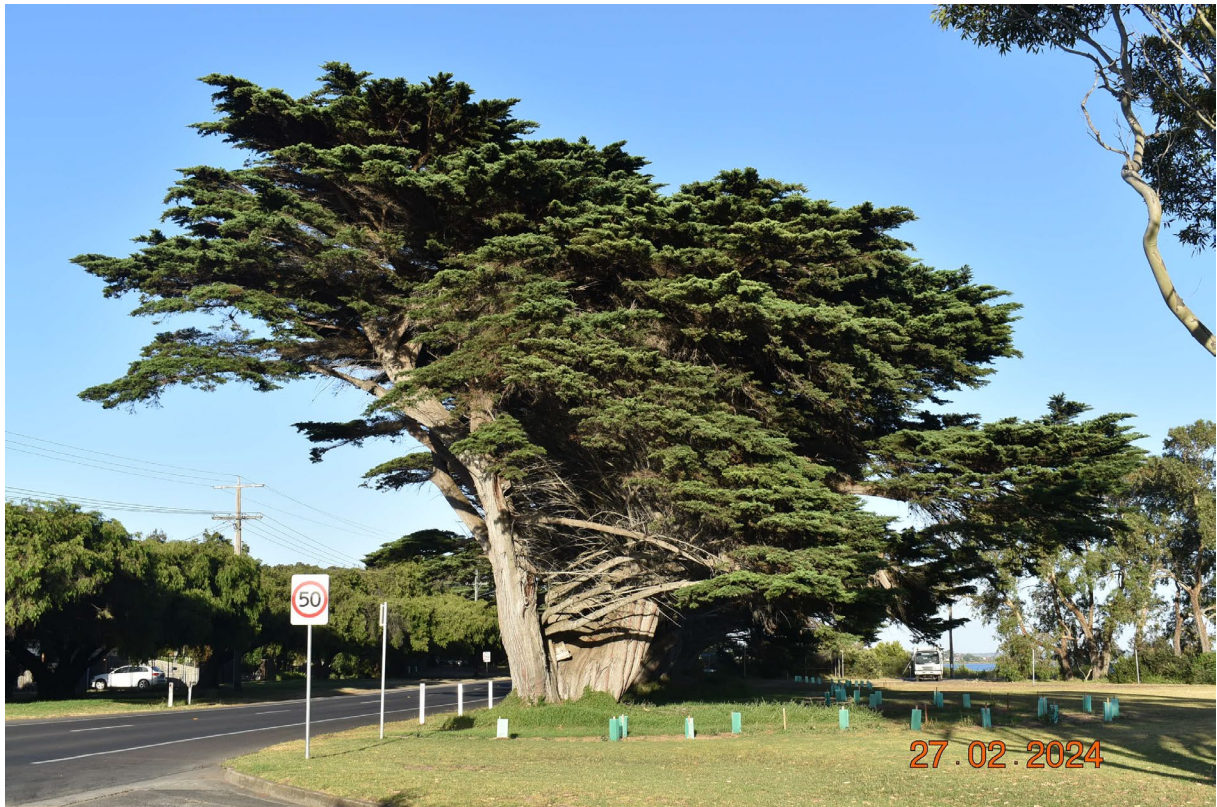
Figure 2: The Old Queenscliff High School Site individuals now underplanted and mulched to exclude informal parking.

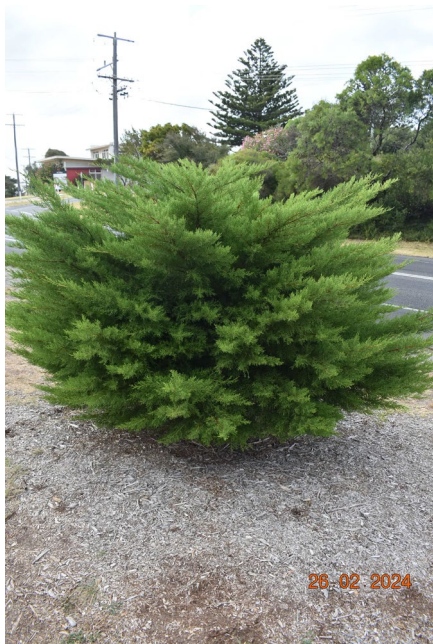
Figure 3: Tree 122, an example of the 'Good' tree stock

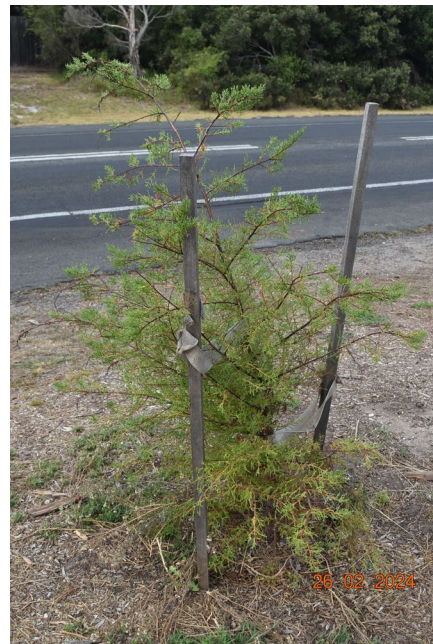
Trees 123, 127, 135, and 142 appear to have been planted more recently and have failed thus far to effectively establish. All four trees are in poor health and while they are tagged as being the correct species, they don't appear to be taking on the same form as the aforementioned good nursery stock. The trees should be actively managed and monitored closely over the coming year and should be removed and replaced if necessary.

Figure 4: Tree 123, an example of the 'Poor' tree stock

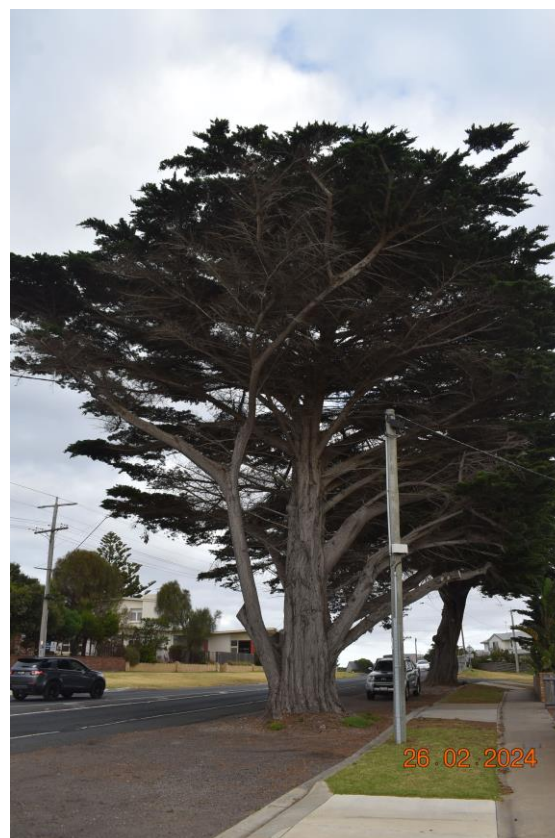
Asset ID:	3
Botanical Name:	<i>Hesperocyparis macrocarpa</i>
Common Name:	Monterey Cypress
Origin:	Exotic
DBH (cm):	185
Height & Width (m):	18 x 18
Maturity:	Mature
Health:	Fair
Structure:	Poor
ULE:	5 to 10 years
Retention Value:	High
Works:	Individual branch removal
Priority:	High
Comments:	Remove splitting branch over footpath

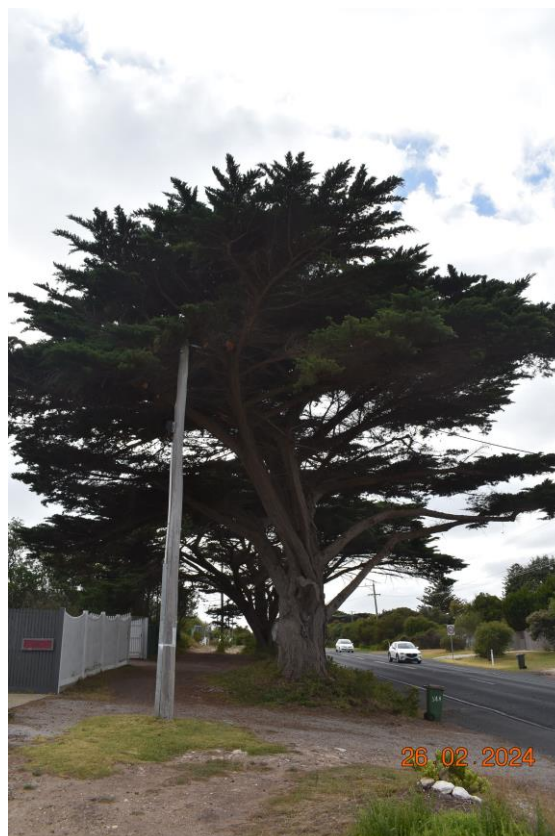
Asset ID:	13
Botanical Name:	<i>Hesperocyparis macrocarpa</i>
Common Name:	Monterey Cypress
Origin:	Exotic
DBH (cm):	290
Height & Width (m):	15 x 21
Maturity:	Mature
Health:	Fair
Structure:	Poor
ULE:	5 to 10 years
Retention Value:	High
Works:	Individual branch removal, Deadwood removal, Broken branch removal
Priority:	High
Comments:	Splitting and broken branch on reserve side

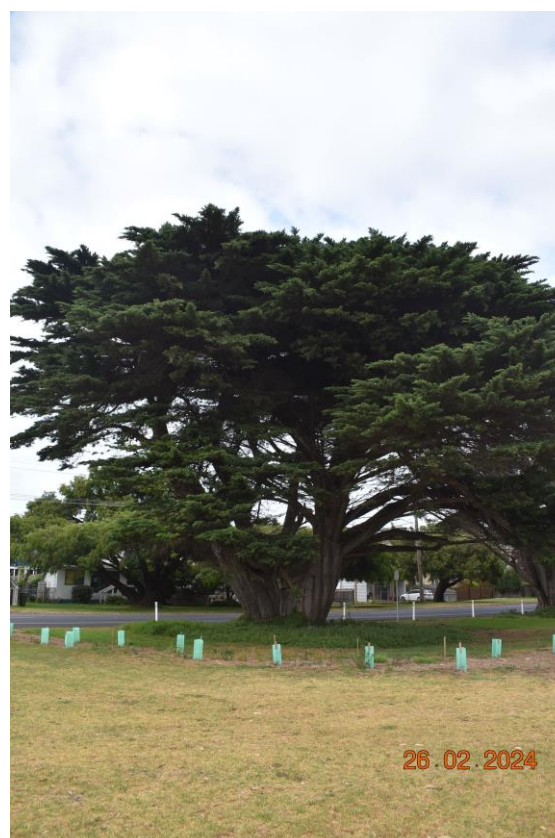
Asset ID:	14
Botanical Name:	<i>Hesperocyparis macrocarpa</i>
Common Name:	Monterey Cypress
Origin:	Exotic
DBH (cm):	280
Height & Width (m):	17 x 20
Maturity:	Mature
Health:	Fair
Structure:	Poor
ULE:	5 to 10 years
Retention Value:	High
Works:	Risk reduction pruning, Deadwood removal
Priority:	Moderate
Comments:	20% reduction over road, max diameter cut of 70mm

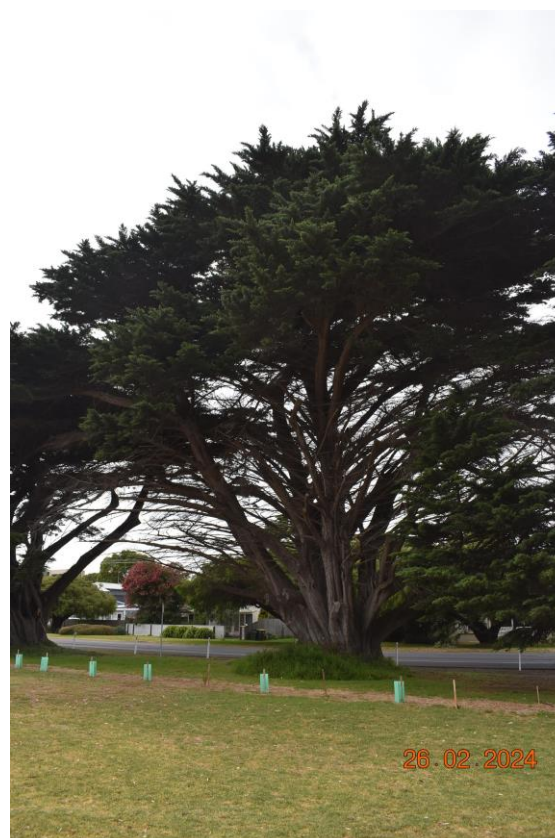
Asset ID:	15
Botanical Name:	<i>Hesperocyparis macrocarpa</i>
Common Name:	Monterey Cypress
Origin:	Exotic
DBH (cm):	290
Height & Width (m):	15 x 22
Maturity:	Mature
Health:	Fair
Structure:	Poor
ULE:	5 to 10 years
Retention Value:	High
Works:	Deadwood removal, Risk reduction pruning
Priority:	Moderate
Comments:	20% reduction over road, max diameter cut of 70mm

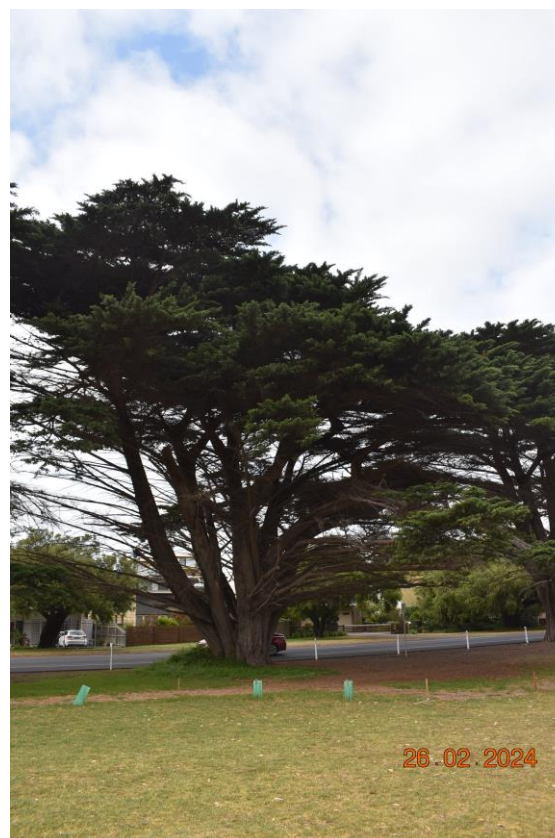
Asset ID:	16
Botanical Name:	<i>Hesperocyparis macrocarpa</i>
Common Name:	Monterey Cypress
Origin:	Exotic
DBH (cm):	260
Height & Width (m):	16 x 21
Maturity:	Mature
Health:	Fair
Structure:	Poor
ULE:	5 to 10 years
Retention Value:	High
Works:	Risk reduction pruning, Deadwood removal
Priority:	Moderate
Comments:	20% reduction over road, max diameter cut of 70mm

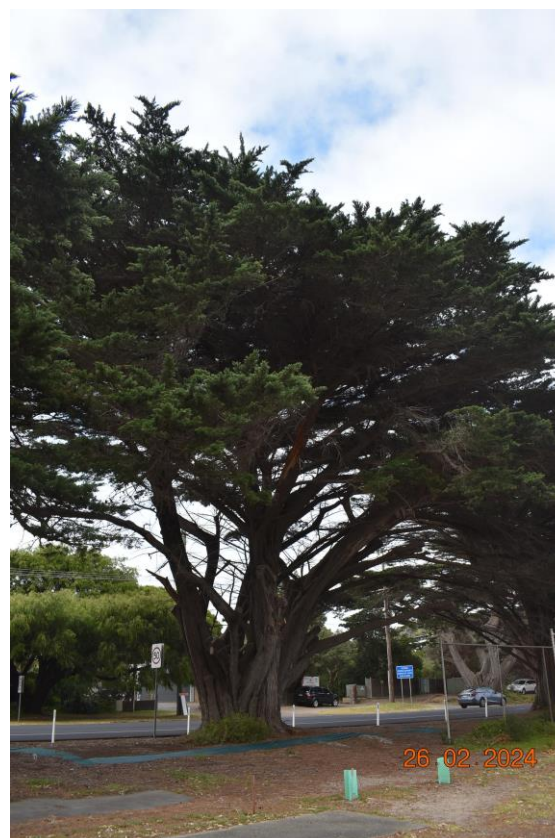
Asset ID:	18
Botanical Name:	<i>Hesperocyparis macrocarpa</i>
Common Name:	Monterey Cypress
Origin:	Exotic
DBH (cm):	185
Height & Width (m):	15 x 19
Maturity:	Mature
Health:	Fair
Structure:	Fair
ULE:	10 to 20 years
Retention Value:	High
Works:	Broken branch removal, Deadwood removal
Priority:	Moderate
Comments:	Small hanging branch

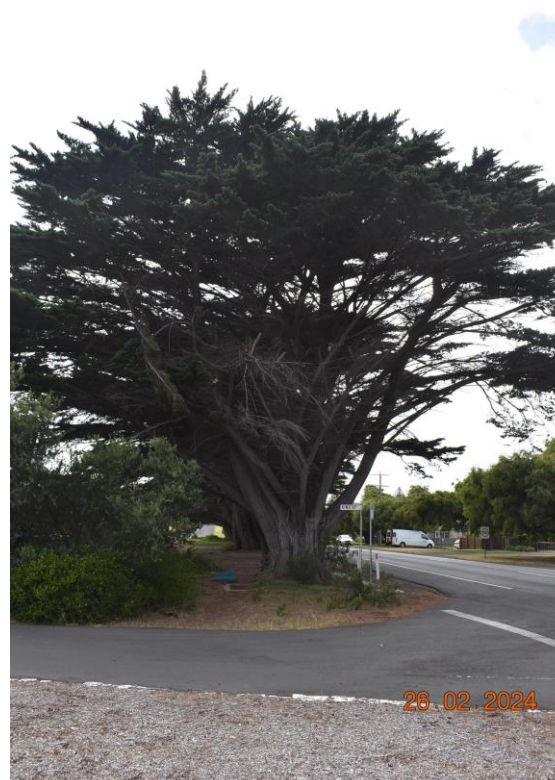
Asset ID:	20
Botanical Name:	<i>Hesperocyparis macrocarpa</i>
Common Name:	Monterey Cypress
Origin:	Exotic
DBH (cm):	200
Height & Width (m):	13 x 20
Maturity:	Mature
Health:	Fair
Structure:	Poor
ULE:	5 to 10 years
Retention Value:	High
Works:	Risk reduction pruning, Deadwood removal
Priority:	Moderate
Comments:	20% reduction of exposed branch over footpath, max diameter cut of 70mm

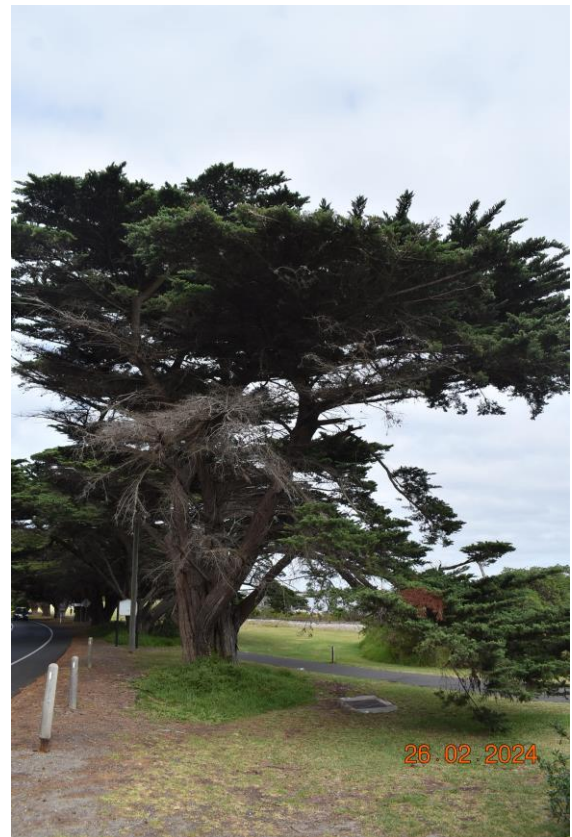
Asset ID:	21
Botanical Name:	<i>Hesperocyparis macrocarpa</i>
Common Name:	Monterey Cypress
Origin:	Exotic
DBH (cm):	165
Height & Width (m):	13 x 20
Maturity:	Mature
Health:	Fair
Structure:	Poor
ULE:	5 to 10 years
Retention Value:	High
Works:	Mulch rootzone, Deadwood removal, Risk reduction pruning
Priority:	Moderate
Comments:	20% reduction of branches over footpath and road, max diameter cut of 70mm

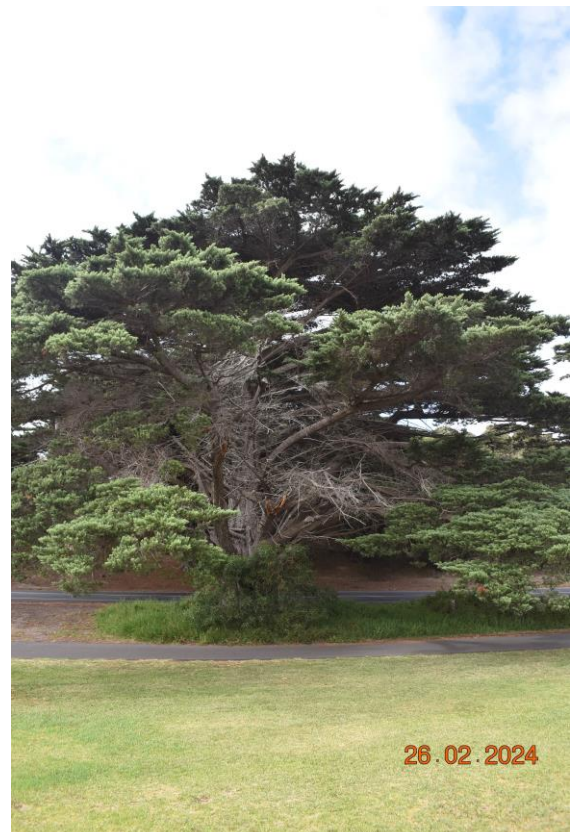
Asset ID:	22
Botanical Name:	<i>Hesperocyparis macrocarpa</i>
Common Name:	Monterey Cypress
Origin:	Exotic
DBH (cm):	195
Height & Width (m):	14 x 21
Maturity:	Mature
Health:	Fair
Structure:	Poor
ULE:	5 to 10 years
Retention Value:	High
Works:	Deadwood removal, Risk reduction pruning
Priority:	Moderate
Comments:	20% reduction over footpath and road, max diameter cut of 70mm

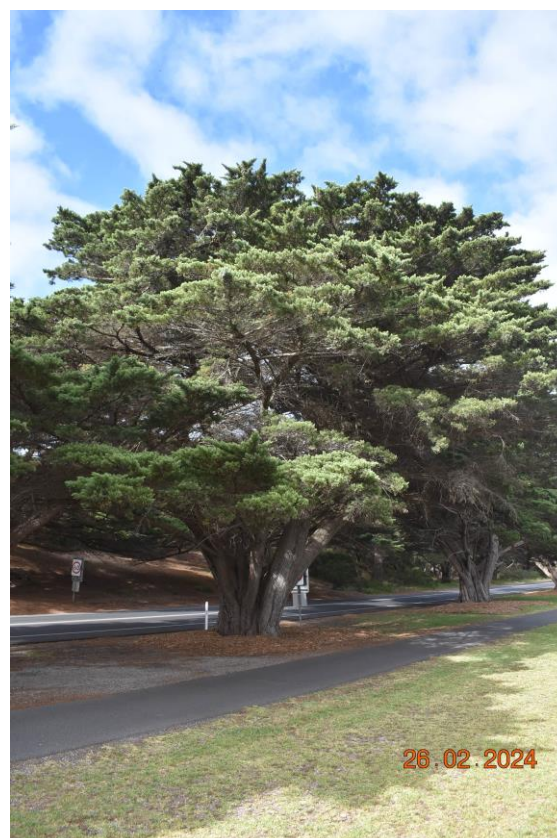
Asset ID:	24
Botanical Name:	<i>Hesperocyparis macrocarpa</i>
Common Name:	Monterey Cypress
Origin:	Exotic
DBH (cm):	180
Height & Width (m):	12 x 22
Maturity:	Mature
Health:	Fair
Structure:	Poor
ULE:	5 to 10 years
Retention Value:	High
Works:	Broken branch removal, Deadwood removal
Priority:	Moderate
Comments:	Small broken branch

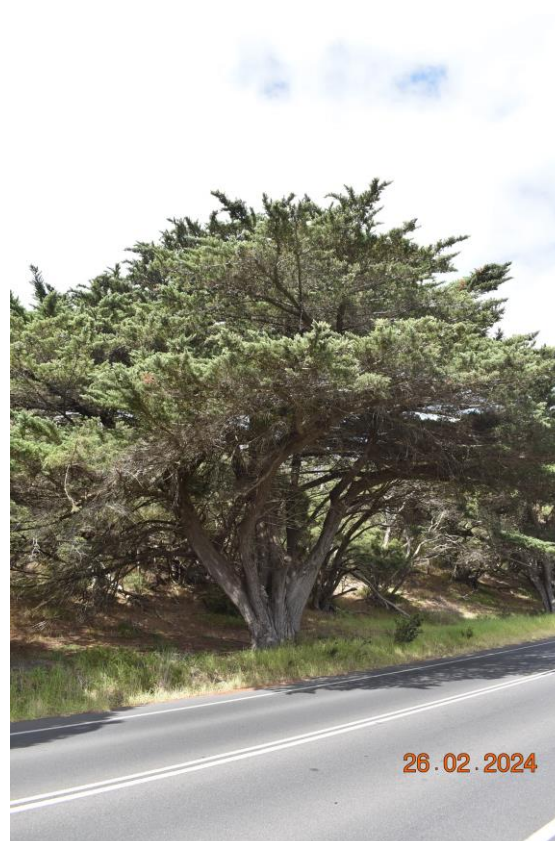
Asset ID:	34
Botanical Name:	<i>Hesperocyparis macrocarpa</i>
Common Name:	Monterey Cypress
Origin:	Exotic
DBH (cm):	185
Height & Width (m):	12 x 19
Maturity:	Mature
Health:	Fair
Structure:	Poor
ULE:	5 to 10 years
Retention Value:	High
Works:	Deadwood removal
Priority:	Low
Comments:	Fire damage

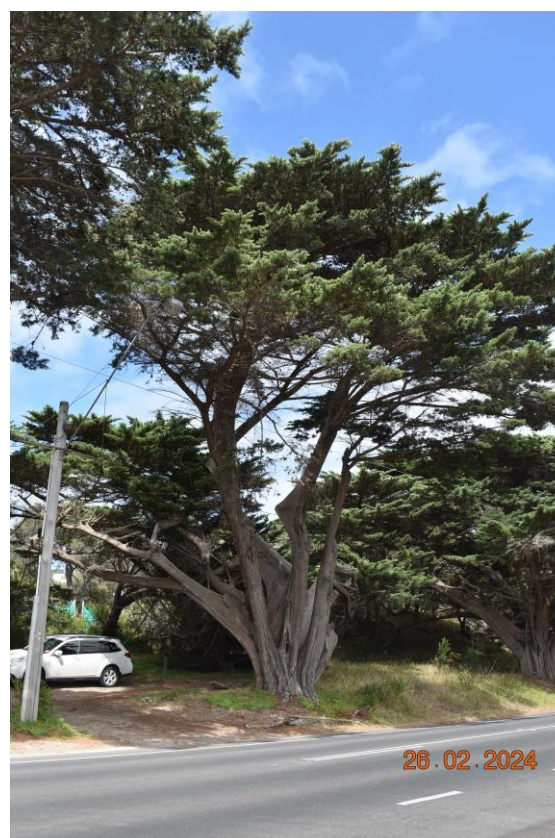
Asset ID:	44
Botanical Name:	<i>Hesperocyparis macrocarpa</i>
Common Name:	Monterey Cypress
Origin:	Exotic
DBH (cm):	300
Height & Width (m):	15 x 22
Maturity:	Mature
Health:	Fair
Structure:	Poor
ULE:	5 to 10 years
Retention Value:	High
Works:	Risk reduction pruning, Deadwood removal
Priority:	Moderate
Comments:	Further reduce decayed limb over informal carparking adjacent to camp entrance

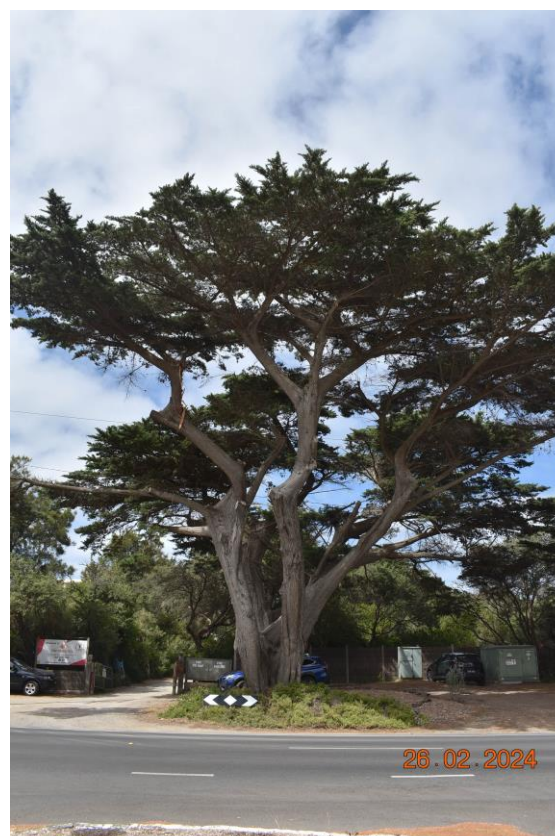
Asset ID:	45
Botanical Name:	<i>Hesperocyparis macrocarpa</i>
Common Name:	Monterey Cypress
Origin:	Exotic
DBH (cm):	250
Height & Width (m):	16 x 20
Maturity:	Mature
Health:	Fair
Structure:	Poor
ULE:	5 to 10 years
Retention Value:	High
Works:	Risk reduction pruning, Mulch rootzone, Deadwood removal
Priority:	Moderate
Comments:	20% reduction over road and footpath, max diameter cut of 70mm

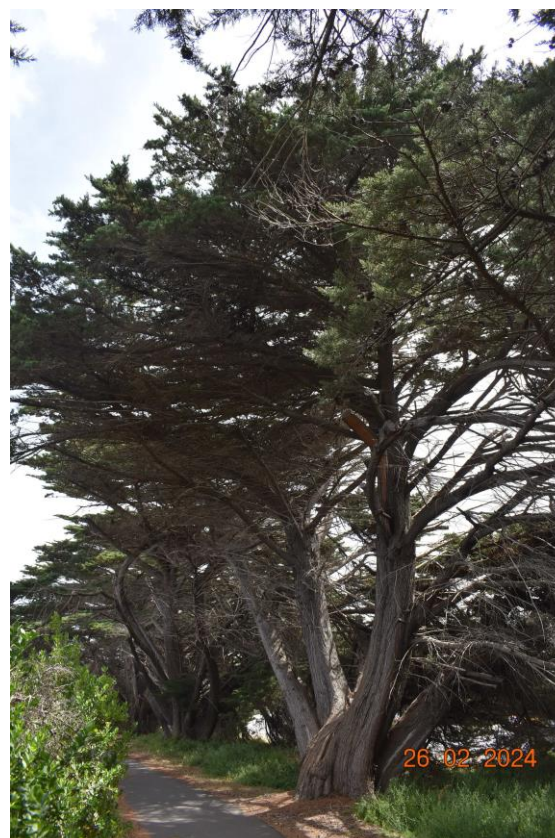
Asset ID:	87
Botanical Name:	<i>Hesperocyparis macrocarpa</i>
Common Name:	Monterey Cypress
Origin:	Exotic
DBH (cm):	220
Height & Width (m):	15 x 23
Maturity:	Mature
Health:	Fair
Structure:	Poor
ULE:	5 to 10 years
Retention Value:	High
Works:	Individual branch removal, Deadwood removal, Other
Priority:	Moderate
Comments:	Clean up larger failure wounds with active splits, above footpath, remove extended and exposed branch over footpath

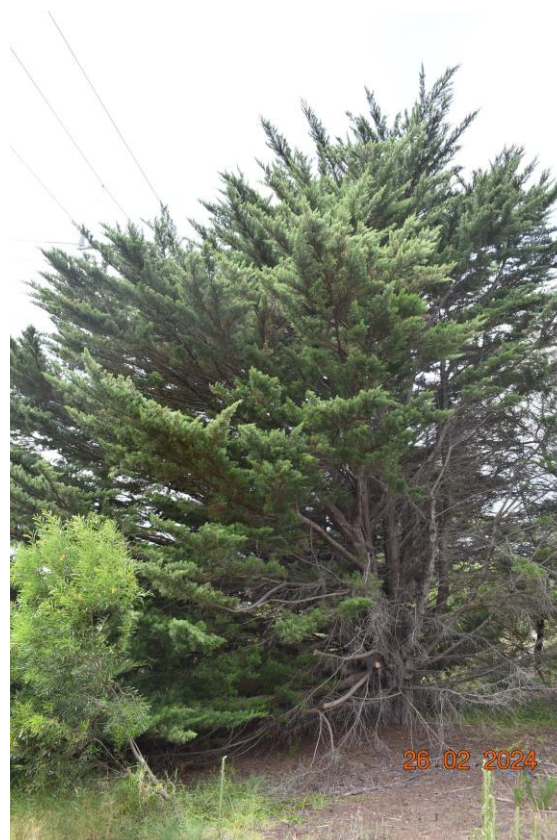
Asset ID:	96
Botanical Name:	<i>Hesperocyparis macrocarpa</i>
Common Name:	Monterey Cypress
Origin:	Exotic
DBH (cm):	275
Height & Width (m):	17 x 20
Maturity:	Mature
Health:	Fair
Structure:	Poor
ULE:	5 to 10 years
Retention Value:	High
Works:	Other, Deadwood removal
Priority:	Moderate
Comments:	Clean up large failure wounds over footpath

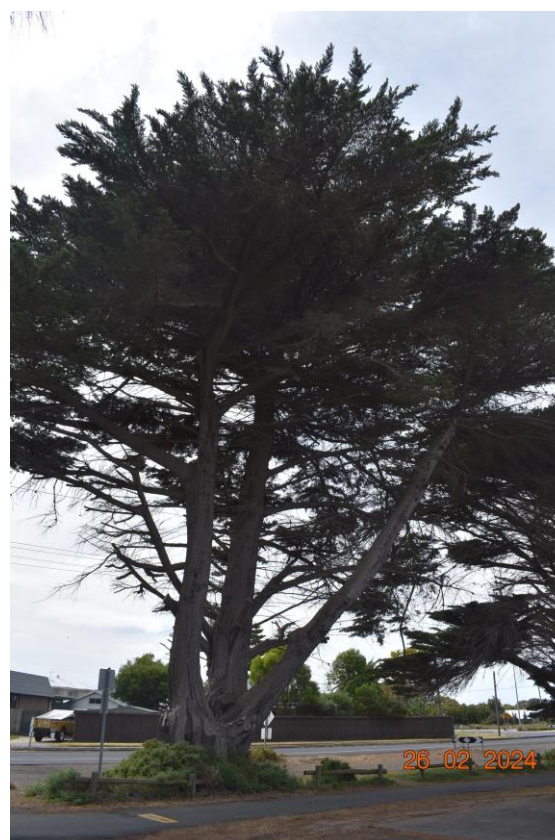
Asset ID:	102
Botanical Name:	<i>Hesperocyparis macrocarpa</i>
Common Name:	Monterey Cypress
Origin:	Exotic
DBH (cm):	175
Height & Width (m):	15 x 17
Maturity:	Mature
Health:	Fair
Structure:	Poor
ULE:	5 to 10 years
Retention Value:	High
Works:	Deadwood removal, Codominant reduction
Priority:	Low
Comments:	Continue reduction of canopy stem with longitudinal crack

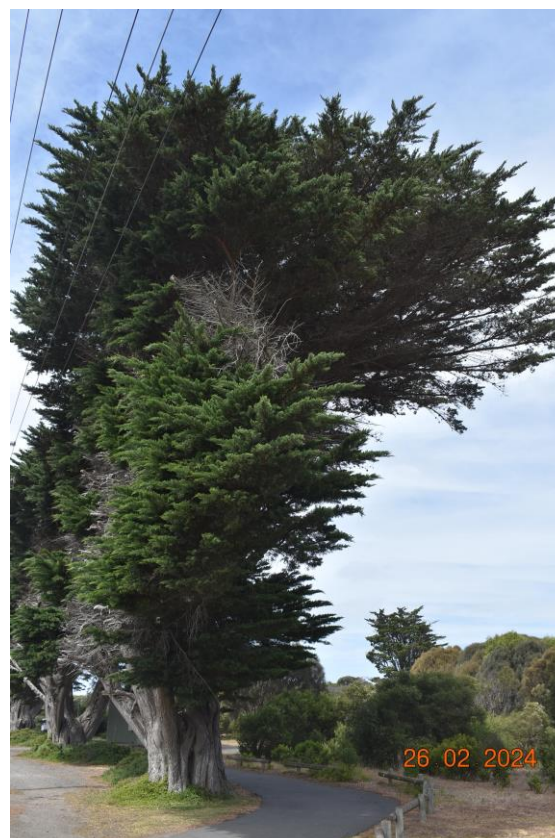
Asset ID:	105
Botanical Name:	<i>Hesperocyparis macrocarpa</i>
Common Name:	Monterey Cypress
Origin:	Exotic
DBH (cm):	130
Height & Width (m):	15 x 17
Maturity:	Mature
Health:	Fair
Structure:	Poor
ULE:	10 to 20 years
Retention Value:	High
Works:	Deadwood removal, Broken branch removal
Priority:	Moderate
Comments:	Broken branches on north western side of canopy

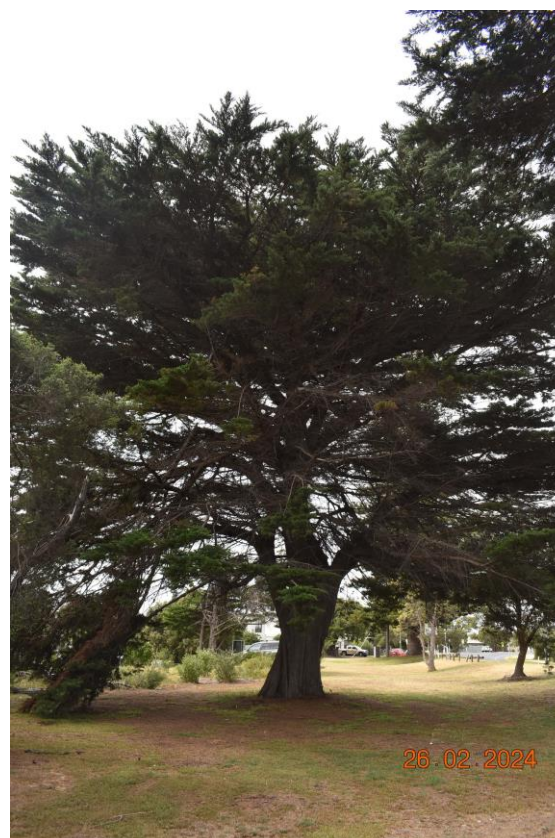
Asset ID:	106
Botanical Name:	<i>Hesperocyparis macrocarpa</i>
Common Name:	Monterey Cypress
Origin:	Exotic
DBH (cm):	155
Height & Width (m):	16 x 17
Maturity:	Mature
Health:	Fair
Structure:	Poor
ULE:	5 to 10 years
Retention Value:	High
Works:	Individual branch removal
Priority:	High
Comments:	Remove historically split canopy branch bent and resting upon two supporting failure stubs over carparking
