Avenue of Honour Tree Management and Replacement Plan

Homewood Consulting Pty Ltd

May 2015

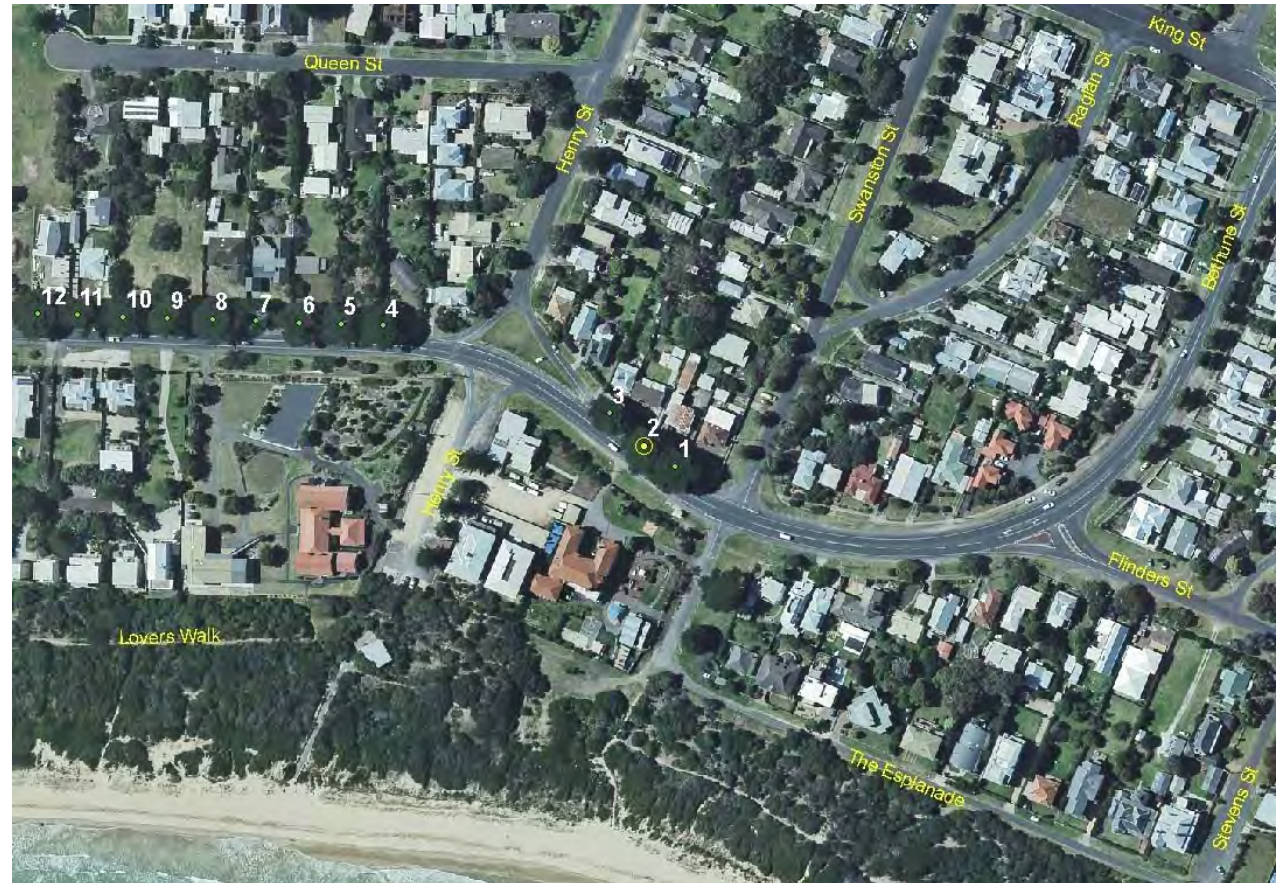
Recommended Works: Individual branch removal
Priority: Moderate
Inspection Regime: Annual
Adjacent Infrastructure: Flinders St, Concrete driveways, Concrete footpath
Comments: Remove damaged branch over road

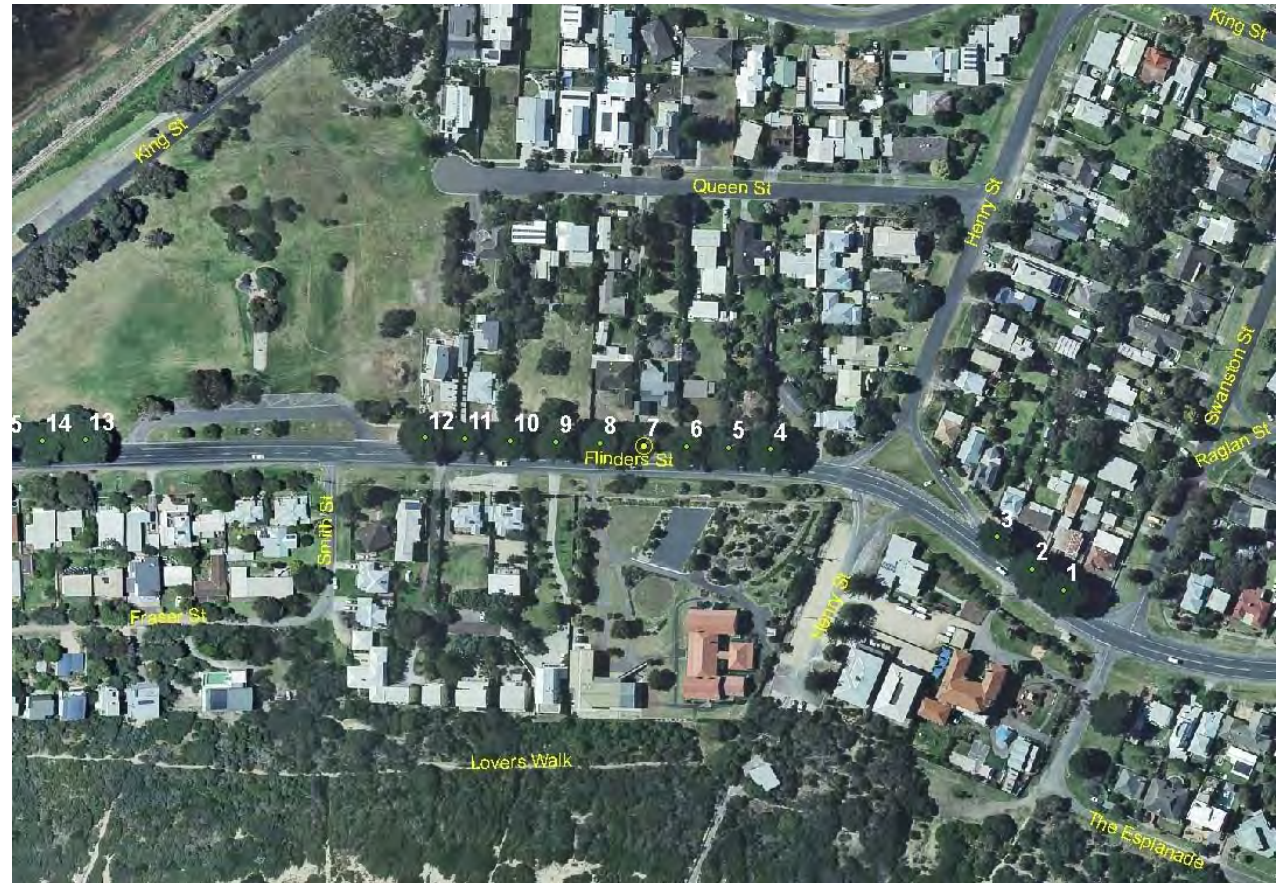
Individual branch removal is recommended for 2 trees with damaged limbs. Tree 7 has a ULE of less than 5 years and is recommended for removal within the next 2-4 years. Many large scaffold branches on Tree 7 have been removed or cut back, presumably due to branch failures or structural defects leaving the canopy quite open (Figure 21). There is substantial decay in the trunk.

Recommended Works: Removal
Priority: Low
Inspection Regime: Annual
Adjacent Infrastructure: Flinders St, Gravel driveway, Gravel path
Comments:

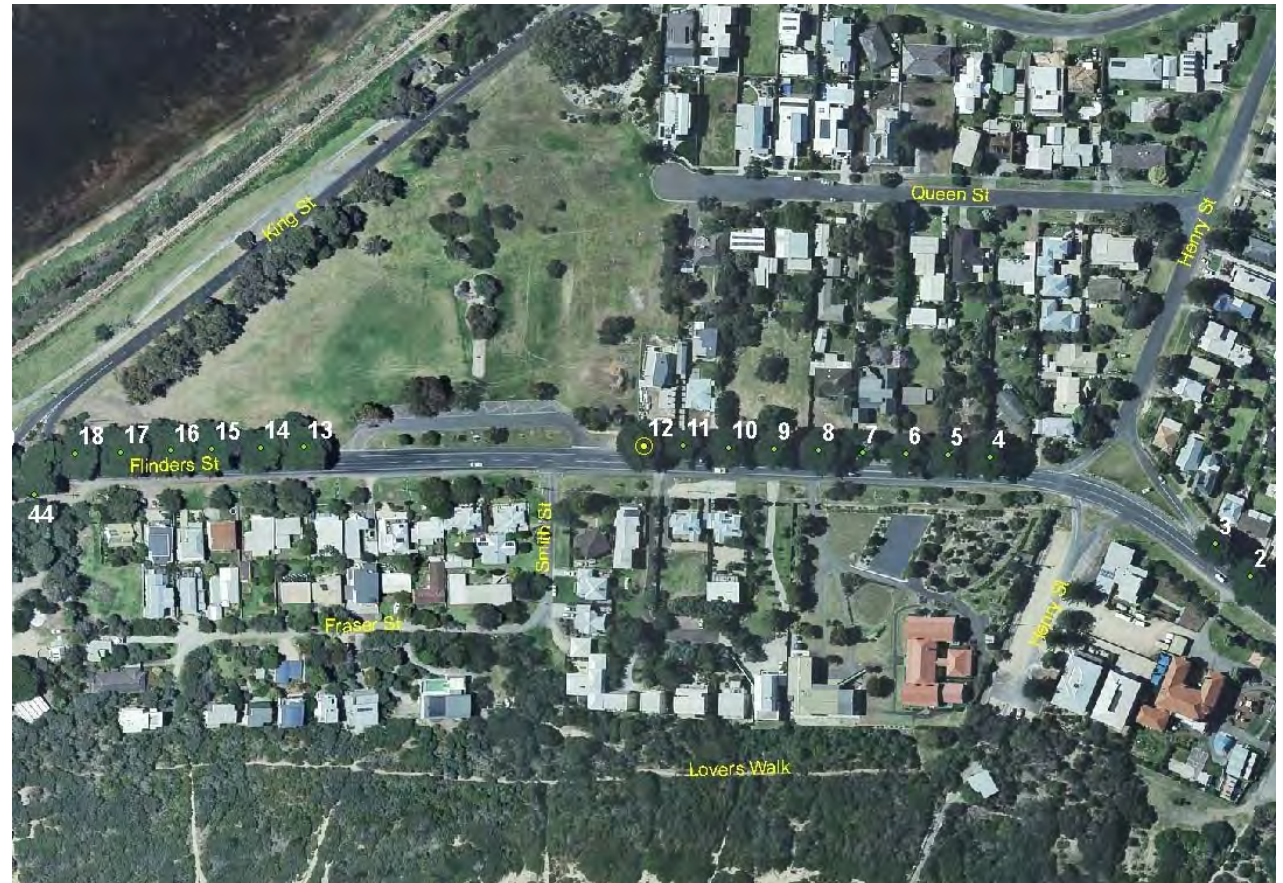
Recommended Works: Individual branch removal
Priority: Moderate
Inspection Regime: Annual
Adjacent Infrastructure: Flinders St, Gravel driveway, Gravel path
Comments: Remove damaged branch above driveway

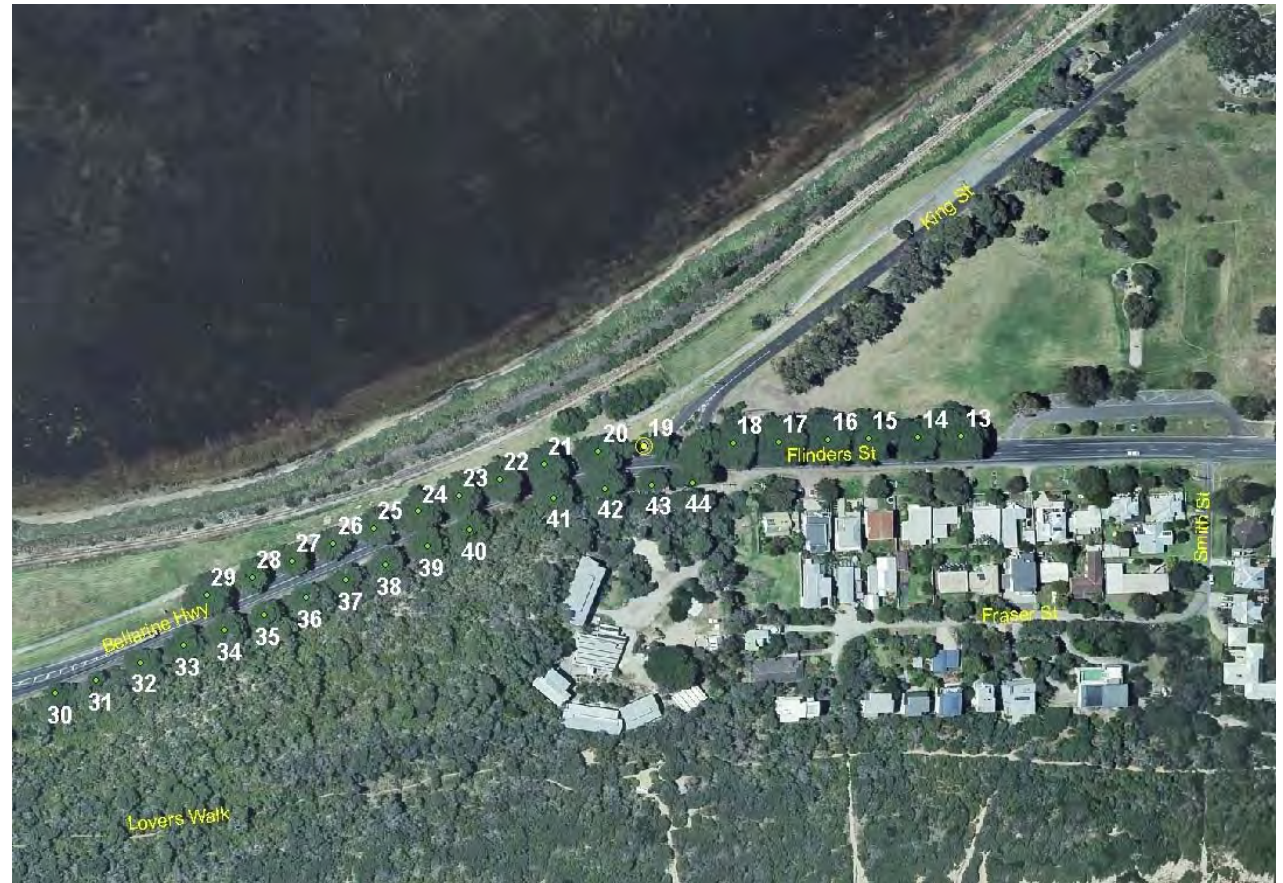
Individual branch removal is recommended for 2 trees with damaged limbs. Tree 19 has a ULE of less than 5 years and is recommended for removal within the next 2 years. Many large scaffold branches have been removed or pruned, presumably due to branch failures or structural defect, leaving the canopy quite open (Figure 27). There is substantial decay in the trunk of Tree 19.

Recommended Works: Removal
Priority: Low
Inspection Regime: Annual
Adjacent Infrastructure: Bellarine Hwy, King St
Comments:

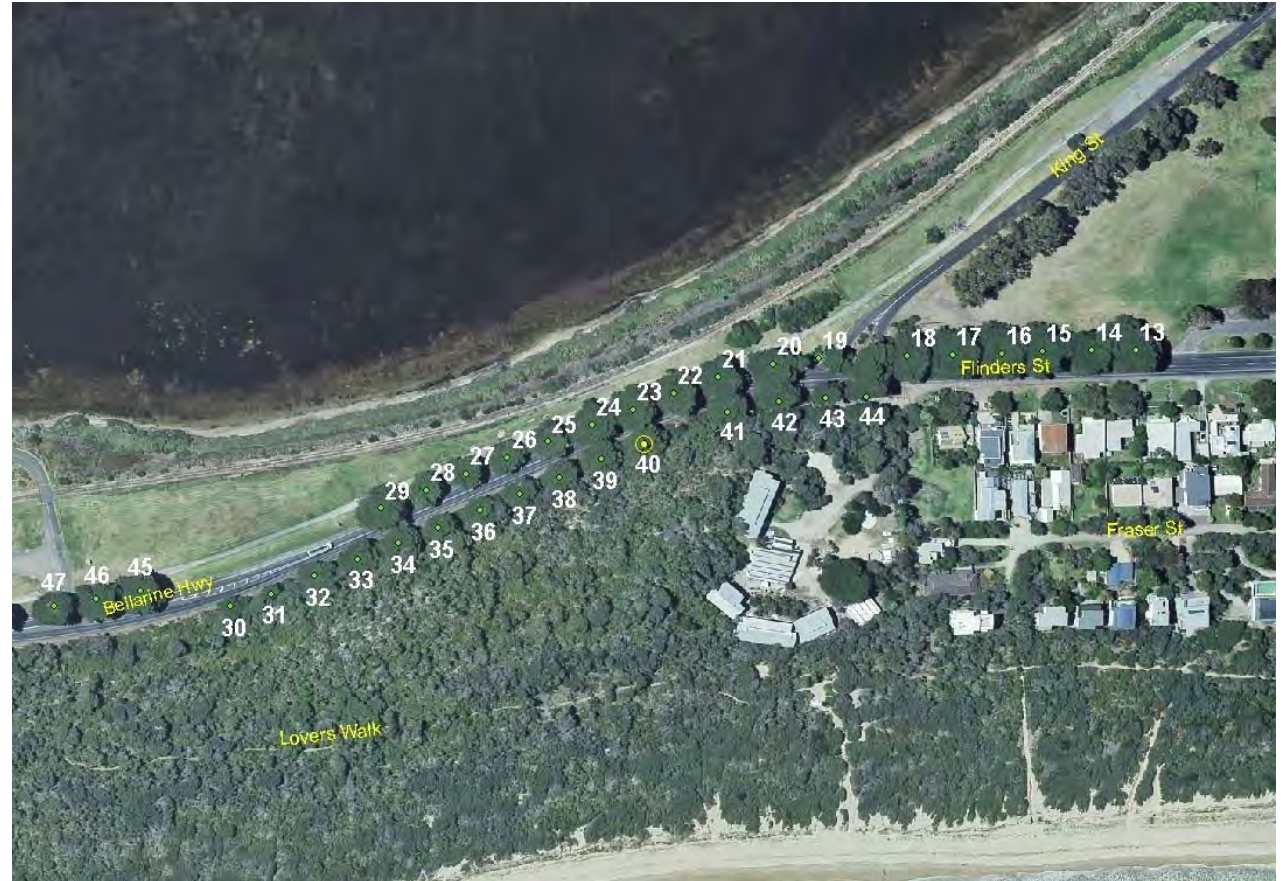
Recommended Works: Risk reduction pruning
Priority: Moderate
Inspection Regime: Annual
Adjacent Infrastructure: Bellarine Hwy, Coastal Moonah Woodland
Comments: Reduce extended limbs over road

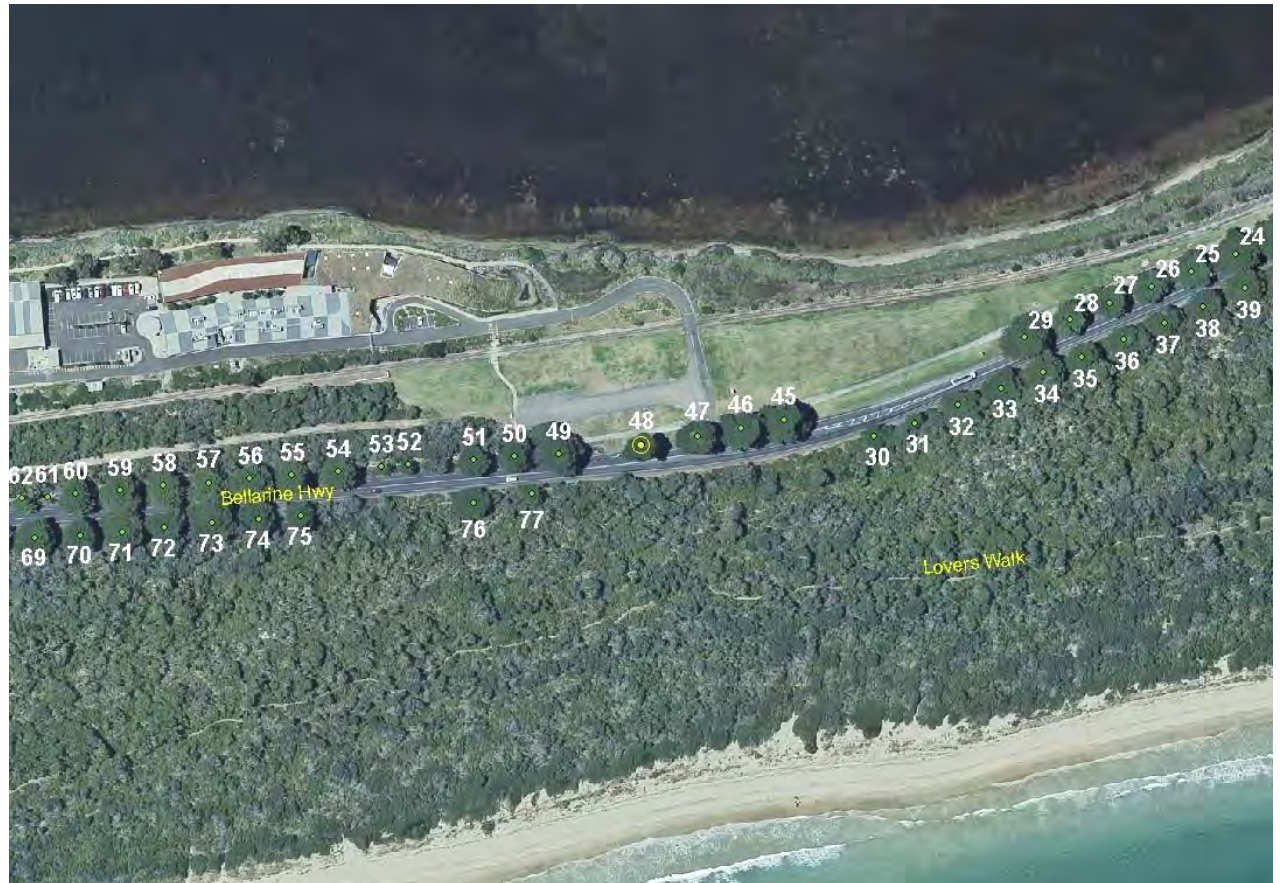
Hanging branch removal is recommended for 1 tree. Tree 48 has a ULE of less than 5 years and is recommended for removal within the next 2-4 years. The codominant stems, heavy trunk decay and lack of foliage on lower branches leave this tree more susceptible to failure under adverse weather conditions.

Recommended Works: Removal
Priority: Low
Inspection Regime: Annual
Adjacent Infrastructure: Surfaced path, Lawn, Bellarine Hwy
Comments: Heavily uplifted, Bee hive in trunk

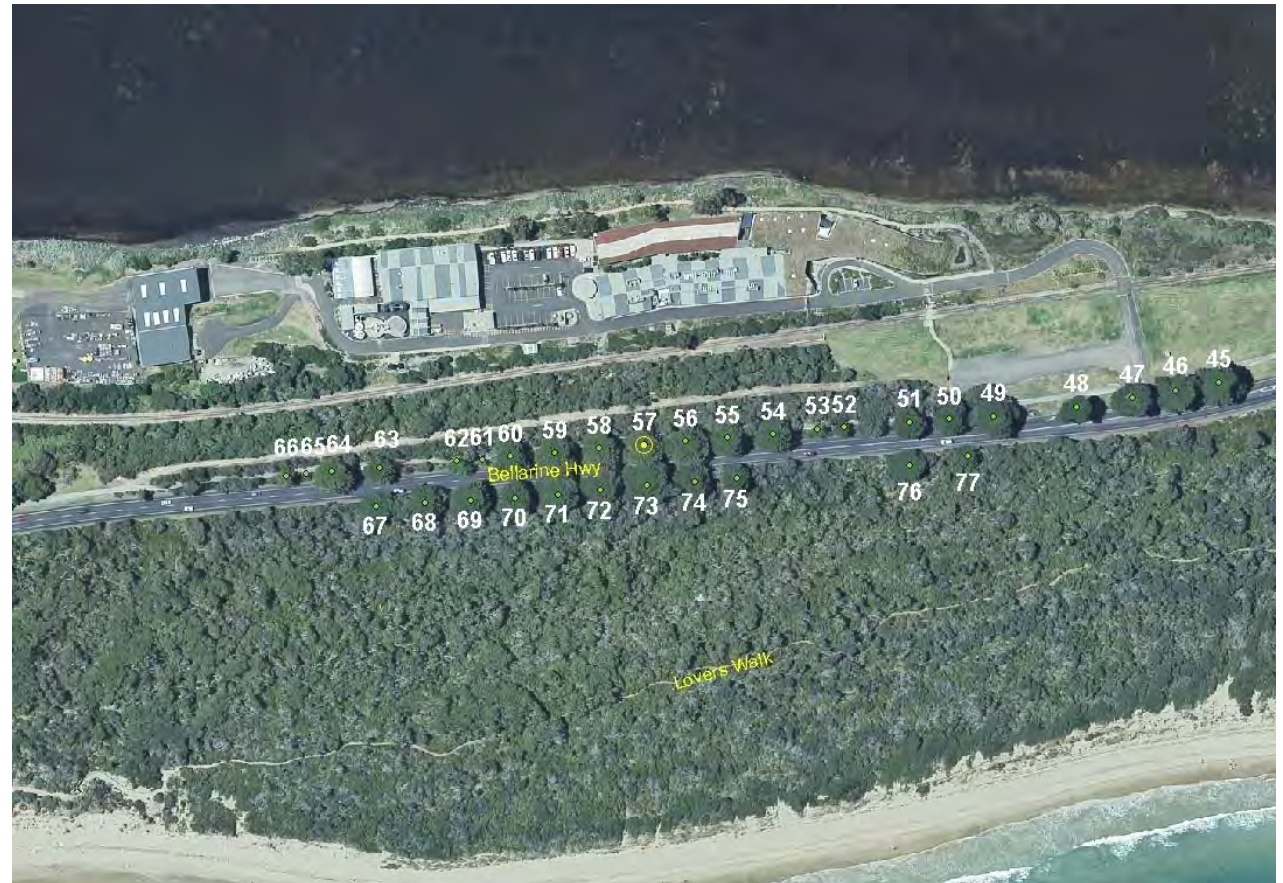
Recommended Works: Individual branch removal
Priority: Moderate
Inspection Regime: 3-5 years
Adjacent Infrastructure: Bitumen path, Bellarine Hwy, Coastal Moonah Woodland
Comments: Broken branch over road

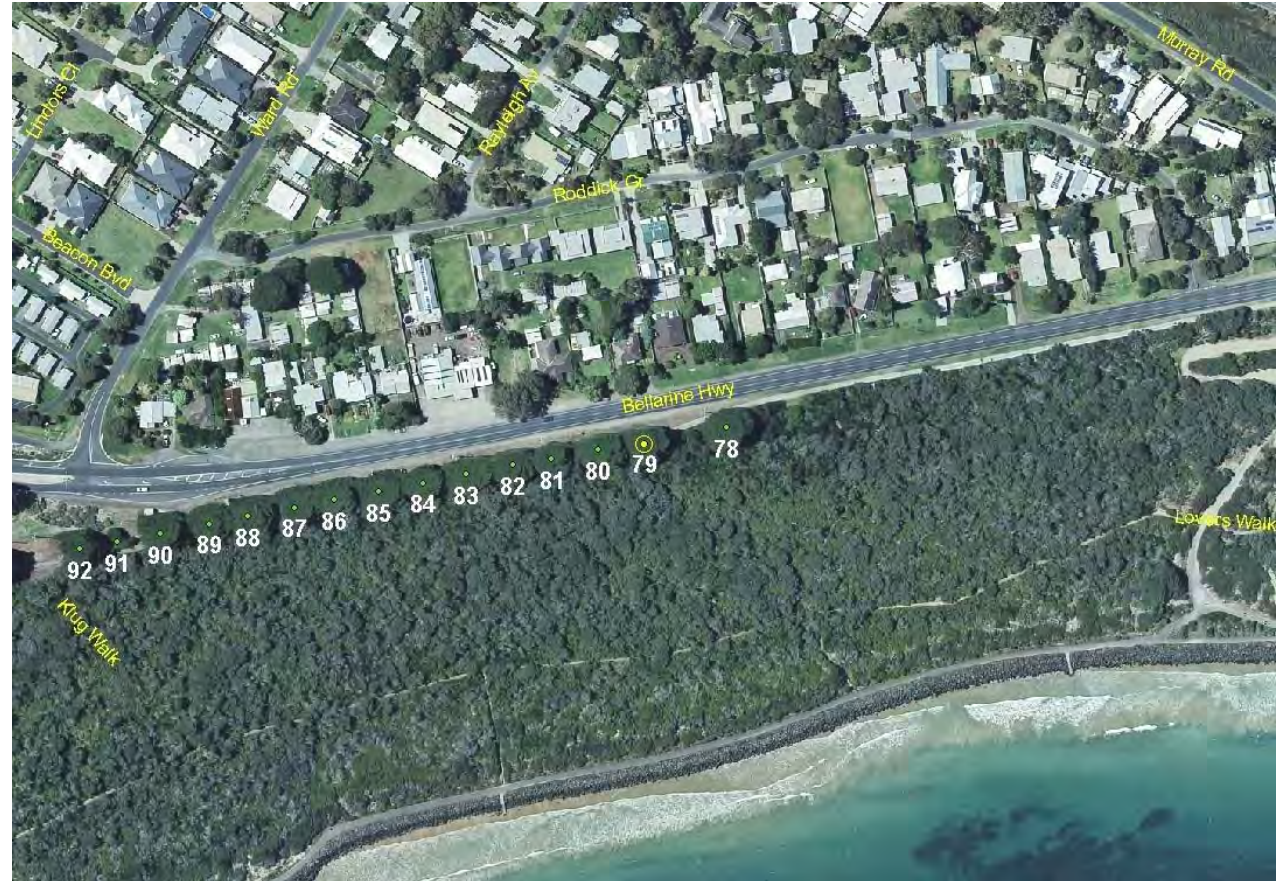
Recommended Works: Broken and hanging branch removal
Priority: High
Inspection Regime: Annual
Adjacent Infrastructure: High Voltage powerlines, Bitumen footpath
Comments: Broken branch above path

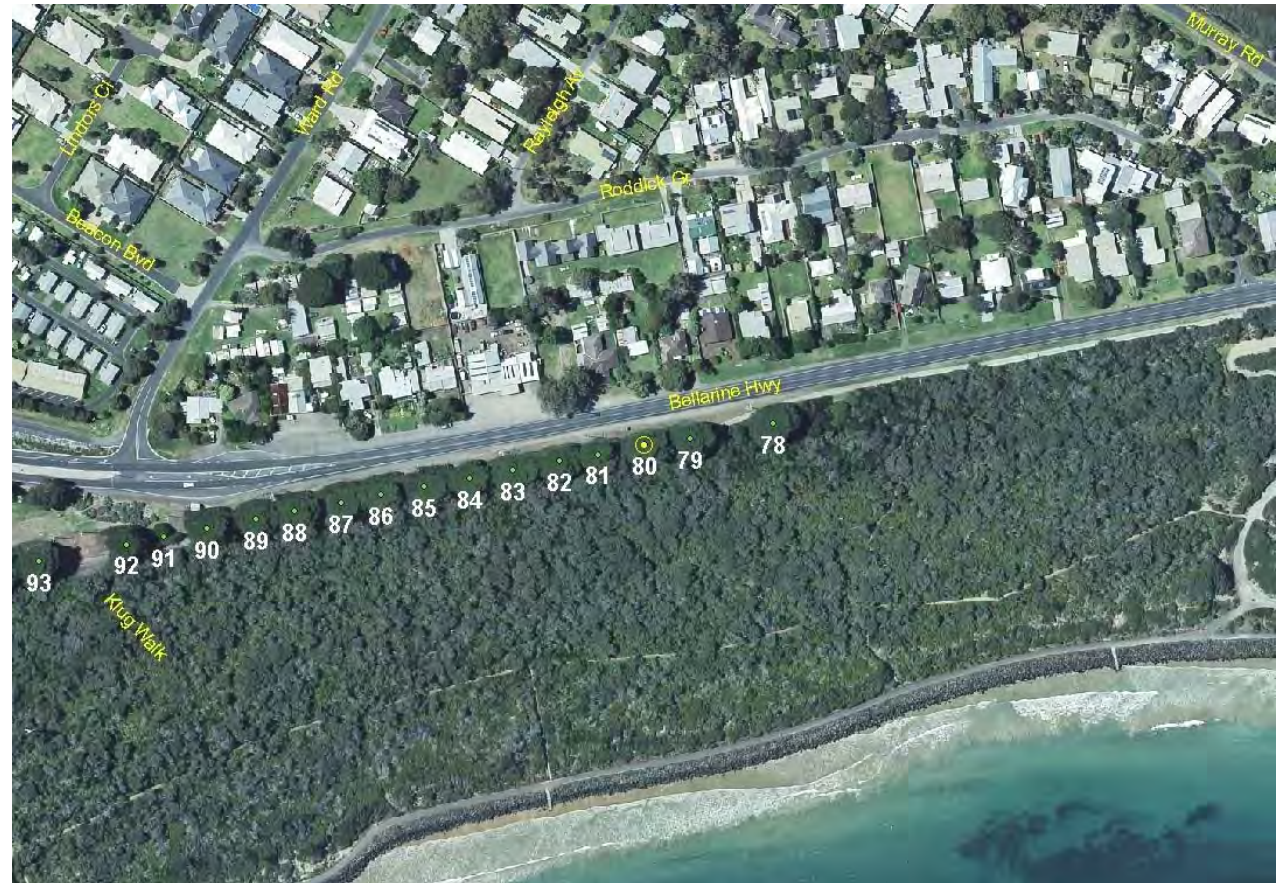
Recommended Works: Broken and hanging branch removal
Priority: High
Inspection Regime: Annual
Adjacent Infrastructure: High Voltage powerlines, Bitumen footpath
Comments: Multiple hanging branches above path

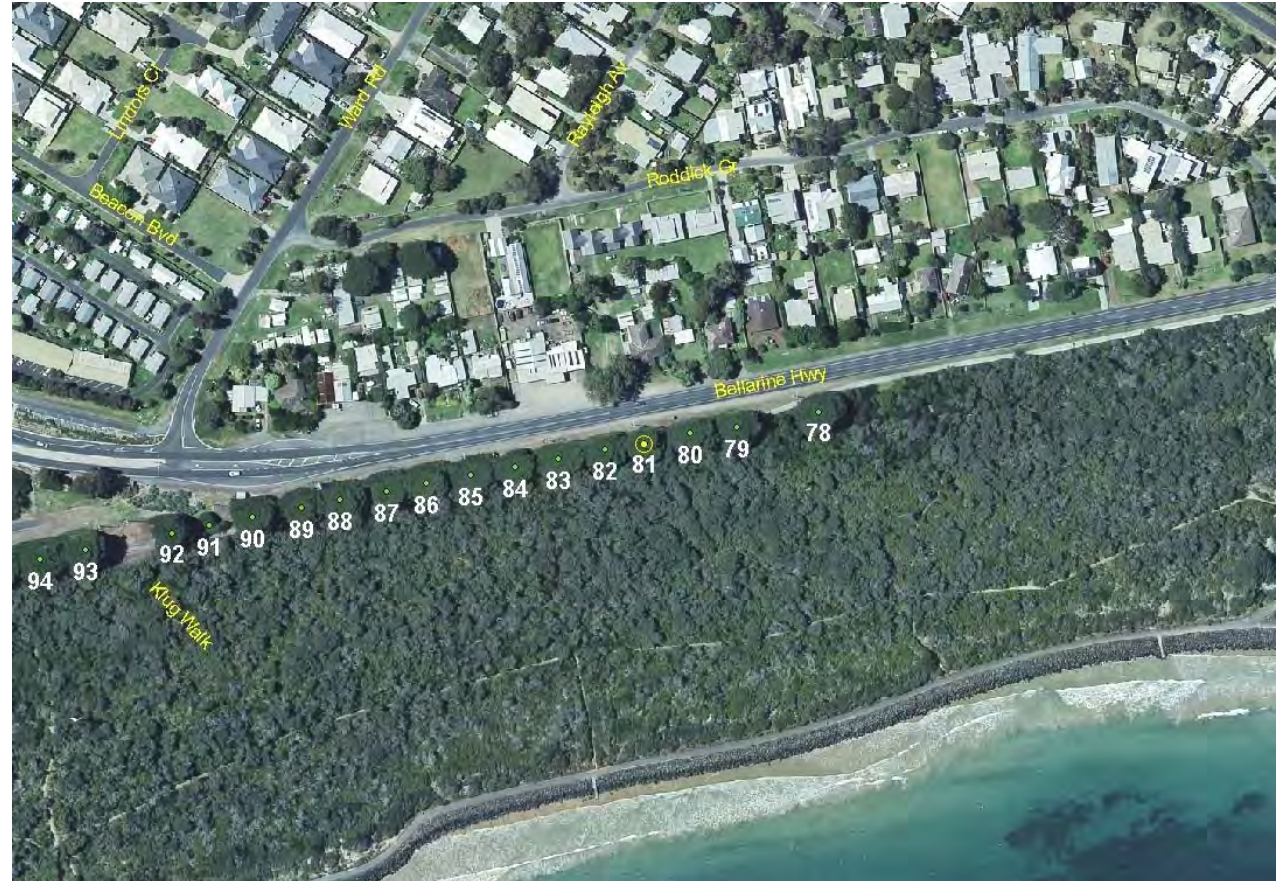
Recommended Works: Broken and hanging branch removal
Priority: High
Inspection Regime: Annual
Adjacent Infrastructure: High Voltage powerlines, Bitumen footpath
Comments: Broken branch above path

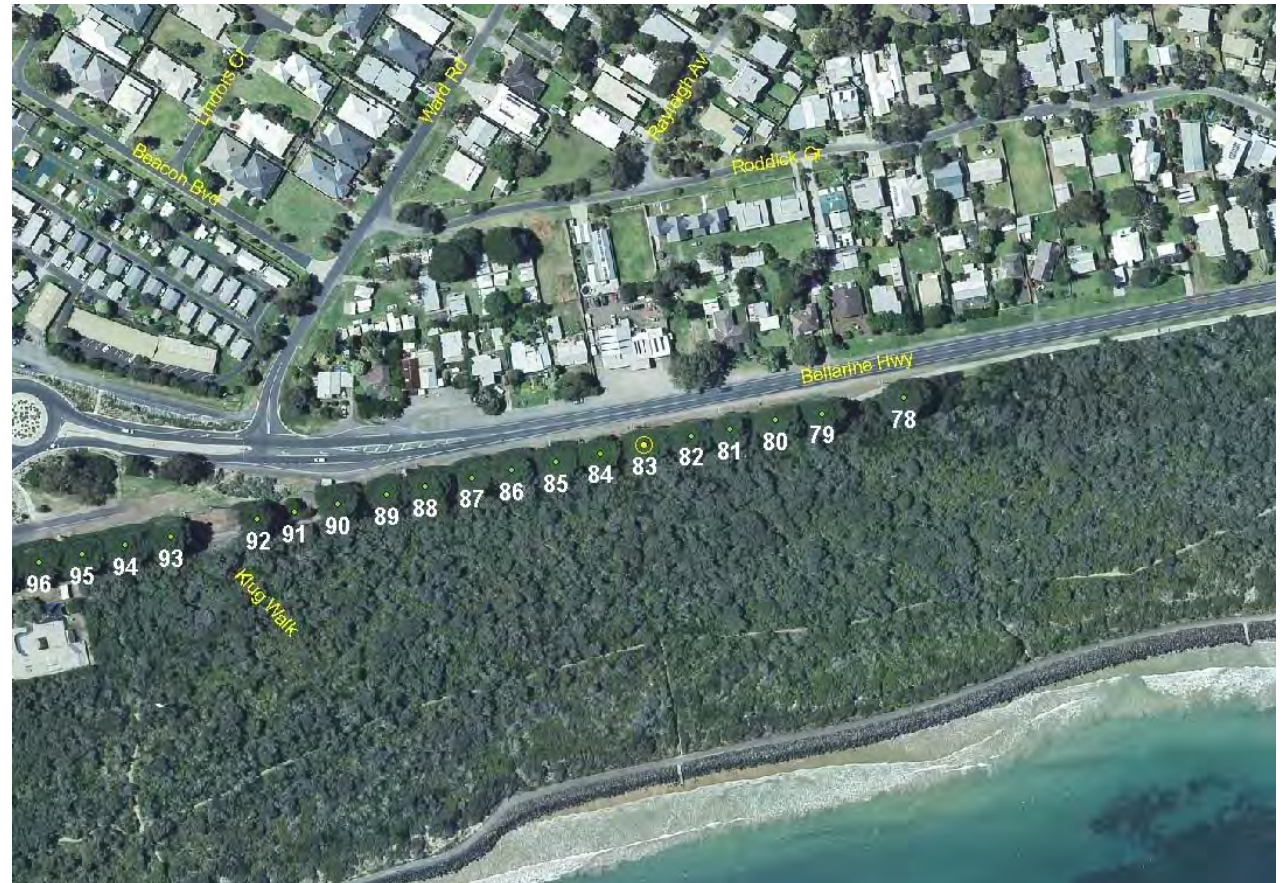
Recommended Works: Removal
Priority: Moderate
Inspection Regime: Annual
Adjacent Infrastructure: High Voltage powerlines, Bitumen footpath
Comments: Active split between trunks

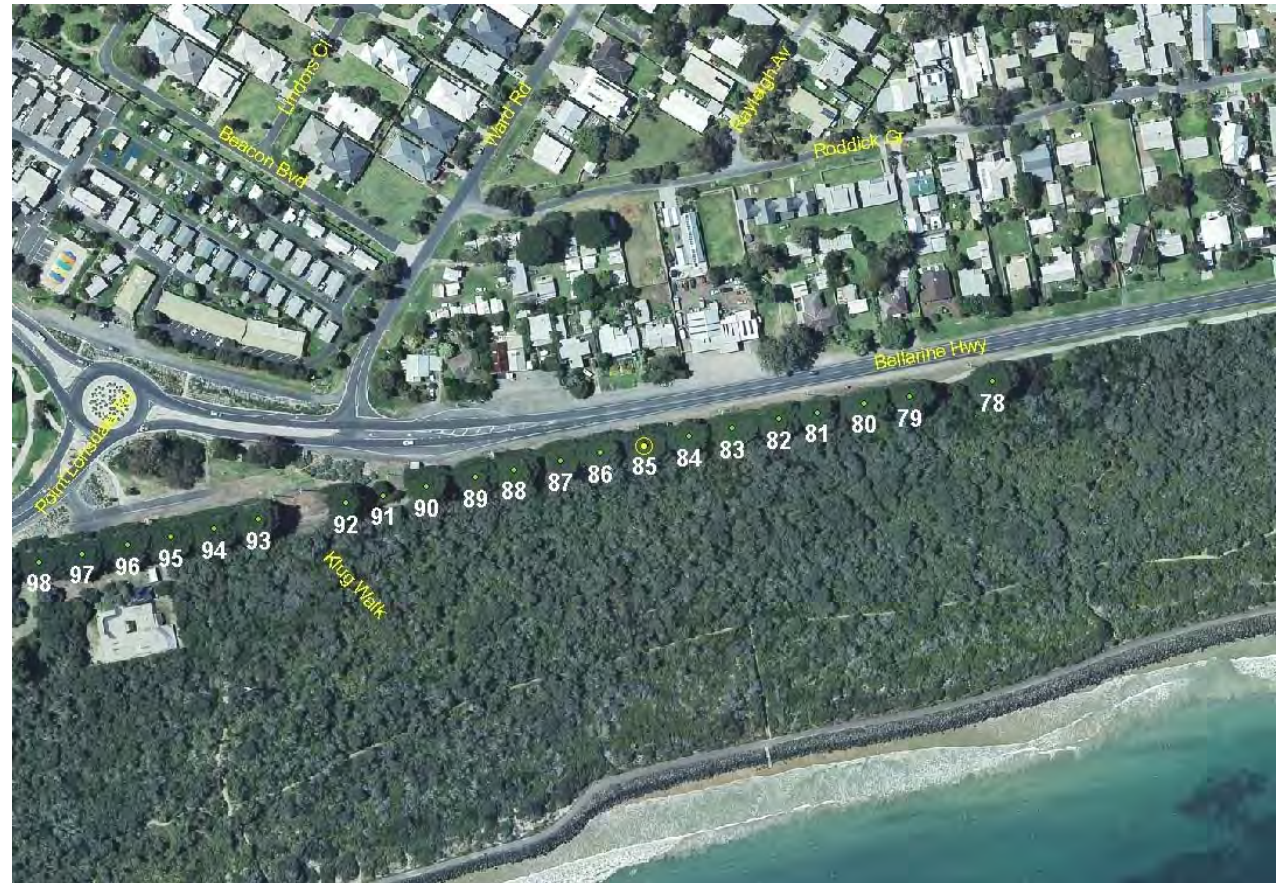
Recommended Works: Risk reduction pruning
Priority: Moderate
Inspection Regime: Annual
Adjacent Infrastructure: High Voltage powerlines, Bitumen footpath
Comments: Reduce extended limbs over path

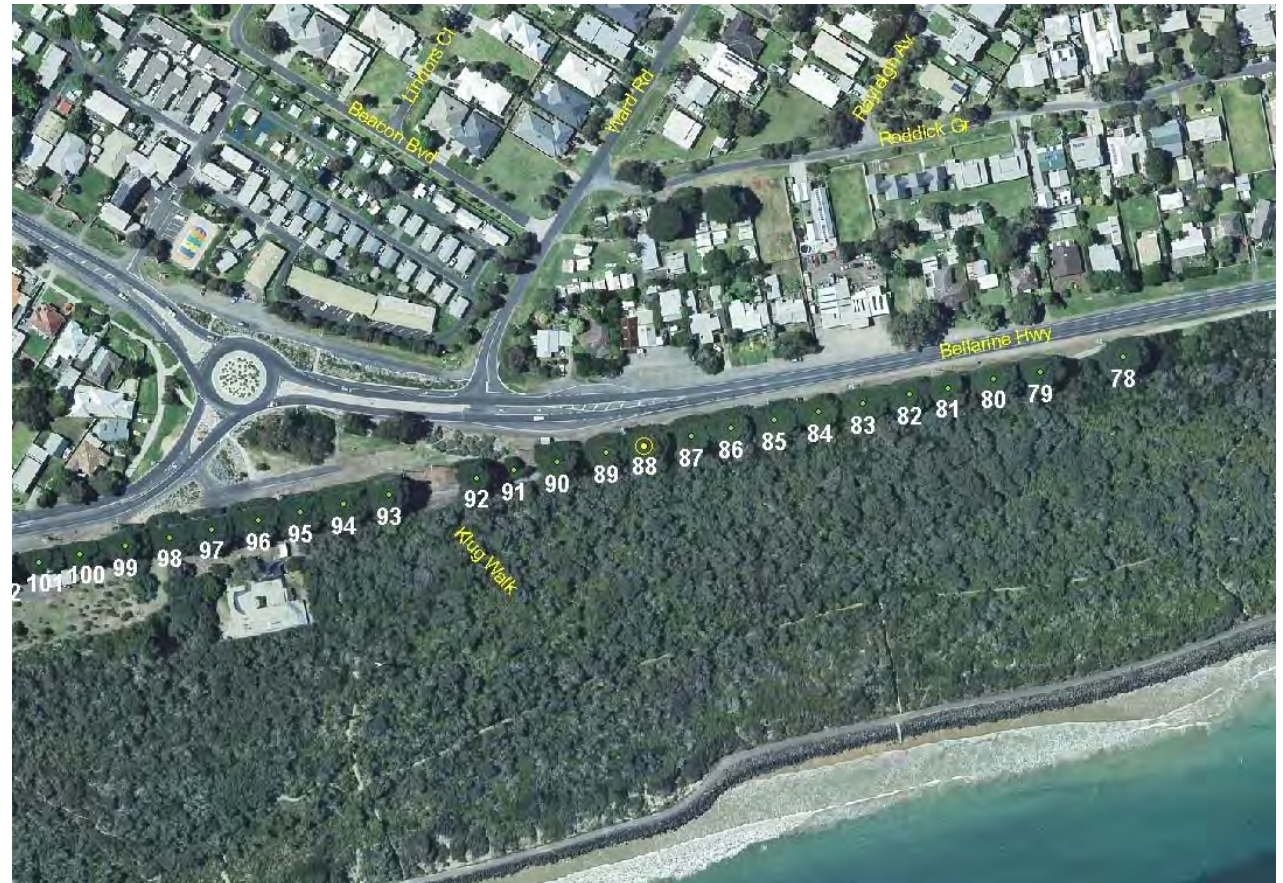
Recommended Works: Risk reduction pruning, Broken and hanging branch removal
Priority: Moderate
Inspection Regime: Annual
Adjacent Infrastructure: High Voltage powerlines, Bitumen footpath
Comments: Reduce extended limbs over path, small hanging branch above path

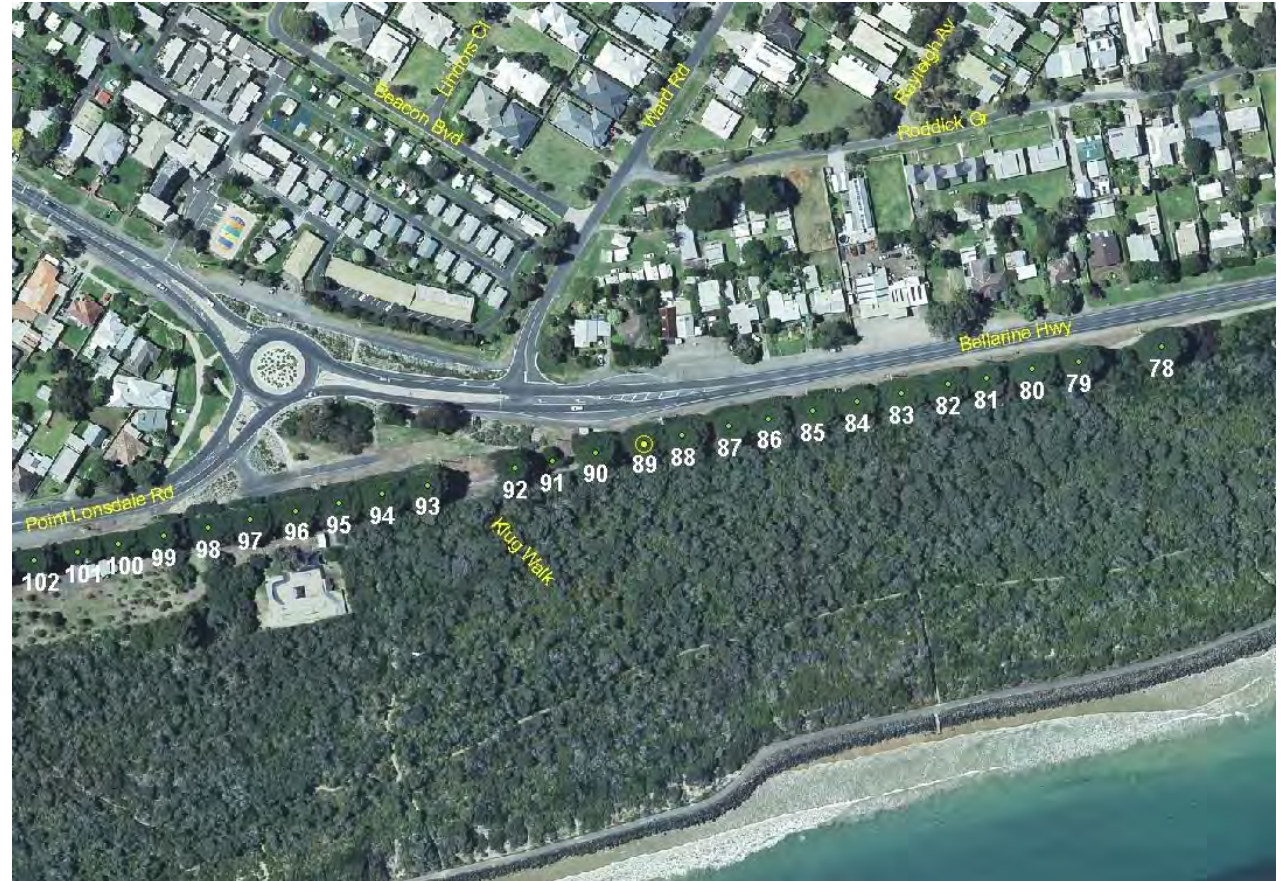
Recommended Works: Risk reduction pruning
Priority: Moderate
Inspection Regime: Annual
Adjacent Infrastructure: High Voltage powerlines, Bitumen footpath
Comments: Reduce extended limbs over path

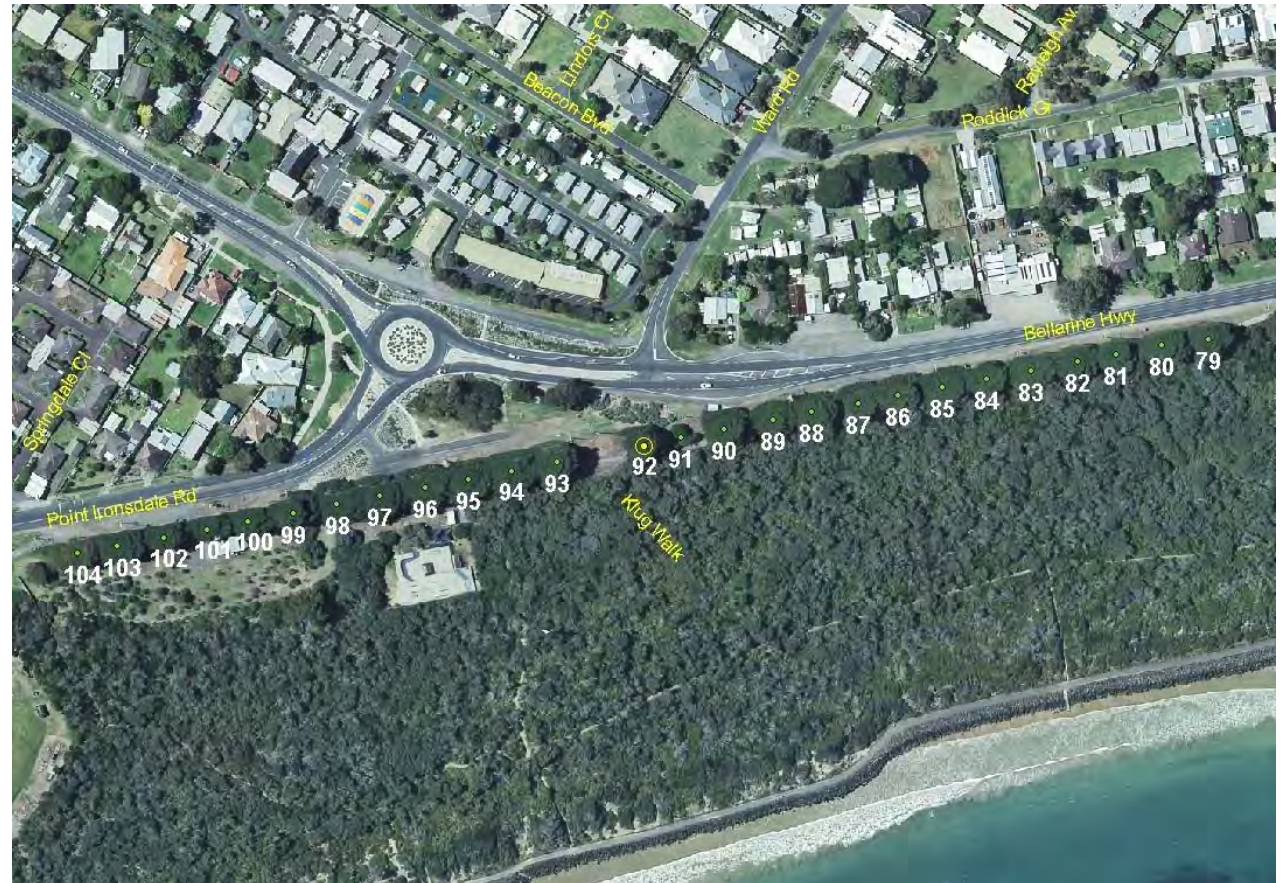
Recommended Works: Risk reduction pruning
Priority: High
Inspection Regime: Annual
Adjacent Infrastructure: High Voltage powerlines, Bitumen footpath
Comments: Shear crack in trunk leaning towards path

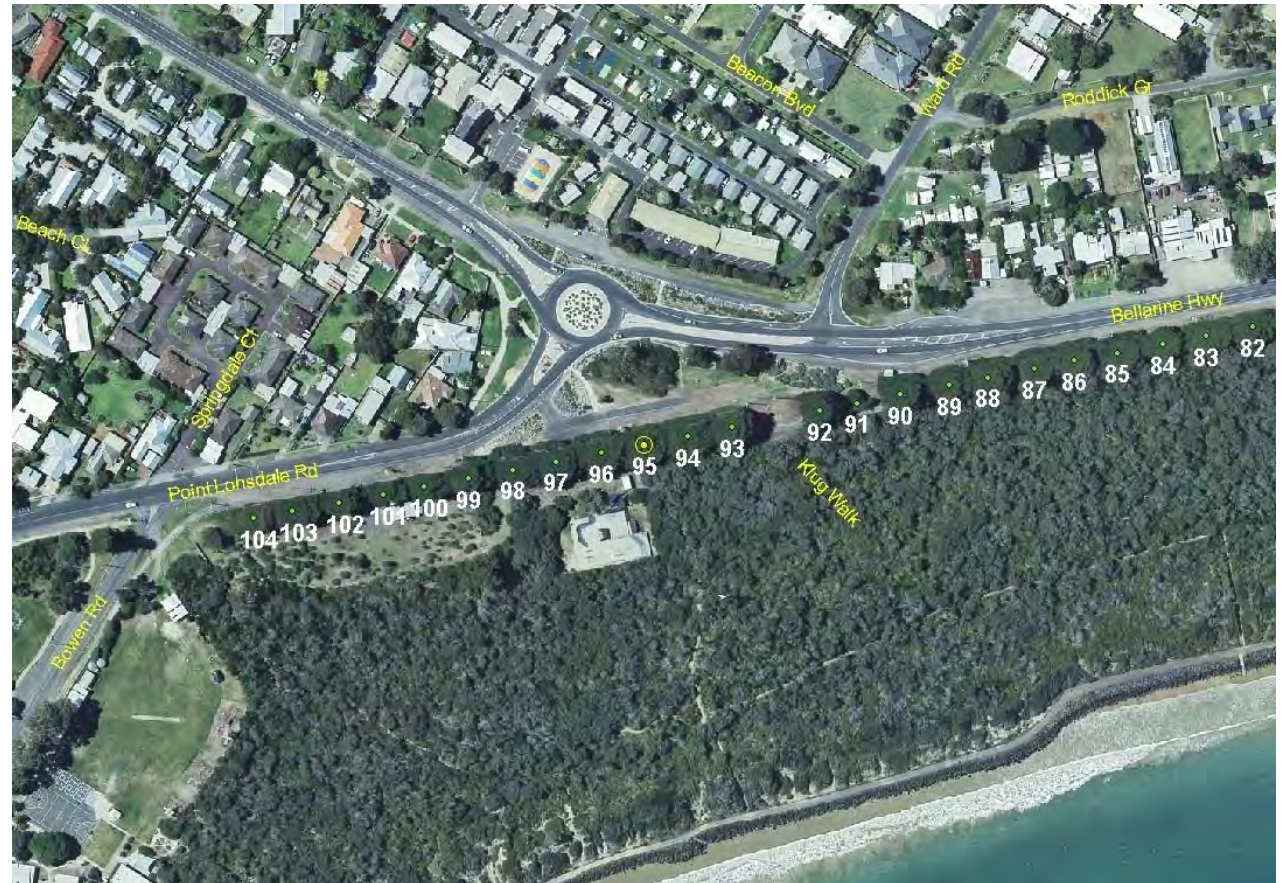
Recommended Works: Deadwood removal, Risk reduction pruning
Priority: Moderate
Inspection Regime: Annual
Adjacent Infrastructure: High Voltage powerlines, Gravel carpark, Bitumen path
Comments: Reduce extended limbs over path
