Avenue of Honour Tree Management and Replacement Plan: Executive Summary

Homewood Consulting Pty Ltd

August 2015

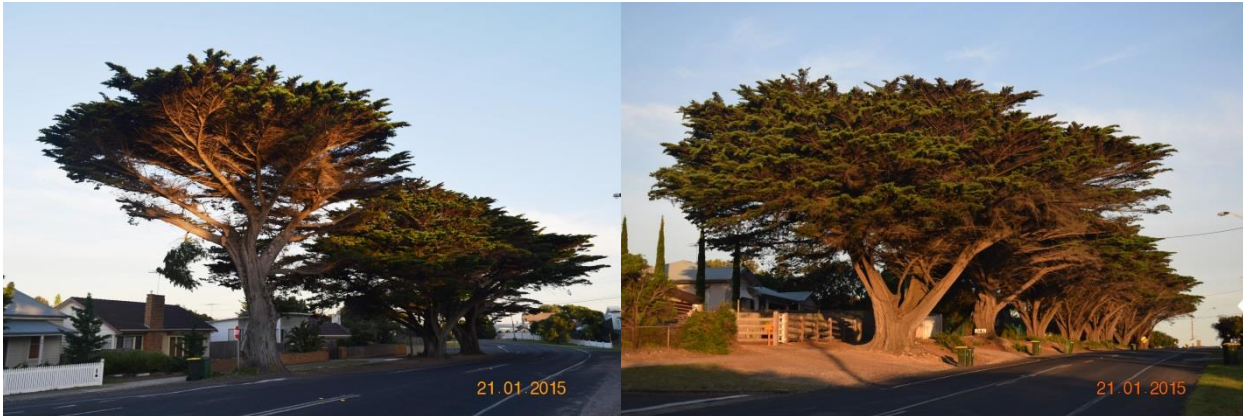
Three of the twelve Flinders Street trees, looking south-east towards Swanston St.

Nine of the twelve Flinders Street trees, looking east towards Henry St.

The majority of the Flinders Street trees are currently in fair condition for their age and location in the landscape but are showing the initial signs of decline and *Seiridium* Canker with a thinning canopy and discoloration of foliage. Minor pruning works are recommended for 2 trees, and 1 tree is recommended for removal in the next 5 years.

The trees are suffering from the effects of soil compaction from adjacent road construction and upgrades, informal gravel parking areas and residential driveways and footpaths across the root plates. In general, the trees are expected to substantially decline over the next 10 years. Due to the age, location, and the presence of *Seiridium* spp. in the trees, there is little opportunity to modify or improve site conditions in order to extend their Useful Life Expectancy.

The Flinders Street trees are of aesthetic, historic and cultural significance and it is recommended that a tree replacement plan is developed and implemented for these trees.

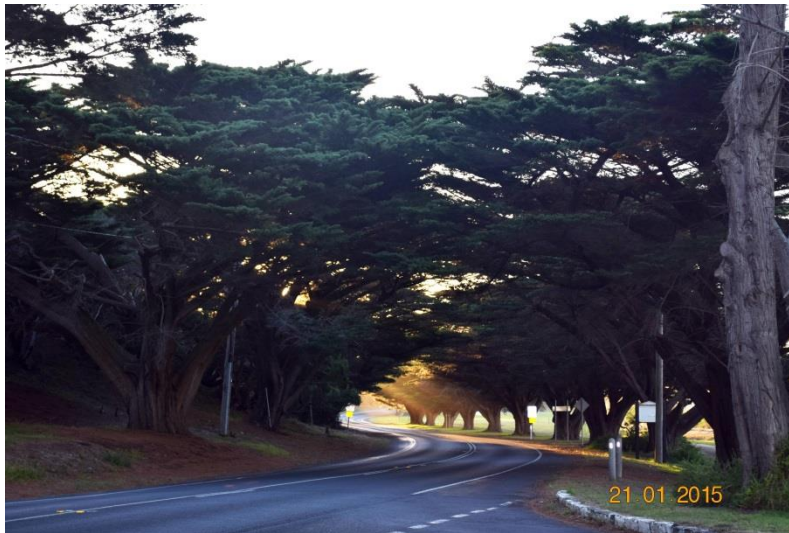
The majority of the Avenue of Honour trees (approximately 60%) are currently in fair condition for their age and location in the landscape and have a Useful Life Expectancy of 10-20 years.

The trees are showing the initial signs of Seiridium infection, with a thinning canopy and discoloration of foliage. There is moderate to heavy deadwood in the crowns however this is typical for the species at this age.

40% of the Avenue of Honour trees exhibit fair health but show poor structure, mostly due to extensive pruning. The canopies have been heavily uplifted, resulting in large, extended and end-weighted limbs. Some trees have been heavily pruned for power line clearance and there is evidence of moderate to large branch failure in many of the trees. These trees have a Useful Life Expectancy of 5-10 years.

Minor pruning works are recommended for 2 trees, and 1 tree is recommended for removal in the next 5 years. In order to ensure the trees reach their maximum Useful Life Expectancy, it is recommended that parking beneath the canopies is excluded wherever possible, and the tree root zones are mulched to improve moisture retention, reduce soil compaction and minimise damage to roots.

The Avenue of Honour trees are of aesthetic, historic and cultural significance and it is recommended that a tree replacement plan is developed and implemented for these trees.

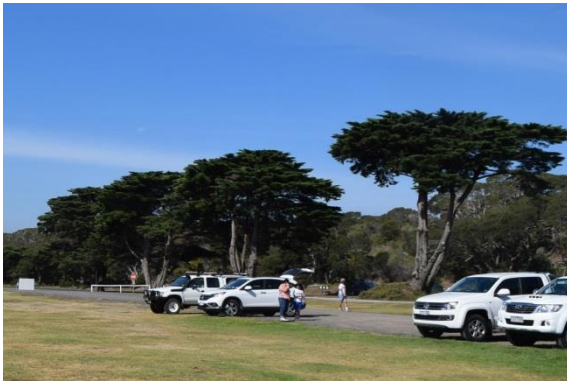
The 4 trees at the entrance to the Marine Discovery Centre.

The 4 trees near the Marine Discovery Centre are estimated to have been planted between 1945 and 1950. There were 5 trees in total planted in this location at the time. There are currently no remains of concrete bases at the foot of these trees and any historical associations are unknown.

These trees are currently in fair health for their age and location; however 3 of the 4 trees have poor structure. 1 tree is recommended for removal in the next 4 years due to structural defects and the remaining trees are expected to substantially decline over the next 10 years.

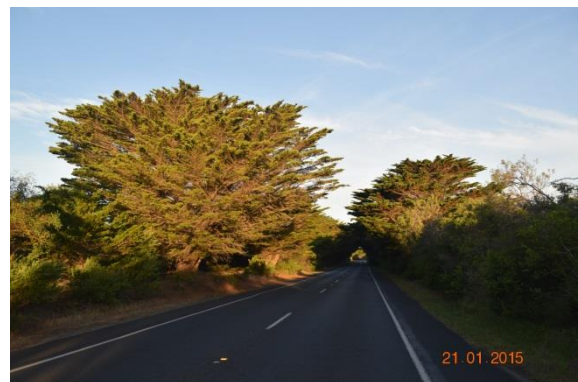
The trees are currently in fair health and have fair or good structure. At present these trees require very little work with regard to public safety. The majority of these trees have a Useful Life Expectancy of 20-40 years. These trees can be safely retained in the landscape in the short to medium term and a tree replacement plan is not required at this time.

The trees at the western end of The Narrows create a bold visual statement for road users.

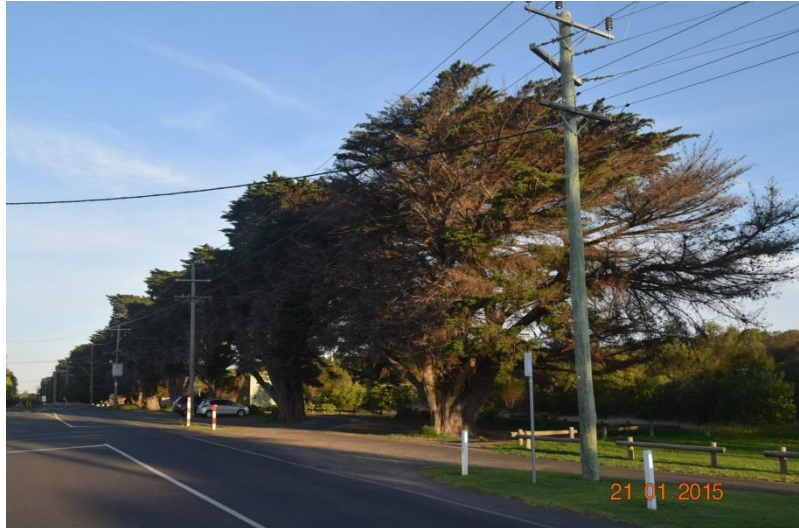
Over two-thirds of the trees require moderate or high priority works to reduce the risk of part of whole tree failure. Recommended works include risk reduction pruning of overextended limbs, deadwood removal and broken and hanging branch removal.

Approximately 60% of these trees are in fair condition with a Useful Life Expectancy of 10-20 years. 30% of the trees exhibit fair health but are structurally poor and are expected to substantially decline over the next 10 years. 3 trees are recommended for removal within the next 2 years due to structural faults.

The single row of trees at The Springs, at the intersection of Point Lonsdale Road and the Bellarine Highway.

The row of trees at The Springs is of aesthetic significance and it is recommended that a tree replacement plan is developed and implemented for these trees.

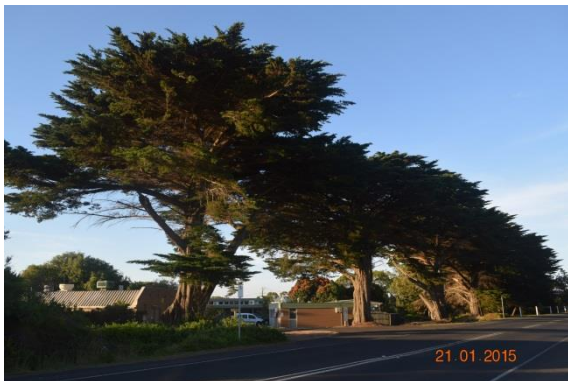
The row of 6 trees outside the Bellarine Community Centre on Point Lonsdale Road.

In general, these trees are of fair health and structure and appear typical examples of the species at maturity. All of these trees contain a moderate amount of deadwood in the canopy and there is evidence of small and moderate sized branch failures. Broken branch removal and risk reduction is recommended for one tree with defective branches above a park bench and an informal gravel path.

3 trees have a Useful Life Expectancy of 10-20 years and 3 trees have a Useful Life Expectancy of 5-10 years.

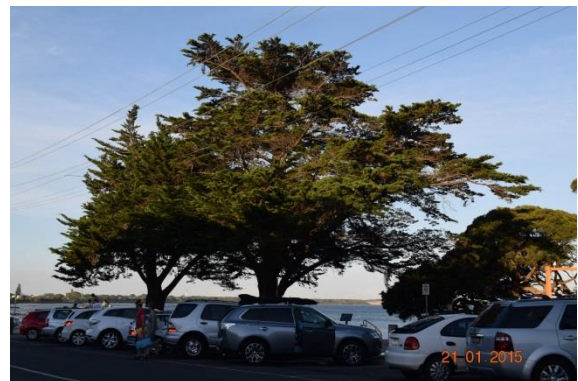
The 2 trees on the Point Lonsdale foreshore are of fair health and structure and appear typical examples of the species at maturity. The canopies of both trees are thinning and this is most likely due to soil compaction of the root zone, with heavy vehicle and pedestrian traffic around both of the trees. These trees have a Useful Life Expectancy of 10-20 years. It is unknown if these trees have historic connections.

The 2 trees on the Point Lonsdale foreshore.

The removal and replacement of trees on the Point Lonsdale foreshore is addressed in the Point Lonsdale Foreshore Draft Tree Plan, part of the Master Plan for the foreshore revitalisation.
