Doc. No:	ECLMP
Rev. No.:	2.6
Rev. Date:	March 2023

Management Plan Particulars

Document number:	ELCMP
Issue Number:	2.5
Authorised by:	Johann Rajaratnam
Authorisation date:	25 March 2021

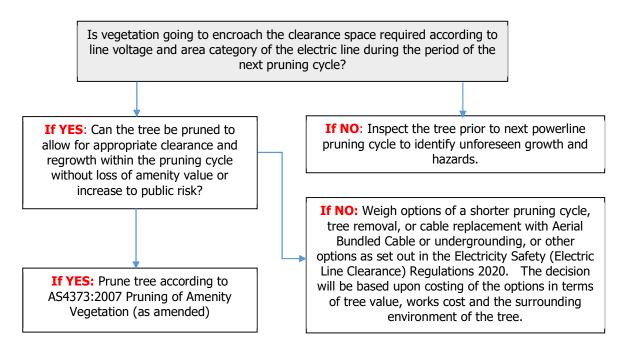
The following outlines the decision making process with regard to maintaining line clearance.

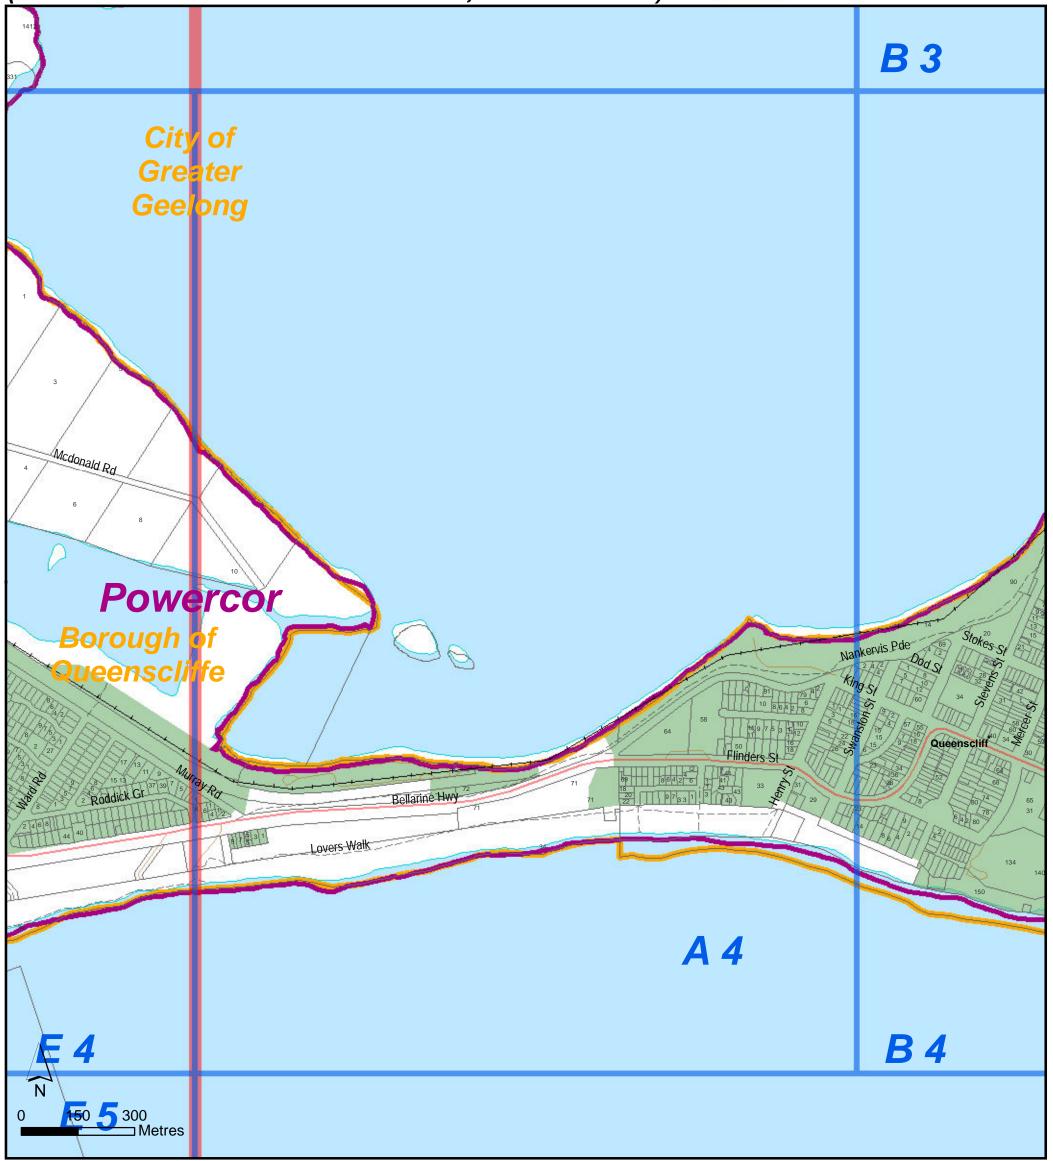
QUEENSCLIFF A 4 MAP 1:10 000

FIRE HAZARD RATINGS (THE ELECTRICITY SAFETY ACT 1998, REVISED 2010)

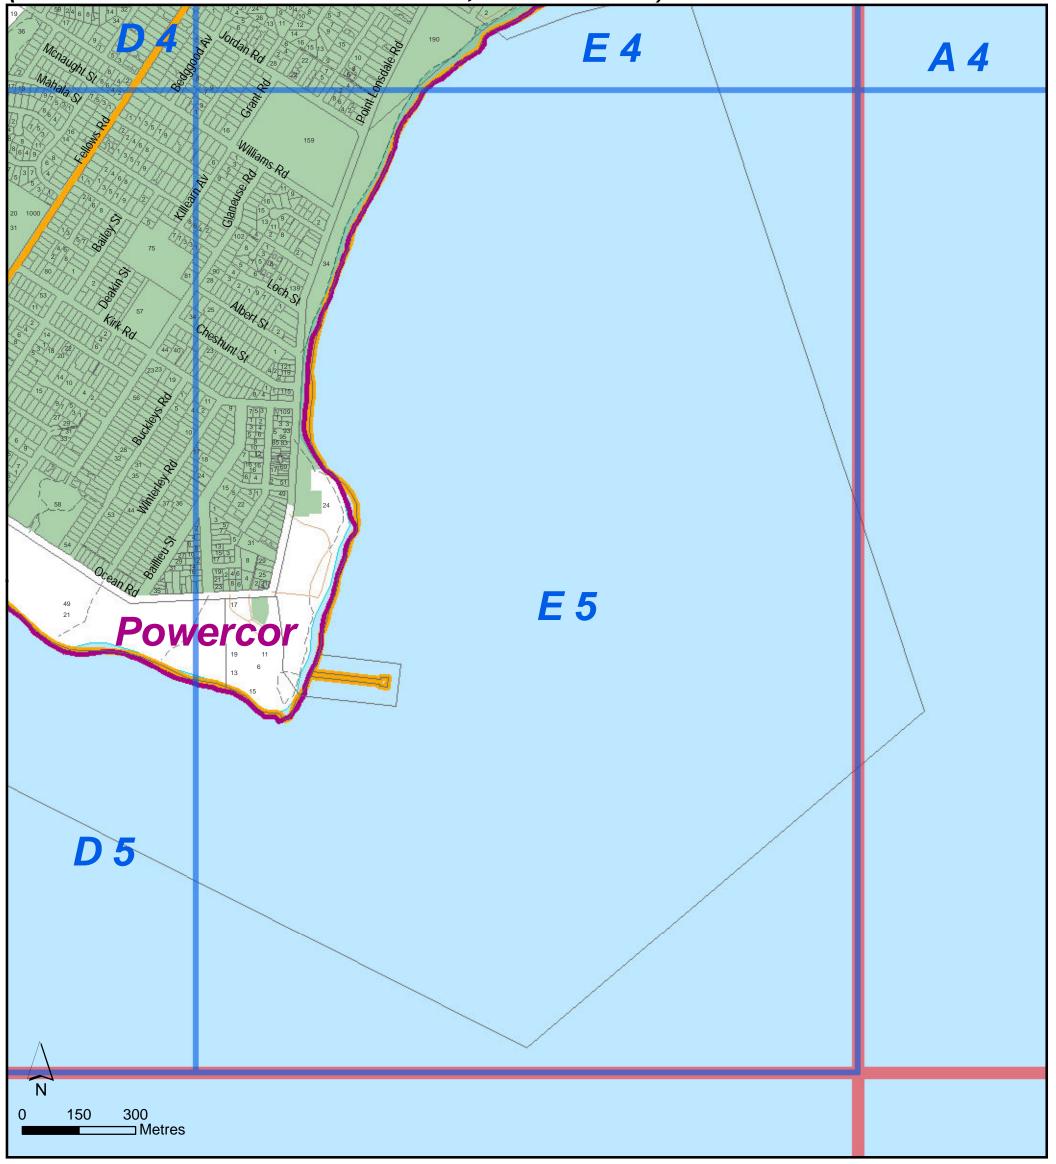
MANNERIM E 5 MAP 1:10 000

FIRE HAZARD RATINGS (THE ELECTRICITY SAFETY ACT 1998, REVISED 2010)
