Agenda

Planning Review Meeting

4.1 18 Girvan Grove, Point Lonsdale

Planning Permit number: 2016/003

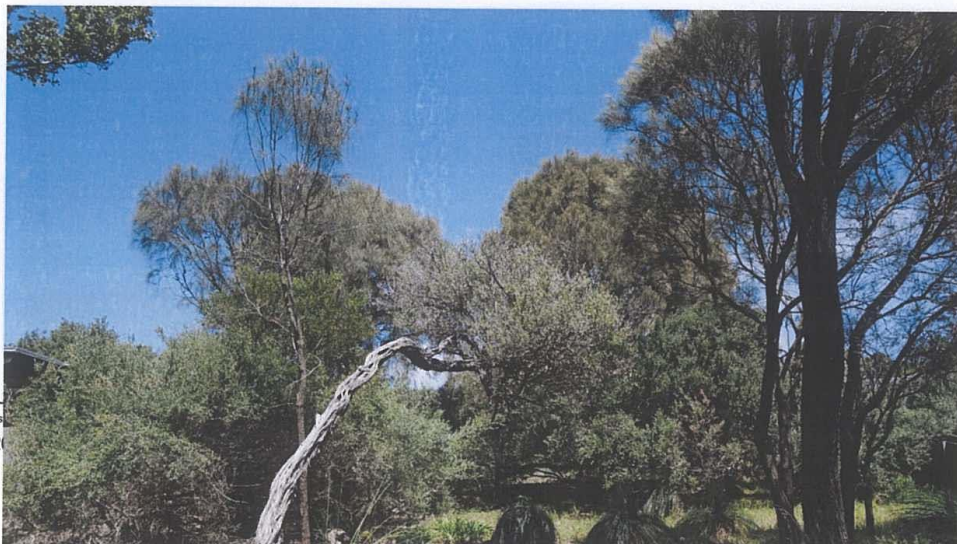
Typical trees of the allotment

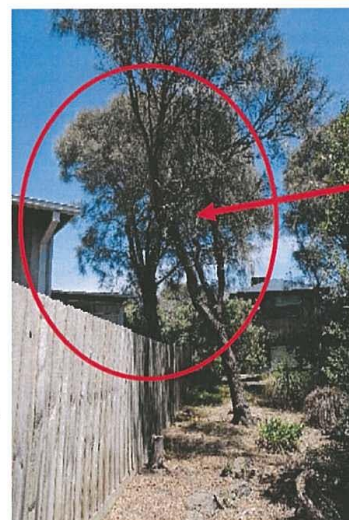
Tree 33 – On neighbouring allotment. Must be protected during development.

In undertaking this practice structural roots can be identified, and footings adjusted in location so as structural roots are not impacted. It should be noted that this tree depends heavily for its structural integrity on the root plate to the west of the tree.

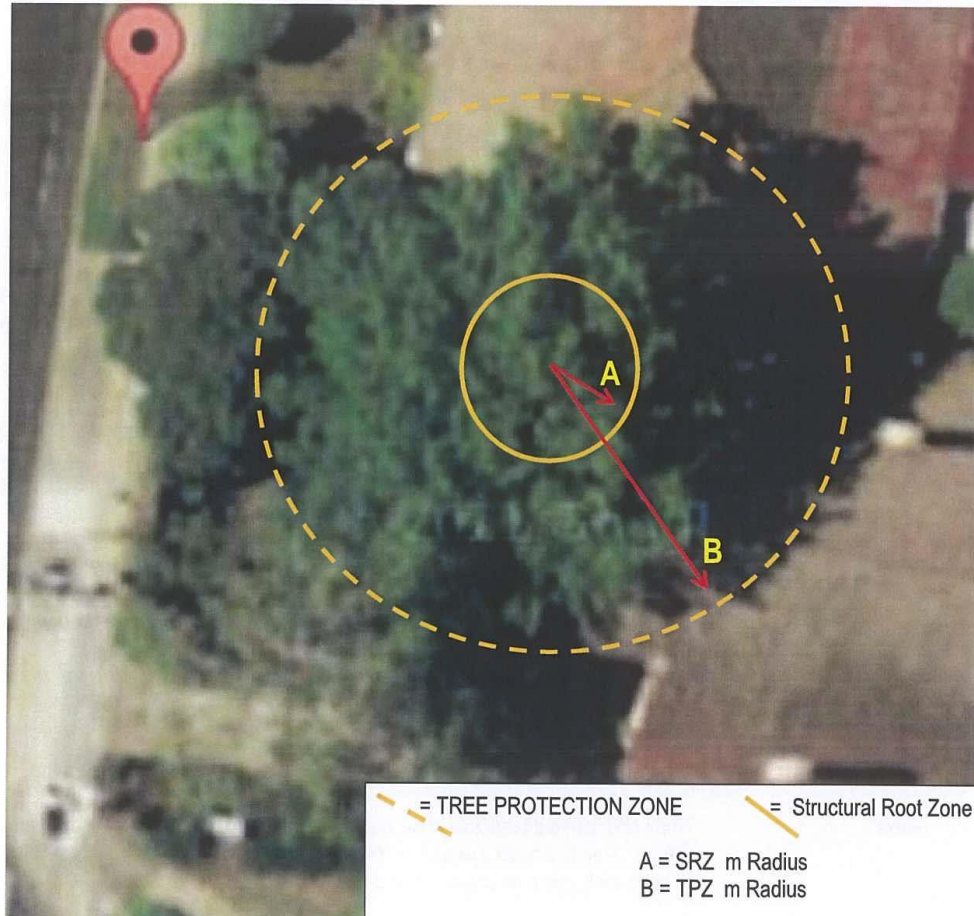
6.3 Applying The Tree Protection Zone (TPZ)

The diagram below indicates how the dimensions of the Structural Root Zone and the Tree Protection Zone are applied.

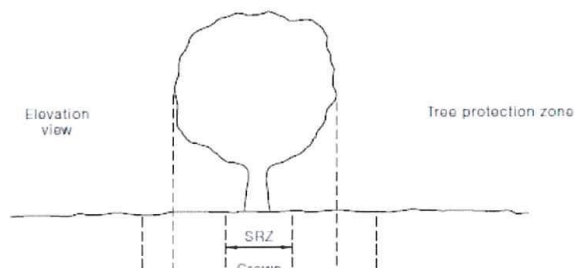
6.5 Structural Root Zone & Tree Protection Zone.

(Note – the TPZ is presented in a calculated value as a Metres Radius Measurement in diagram the Tree Protection zone is a diameter and extends around the outer edge of a tree as a circumference.)

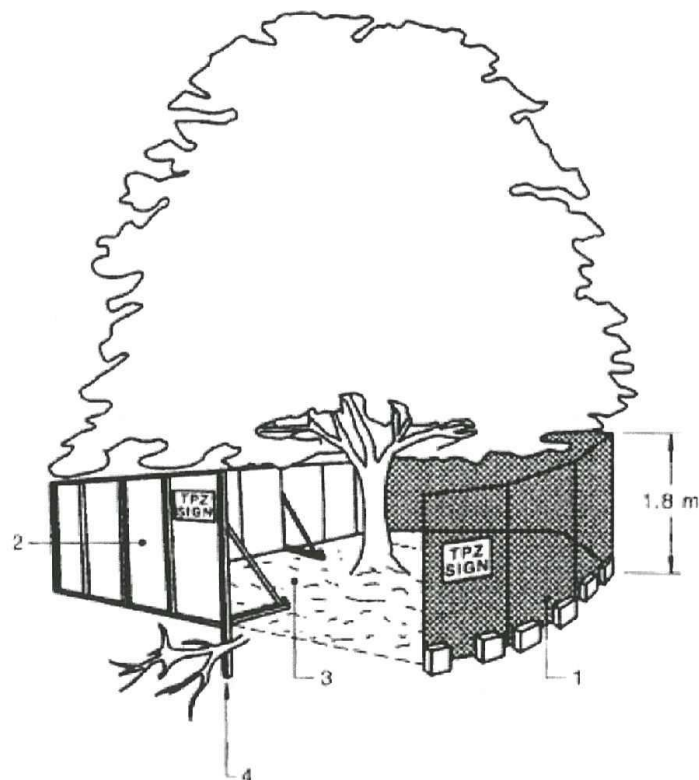
Signs identifying the TPZ should be placed around the edge of the TPZ and be visible from within the development site (refer Figure 3). The lettering on the sign should comply with AS 1319. Appendix C provides an example of a suitable TPZ sign.

- 1 Chain wire mesh panels with shade cloth (if required) attached, held in place with concrete feet.
- 2 Alternative plywood or wooden paling fence panels. This fencing material also prevents building materials or soil entering the TPZ.
- 3 Mulch installation across surface of TPZ (at the discretion of the project arborist). No excavation, construction activity, grade changes, surface treatment or storage of materials of any kind is permitted within the TPZ.
- 4 Bracing is permissible within the TPZ. Installation of supports should avoid damaging roots.

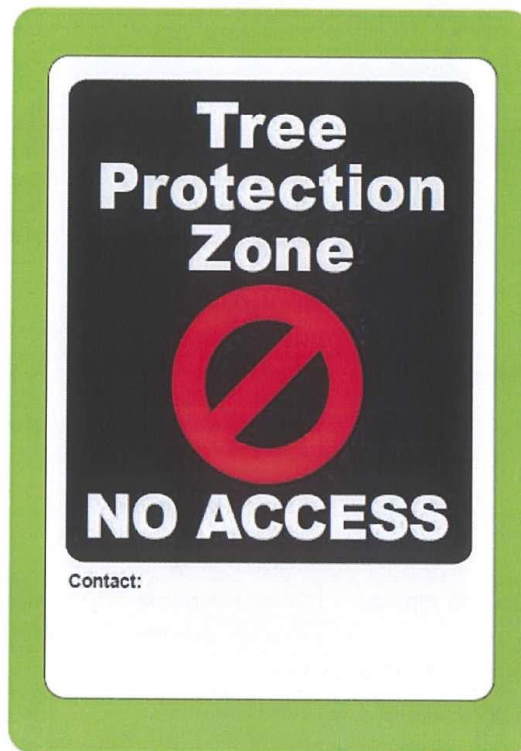
FIGURE C1 TREE PROTECTION ZONE SIGN

A TPZ sign provides clear and readily accessible information to indicate that a TPZ has been established. Figure C1 provides an example of a suitable sign.
