Borough of Queenscliffe Public Toilet Strategy 2015 – 2025 (Updated July 2018)

Borough of Queenscliffe Public Toilet Strategy 2015 – 2025

(Updated July 2018)

Strategy produced by:
gilbert consulting pty ltd
with the assistance of:
Borough of Queenscliffe Staff and Community

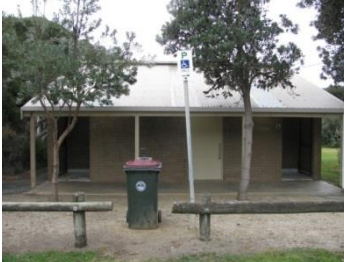
| Toilet No 9 –Ganes Reserve - Ocean Road, Point Lonsdale | | |

| Toilet No 9 –Ganes Reserve - Ocean Road, Point Lonsdale | | |
|---|---|--|
| | Style | Stand Alone - Traditional with Unisex Disabled cubicle direct access |
| | Age | Newer |
| | Cubicles | 4Female, 3Male, 1 Urinal, 1Unisex Disabled, |

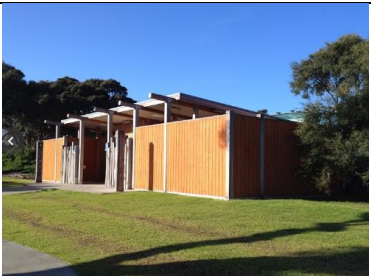
| Toilet No 12 –Point Lonsdale Foreshore - Point Lonsdale Road, Point Lonsdale | | |

| Toilet No 12 –Point Lonsdale Foreshore - Point Lonsdale Road, Point Lonsdale | | |
|---|---|---|
| | Style | Stand Alone - Traditional with Unisex Disabled cubicle direct access |
| | Age | New |
| | Cubicles | 3Female, 2Male, 1 Urinal, 1 Unisex Disabled with baby change facility direct access |

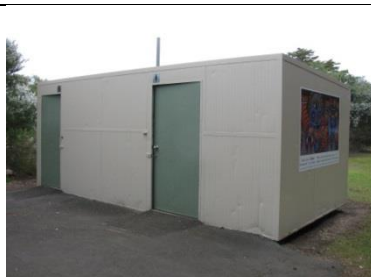
| Toilet No 13 –Gas Works Skate Park - Point Lonsdale Road, Point Lonsdale | | |

| Toilet No 13 –Gas Works Skate Park - Point Lonsdale Road, Point Lonsdale | | |
|---|---|---|
| | Style | Stand Alone - Traditional - Portable Type |
| | Age | Old |
| | Cubicles | 3Female, 2Male, 1 Urinal, Disabled (M,F) but poor accessibility |

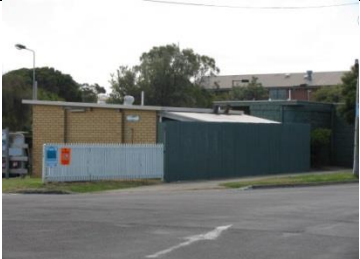
| Toilet No 8 –Queenscliff Recreation Reserve – Hesse Street, Queenscliff | | |

Only one (1) traditional style public toilet is incorporated with another building and it is an old building with old fittings. The following provides a snapshot of this public toilet.

| Toilet No 8 –Queenscliff Recreation Reserve – Hesse Street, Queenscliff | | |
|---|---|--|
| | Style | Attached to Amenities Block –(No Disabled) |
| | Age | Very Old |
| | Cubicles | 3Female, 2 Male, Urinal, |

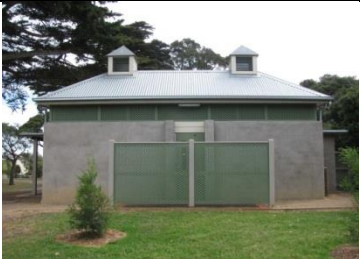
| Toilet No 5 –Victoria Park – King Street, Queenscliff | | |

| Toilet No 5 –Victoria Park – King Street, Queenscliff | | |
|---|---|--|
| | Style | Incorporated Amenities Block - Unisex Disabled cubicle direct access |
| | Age | New |
| | Cubicles | 1Unisex Disabled, |

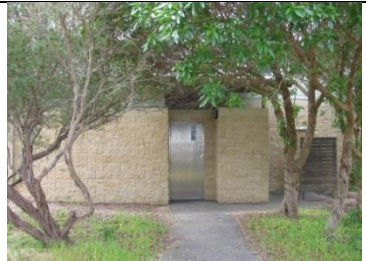
| Toilet No 4 –Santa Casa Beach – Henry Street, Queenscliff | | |

| Toilet No 4 –Santa Casa Beach – Henry Street, Queenscliff | | |
|---|---|--|
| | Style | Incorporated with Surf Life Saving Clubrooms - Unisex Disabled cubicle direct access |
| | Age | New |
| | Cubicles | 1Unisex Disabled, |

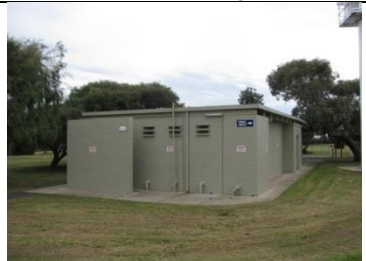
| Toilet No 14 –Royal Park – King Street, Queenscliff | | |

One (1) public toilet has separate Male and Female cubicles incorporated with another building opening directly onto public spaces. A unisex toilet also exists with disability access but it is kept locked.

| Toilet No 14 –Royal Park – King Street, Queenscliff | | |
|---|---|--|
| | Style | Incorporated with Amenities Block – Male and Female Separate Units – Direct Access |
| | Age | Old |
| | Cubicles | 1Male, 1 Female 1Unisex Disabled (not Open), |

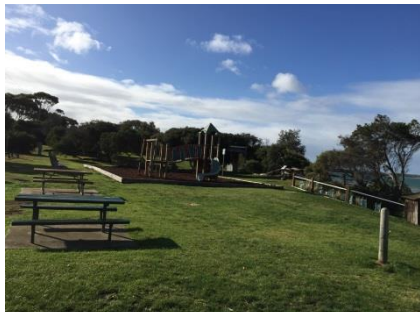
8.3.1 Point Lonsdale Beach – Northern End Opposite Loch Street

The users of the northern end of Point Lonsdale beach, playground equipment and the new barbeque facilities recently installed by Council have to walk 450 metres to the Point Lonsdale Foreshore Toilets or 700 metres to Royal Park toilets. As the number of people using this area, include young families, is increasing, it is appropriate to consider the installation of a new public toilet at this location. A toilet at this site will also benefit walkers. Using the New Toilet Assessment Chart (Section 14.8 – Demand for New Toilets) the proposal scores 22, which is high

enough for the new toilet to be considered.

The estimated cost is \$120,000.

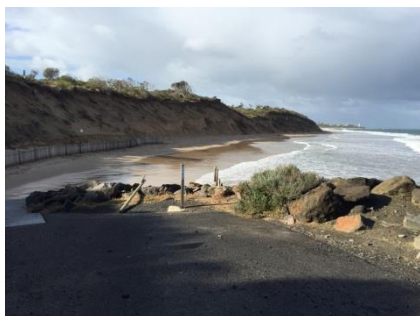
8.3.2 Dog Beach Carpark

Dog beach is located midway between Queenscliffe and Point Lonsdale, about 1.5 kilometres from each town and also from public toilet facilities. Users of the walking track would welcome a toilet at this location and it could service occasional peaks during events such as the Rip View Swim Classic. A toilet located in the carpark could access sewer connections.

Using the New Toilet Assessment Chart (Section 14.8 – Demand for New Toilets) the proposal scores 16, which is not high enough for a new toilet to be considered, unless circumstances change.

A possible option, worthy of consideration, is provision of a slab with service connections suitable for placing and connecting temporary toilets during high peak use times including events.

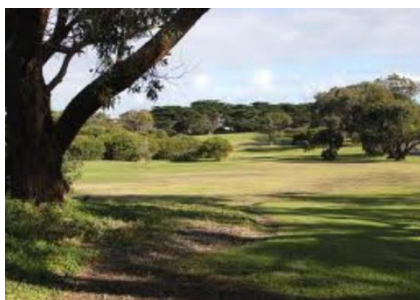
8.3.3 Old High School Site - Proposed Queenscliffe Botanic Gardens Development

The strategy for the proposed development of the old high school site into a botanic garden incorporating community and indigenous gardens also includes a community building containing externally accessible public toilets. The toilets, if developed, will be located in King Street and service users of the site and the Bellarine Rail Trail.

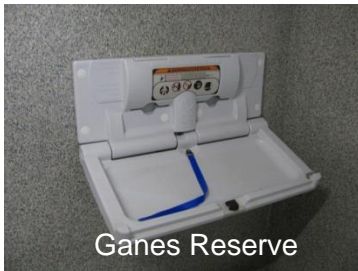
11.1 Baby Change Facilities

Baby change facilities are required in areas that attract or need to accommodate families with young children such as foreshore, shopping centres, parks and reserves with playground equipment. Public toilets in each of these areas should have baby change facilities, preferably located in the unisex cubicle that is accessible by people with disabilities. Each baby change facility must include a nappy bin.

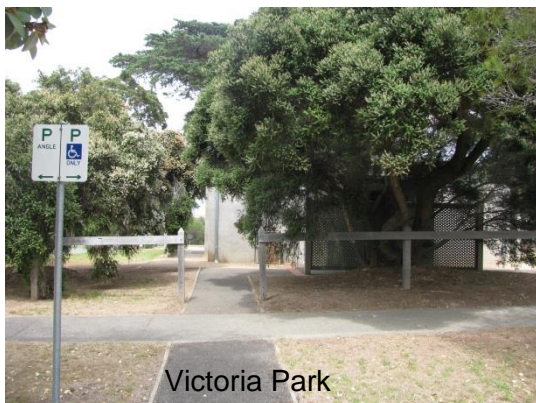
11.4 Disabled Parking Spaces

Disabled carpark spaces are located near public toilets in some instances. As a rule where public toilets are provided adjacent to or very near a carpark, the Borough of Queenscliffe should, where possible, provide at least one disabled car parking space in a bay that is closest to the toilet.

This makes it easier for any impaired person to access the toilet.

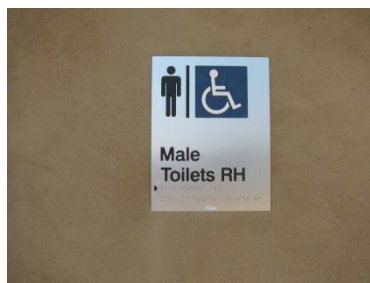
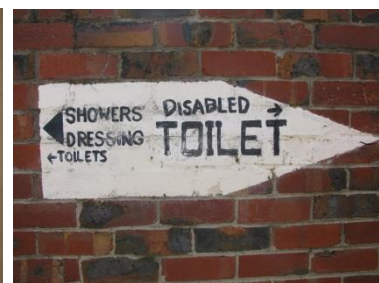
12.2 Signage on Public Toilets

The cubicles doors are currently signed with a variety of styles. To assist identification, the cubicle doors should have standardised and clear identity signage.

Stand-alone public toilets, unless easily identified as a public toilet, and pavilion type public toilet collocated with another building should have a sign 'Public Toilet' clearly visible on the building.

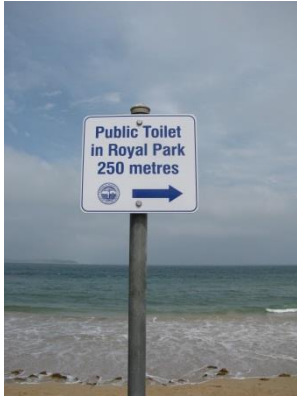
12.3 Signage Standards

The following signage matters should be addressed:

- Develop design guidelines which give clear indications of the nature of signage to be incorporated in public toilet projects. These might include:
 - Directional signs from multiple directions, including nearby car parking.
 - Signage on access routes for people with mobility impairment whether ambulant or wheelchair/scooter based.
 - In parks or foreshores, signage may be required at entry/ exit points if the public toilet is not immediately visible.
- If on walkways or shared pathways directional/distance signage may be required to indicate the distance to the nearest public toilet as well as directional guidance.

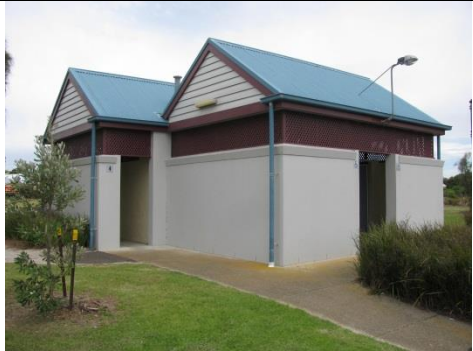
| | Public Toilet No. 1 | Description & Location: |

| | | JL Jordan Reserve – Boat Ramp Hesse Street Extension Queenscliff (Open 24 Hours) |

- Directional signage to toilet

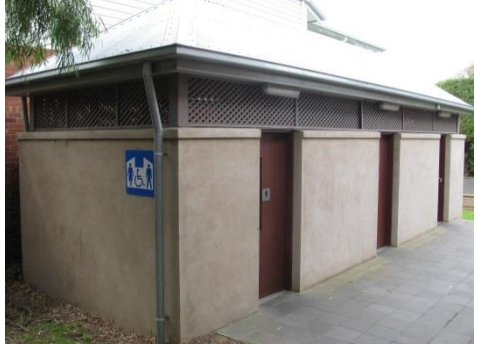
| | Public Toilet No. 2 | Description & Location: |

| | | Hesse Street Hesse Street Queenscliff (Open 24 hours) |

- Directional signage needs better arrow
- Doors hard to open (heavy)
- Dark when first enter even though seems to be good natural light
- Lighting of walkway

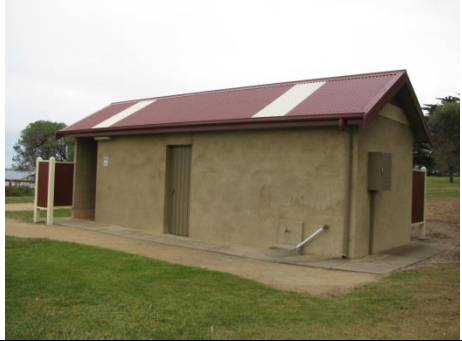
| | Public Toilet No. 3 | Description & Location: |

| | | Citizen's Park Gellibrand Street Queenscliff (Open 24 Hours) |

- Directional signage to toilet
- Requires Public Toilet sign on toilet facing carpark
- Access could be improved for mobility impaired
- Screens at doorways be replaced with slats or perforated metal to improve safety and ability to see cubicle doors

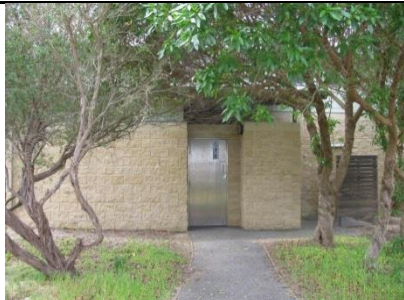
| | <p align="center">Public Toilet No. 4</p> | <p>Description & Location:</p> |

| | | <p align="center">Santa Casa Beach</p> <p align="center">Henry Street Queenscliff</p> <p align="center">(Open 24 Hours)</p> |

- Visibility of entrance and consequently safety is an issue
- Requires Public Toilet sign on toilet facing carpark/beach
- Building located in scrub area, although trees trimmed up possible concealment at night
- Light on building at door and side of building as access but no other lighting – needs improvement.
- Not a 24 hour toilet

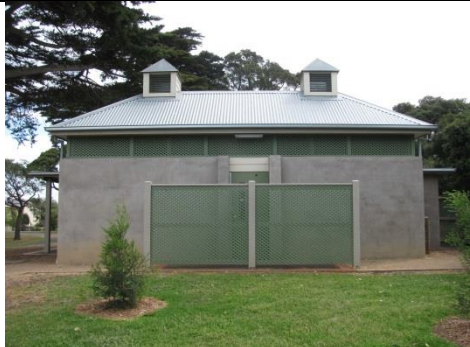
| | Public Toilet No. 5 | Description & Location: |

| | | Victoria Park King Street Queenscliff (Open 24 Hours) |

- Difficulty locating from street.- requires Public Toilet sign on toilet facing park and street sign pointing to toilet
- Tree on roadside needs to be trimmed up for visibility
- Requires natural light if possible
- For 24 hours requires better access lighting

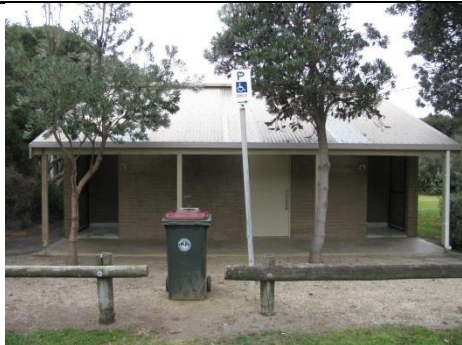
| | Public Toilet No. 9 | Description & Location: |

| | | Ganes Reserve Ocean Road Point Lonsdale (Open 24 Hours) |

- Traditional design for M7F – safety issues
- Access could be improved - gravel
- Disabled needs updating
- Signage to toilet
- External lighting

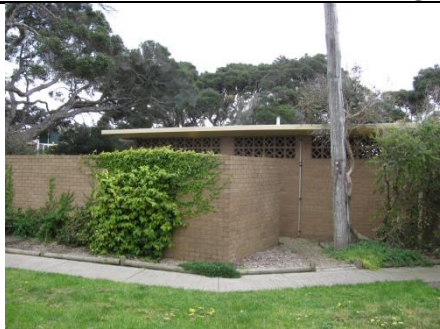
| | Public Toilet No. 12 | Description & Location: |

| | | Point Lonsdale Foreshore Point Lonsdale Road Point Lonsdale (Open 24 Hours) |

Renewed in 2017

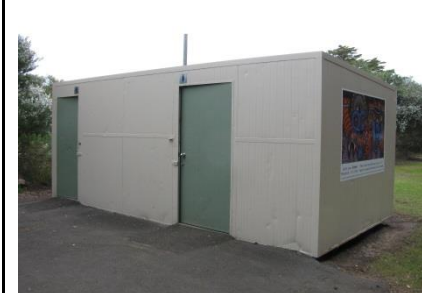
| | Public Toilet No. 13 | Description & Location: |

| | | Gas Works Skate Park Point Lonsdale Road Point Lonsdale (Open 24 Hours) |

- D toilet not suitable facility
- External lighting
- Vegetation trimming
- Building Orientation
- Design (traditional)
- Old and tired interior

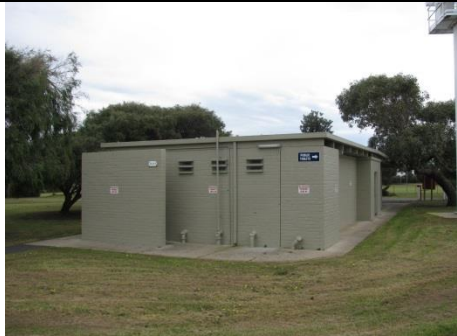
| | Public Toilet No. 14 | Description & Location: |

| | | Royal Parade Point Lonsdale Road Point Lonsdale (Open 24 Hours) |
