# Borough of Queenscliffe

# Public Toilet Strategy

## 2025 - 2030

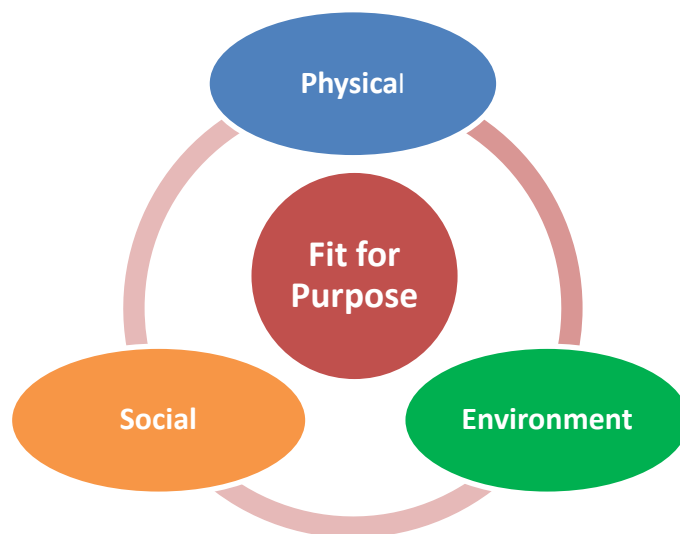
For public toilets, the measure of performance is really a measure of ‘fit for purpose’ drawing upon community expectations, changes in legislation and guidelines relating to the safety and accessibility of public toilets which can be broadly grouped under three sub- criteria: physical, social, and environment.

The physical, social and environmental sub-criteria are brought together in an asset management process capable of measuring the overall performance or ‘fit for purpose’ of individual public toilets. By assigning a score against a range of elements for each sub-criteria and weighting the score based on risk allows a performance ranking of toilets.

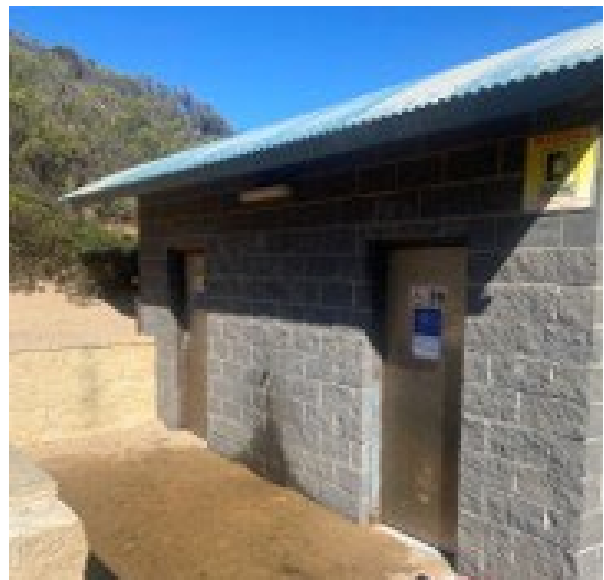
#### Point Lonsdale Back Beach toilets

The steel door frames have corroded and need replacing. Also, on the east side of the toilet there is a low wall that sand blows over into the toilet entrance and so extension of this wall is advisable to prevent sand build up

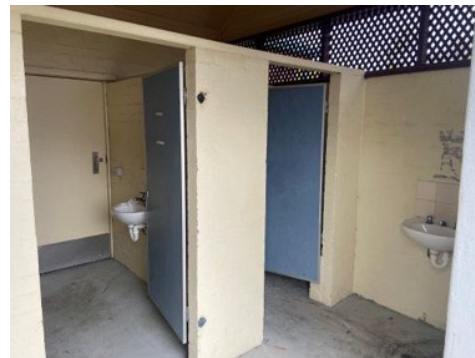
### **Jordan Reserve**

Has floors that are difficult to clean and no hot water access for cleaners. Attending to these two items would assist the cleaners to maintain this busy toilet. This issue is shared with a number of the public toilets.

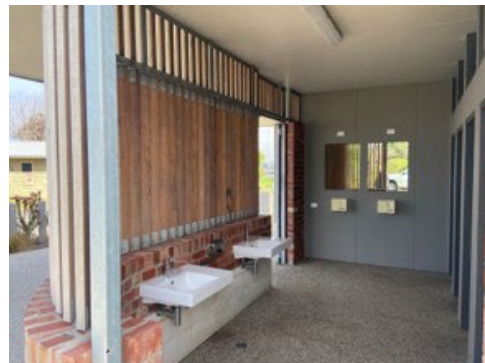
### **Queenscliff Recreation Reserve**

Although this is a relatively new facility there is no access to a water tap for cleaners and so this is considered a high priority to attend to.

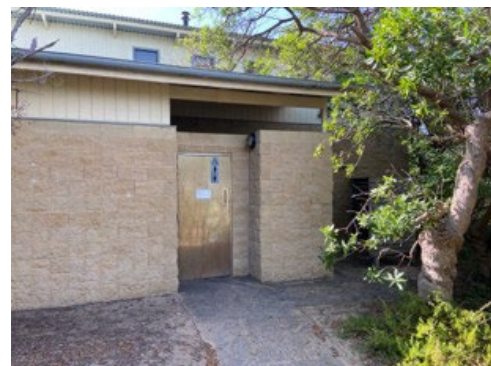
### **Victoria Park, Santa Casa and Ganes Reserve**

These public toilets are all obscured by large bushy trees out front of the toilets. These should be trimmed up for safety and visibility of the toilet.

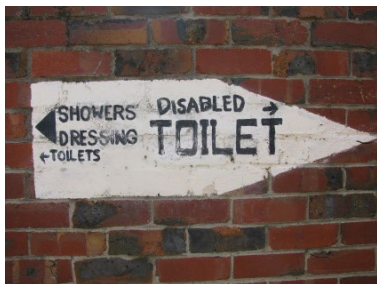
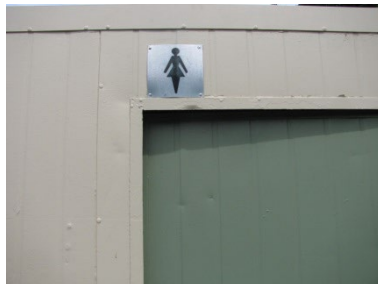
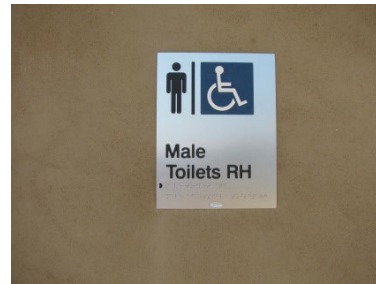
## 10.2 Signage on Public Toilets

Stand-alone public toilets, unless easily identified as a public toilet, and pavilion type public toilet colocated with another building should have a sign 'Public Toilet' clearly visible on the building.

The cubicles doors are currently signed with a variety of styles. To assist identification, the cubicle doors should have standardised and clear identity signage. A standardised approach should be considered within the Borough's proposed wayfinding signage review.

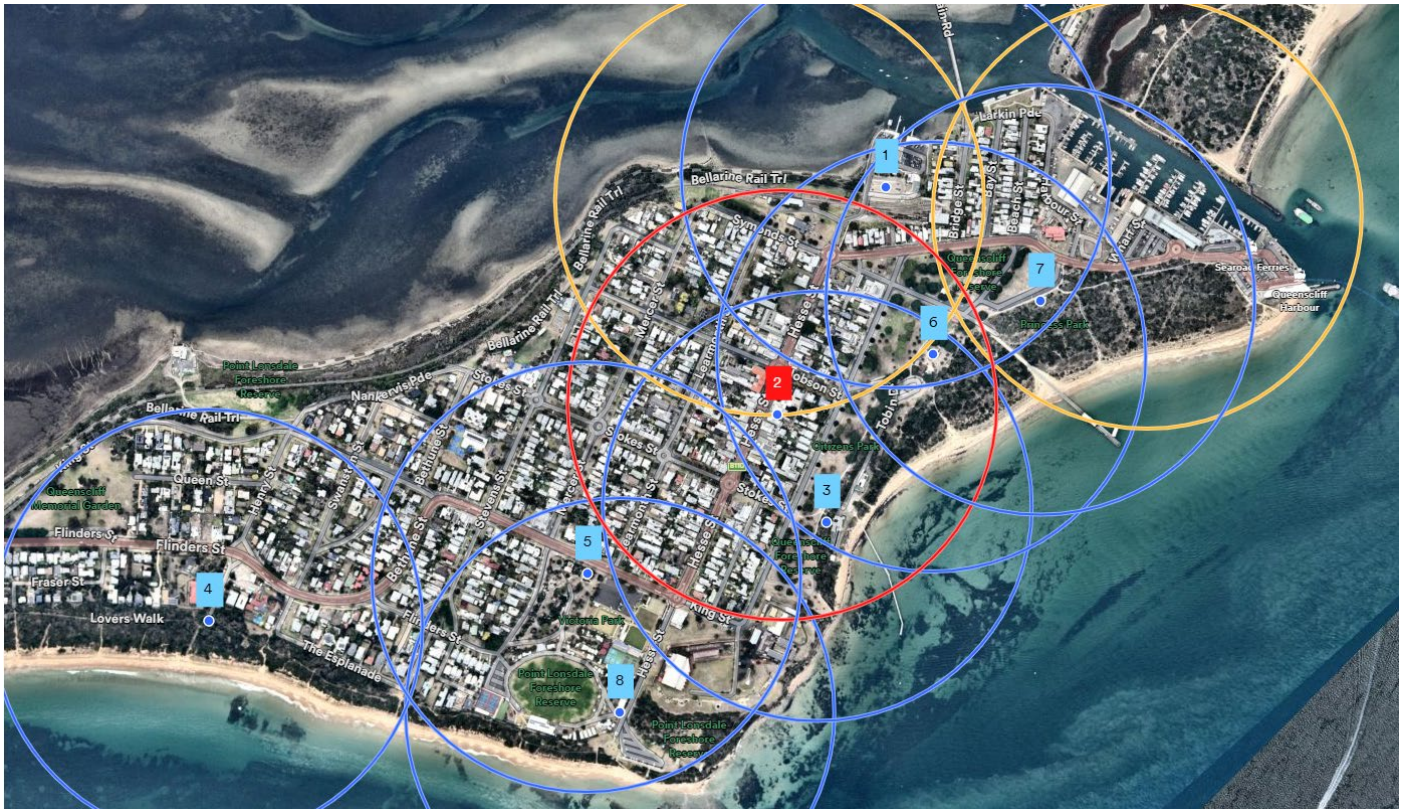
### Queenscliff

- 1 J L Jordan Reserve - Boat Ramp**

Hesse Street Extension, Queenscliff  
 Open: Open 24 hours
- 2 Hesse Street**

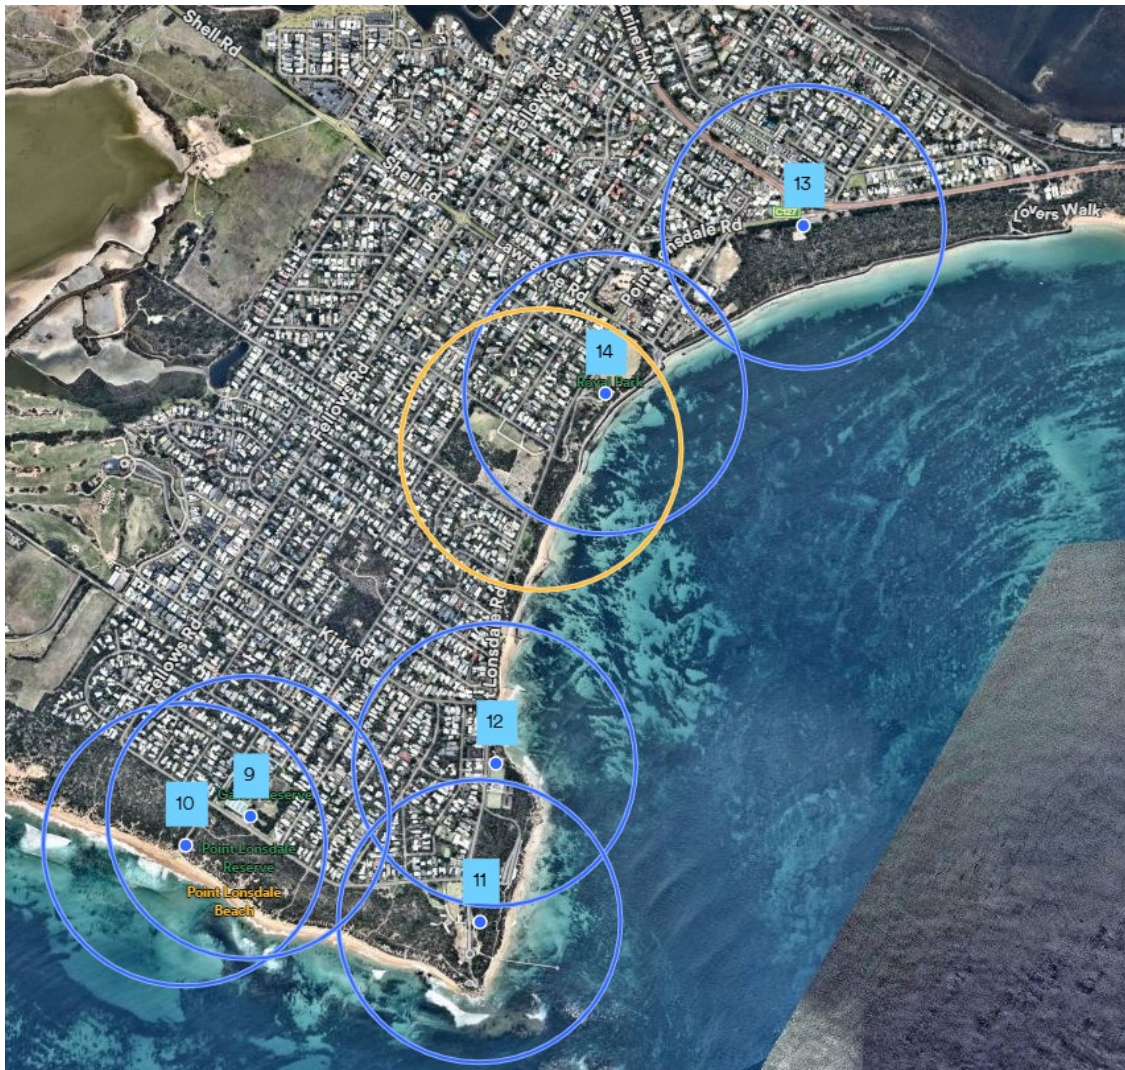
## Point Lonsdale

- 9**

**Ganes Reserve**
