TREE MANAGEMENT, REMOVAL AND REPLACEMENT STRATEGY FOR PRINCESS, CITIZENS AND VICTORIA PARKS BOROUGH OF QUEENSLIFFE

SEPTEMBER 2009

Produced By:

JOHN PATRICK PTY LTD

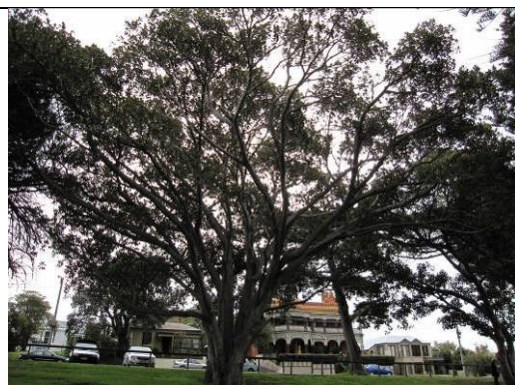
Tree No. 28

Ficus macrophylla, Moreton Bay Fig

Removal Timeframe:

10 years plus

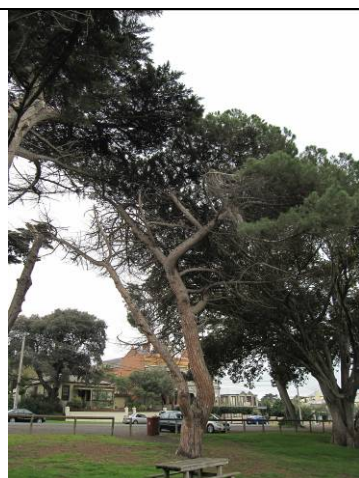
Tree No. 29

Pinus pinea, Stone Pine

Removal Timeframe:

Before next summer (but remedial works are more immediate)

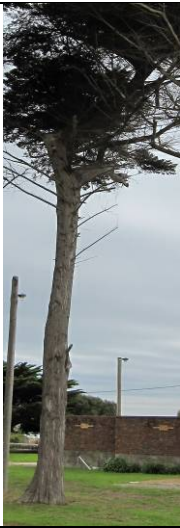
<p>Tree No. 43 <i>Cupressus macrocarpa</i>, Monterey Cypress Condition: Tree has poor branch structure, a lack of supporting branches, evidence of very large limb shed and decay. <i>The tree is recommended for immediate removal as it is a large, over-mature tree which is structurally unsound and located within a public park (see also notes on mature cypress).</i> Remedial works would not be effective for this tree. This tree is dangerous in a public place. Arborists should note that there is a metal spike in the trunk. Removal Timeframe: Immediately</p>

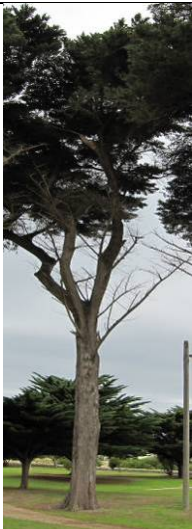
<p>Tree No. 45 <i>Cupressus macrocarpa</i>, Monterey Cypress Condition: Poor branch structure, evidence of shedding of large limbs, lack of supporting branches, bifurcated. <i>The tree is recommended for immediate removal as it is a large, over-mature tree which is structurally unsound and located within a public park (see also notes on mature cypress).</i> Remedial works would not be effective for this tree. This tree is dangerous in a public place. Removal Timeframe: Immediately</p>

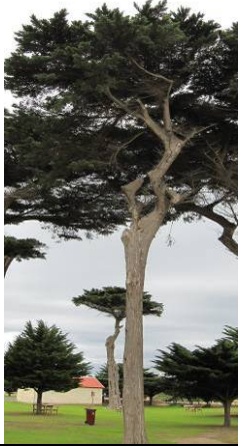
<p>Tree No. 46 <i>Cupressus macrocarpa</i>, Monterey Cypress</p> <p>Condition: Tree has a very limited canopy extremely poor branch structure, a lack of supporting branches and evidence of very large limb shed. <i>The tree is recommended for immediate removal as it is a large, over-mature tree which is structurally unsound and located within a public park (see also notes on mature cypress).</i> Remedial works would not be effective for this tree. This tree is dangerous in a public place.</p> <p>Removal Timeframe: Immediately</p>

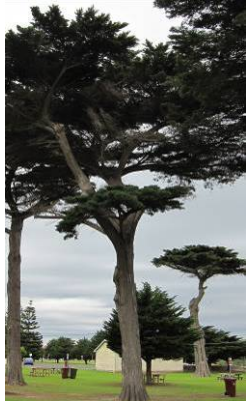
<p>Tree No. 47 <i>Cupressus macrocarpa</i>, Monterey Cypress</p> <p>Condition: Tree has poor branch structure, a lack of supporting branches and evidence of very large limb shed. <i>The tree is recommended for immediate removal as it is a large, over-mature tree which is structurally unsound and located within a public park (see also notes on mature cypress).</i> Remedial works would not be effective for this tree. This tree is dangerous in a public place.</p> <p>Removal Timeframe: Immediately</p>

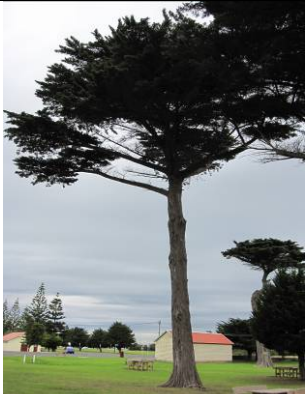
<p>Tree No. 48 <i>Cupressus macrocarpa</i>, Monterey Cypress</p> <p>Condition: Tree has poor branch structure and a lack of supporting branches. <i>The tree is recommended for immediate removal as it is a large, over-mature tree which is structurally unsound and located within a public park (see also notes on mature cypress).</i> Remedial works would not be effective for this tree and tree will be at increased risk of failure when rest of row is removed.</p> <p>Removal Timeframe: Immediately</p>

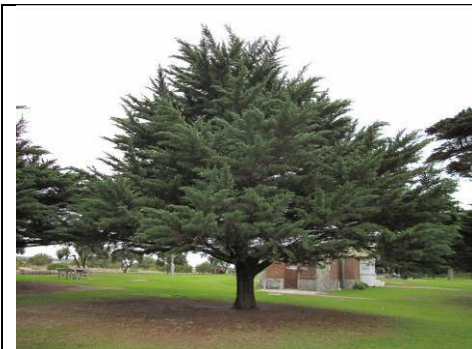
<p>Tree No. 50 <i>Cupressus macrocarpa</i>, Monterey Cypress Condition: A good young tree. Removal Timeframe: 10 years plus</p>

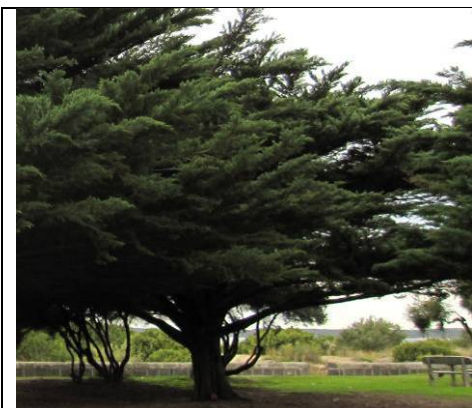
<p>Tree No. 51 <i>Cupressus macrocarpa</i>, Monterey Cypress Condition: A good young tree. Removal Timeframe: 10 years plus</p>

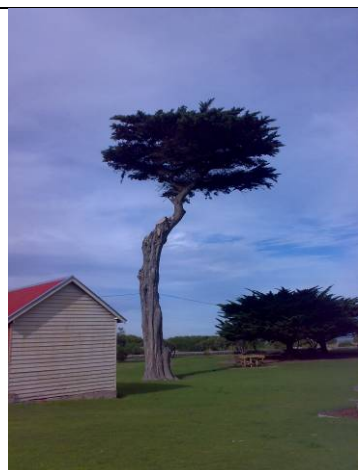
**Tree No. 55****Species:**

Cupressus macrocarpa, Monterey Cypress

Very limited and poorly attached canopy with a history of limb shed and a lack of support for limbs. Decay present from high and extensive decay in lower trunk. Unbalanced canopy, large fissure. *The tree is recommended for immediate removal as it is large, over-mature tree which is structurally very unsound and located within a public park (see also notes on mature cypress).* Remedial works would not be effective for this tree. NOTE: Tree is being used as an electricity post, and this makes removal even more urgent. Tree workers must be aware of the electrical issues.

Immediately

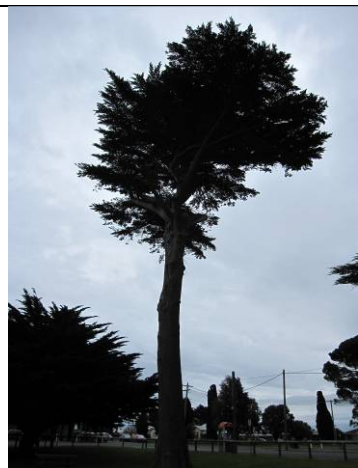
**Tree No. 61**

Recommend removal of this tree. A large scaffold branch has failed and there is a lack of support for remaining scaffolds. The tree is recommended for immediate removal as it is large, over-mature tree which is structurally unsound and located within a public park (see also notes on mature cypress). Remedial works would not be effective for this tree. The tree has a large hanger which makes it especially dangerous.

Immediately

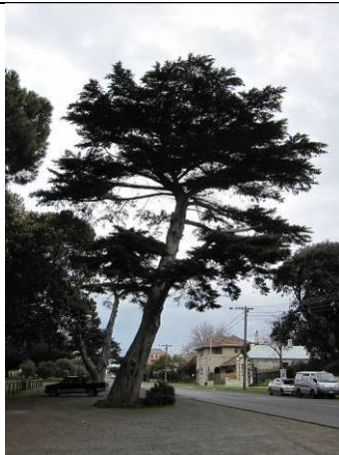
<p>Tree No. 70</p> <p>Species: <i>Cupressus macrocarpa</i>, Monterey Cypress</p> <p>Condition: Sizeable tract of decay in lower trunk where large limb has been lose. Lean to west over road with some root damage opposite the lean, therefore making the tree potentially dangerous. Lack of branching support. Better structure than some cypress but still at real risk of limb failure. Continue to manage through inspections and works if retaining in short term.</p> <p>Removal Timeframe: Before next summer</p>

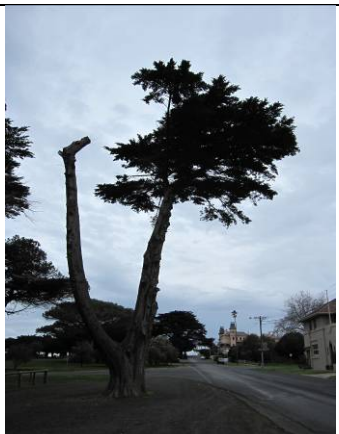
<p>Tree No. 71</p> <p>Species: <i>Cupressus macrocarpa</i>, Monterey Cypress</p> <p>Condition: Large limb to the east with no support and at risk of failure. Evidence of large limb failure and no branching support on the small portion of live canopy. The tree is recommended for immediate removal as it is large, over-mature tree which is structurally unsound and located within a public park. Remedial pruning may potentially work, but only in the very short term and are therefore not advisable. This tree is dangerous in a public place.</p> <p>Removal Timeframe: Immediately</p>

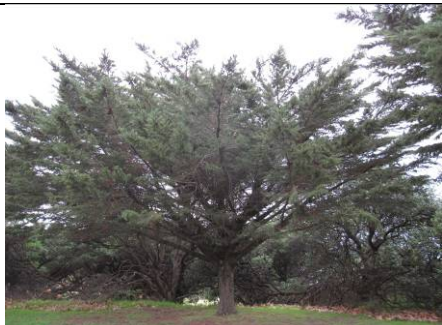
<p>Tree No. 77 <i>Cupressus macrocarpa</i>, Monterey Cypress Condition: A good young tree. Removal Timeframe: 10 years plus</p>

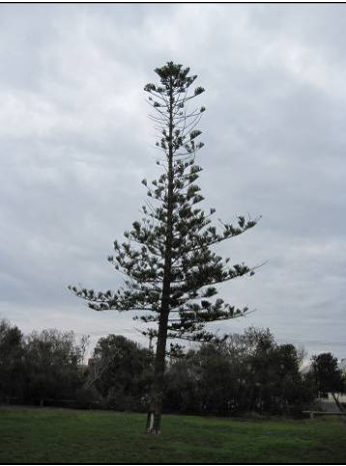
<p>Tree No. 141 <i>Araucaria heterophylla</i>, Norfolk Island Pine</p> <p>Condition: Fair health. Gash at base limits the long-term viability of the tree. It is recommended that replacement planting take place and that the tree is then removed. Manage in accordance with Section 4.3 leading up to removal. <i>A clump of dieing Coast Tea-tree to the south is recommended for removal immediately as it is senescent and breaking apart.</i></p> <p>Removal Timeframe: 5 years</p>
 	<p>Tree No. 142</p> <p>Species: <i>Pinus halepensis</i>, Aleppo Pine</p> <p>Condition: Young tree which has poor structure and limited long term viability. It is recommend that regular inspections and maintenance work be carried out to manage the stability of the tree leading up to removal. Tree should be removed if inspections indicate it poses an unacceptable risk to the public; even if within the 10 year retention period.</p> <p>Removal Timeframe: 10 years</p>

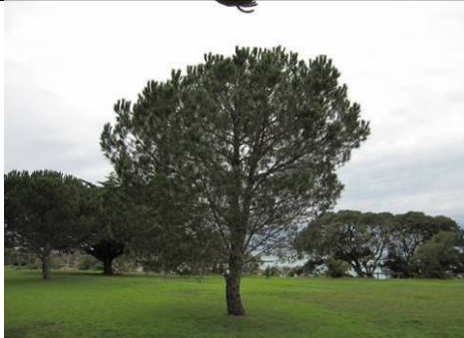
<p>Tree No. 144 <i>Pinus halepensis</i>, Aleppo Pine</p> <p>Condition: Bifurcated with included bark and swelling, but with low level of weight on limbs. Tree is not an imminent failure risk but won't develop well and cabling is not recommended for such a young tree.</p> <p>Removal Timeframe: 5 years</p>

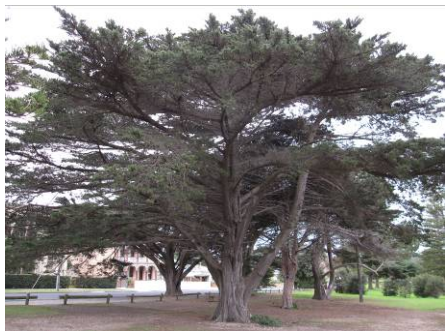
<p>Tree No. 152 <i>Cupressus macrocarpa</i>, Monterey Cypress</p> <p>Condition: Lost moderately sized limbs. Younger than other mature cypresses in parks. Central leader. <i>Recommend removal of deadwood in lower canopy before next summer as long as this is necessary on safety grounds and if it will not compromise the tree structurally. It is recommended that the tree be reassessed to determine the appropriateness of carrying out deadwooding works before this occurs.</i> Leaders have a lot of weight on them. Recommend ongoing inspections and maintenance work to aid tree retention and manage risk. Retain only while safe to do so.</p> <p>Removal Timeframe: 10 years plus</p>

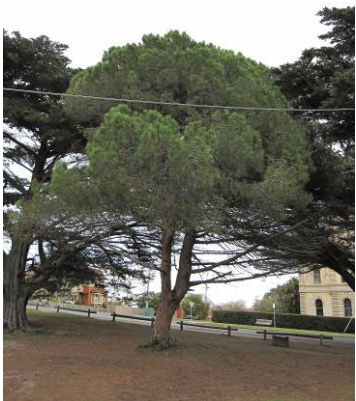
<p>Tree No. 153 <i>Pinus pinea</i>, Stone Pine</p> <p>Condition: Large amounts of deadwood in lower canopy. Damage in bifurcation union. Compromised by the adjacent Cypress. Recommend removal at the same time as tree 152 if not required earlier. It is recommend that regular inspections and maintenance work be carried out to manage the stability of the tree leading up to removal. Tree should be removed if inspections indicate it poses an unacceptable risk to the public; even if within the 5 year retention period.</p> <p>Removal Timeframe: 5 years</p>

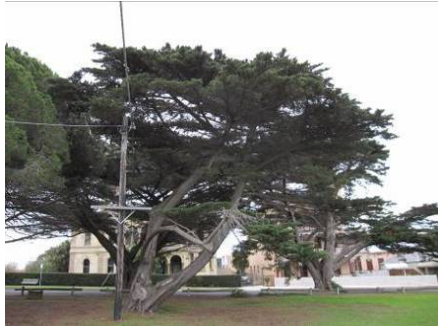
<p>Tree No. 154 <i>Cupressus macrocarpa</i>, Monterey Cypress</p> <p>Condition: Tree has poor structure, is over mature and has a lack of supporting branches. Enormous limb to the north. It is recommend that regular inspections and maintenance work be carried out to manage the stability of the tree leading up to removal. Tree should be removed if inspections indicate it poses an unacceptable risk to the public; even if within the 1-2 year retention period.</p> <p>Removal Timeframe: 1-2 years</p>

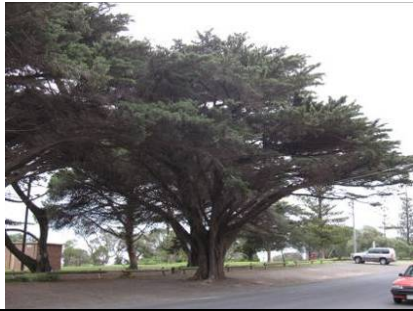
<p>Tree No. 155 <i>Cupressus macrocarpa</i>, Monterey Cypress Condition: Tree is at age where a pattern of failure is likely to commence. The tree's location within a car park makes it hazardous and remedial works are not appropriate. Removal Timeframe: Before next summer.</p>

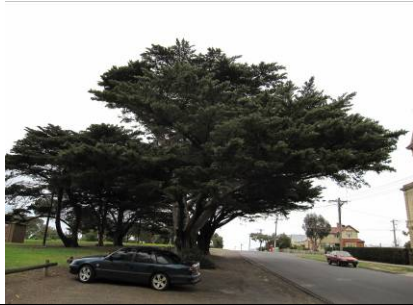
<p>Tree No. 156 Species: <i>Cupressus macrocarpa</i>, Monterey Cypress Condition: Tree is at age where limbs are being lost and a pattern of failure has started. Tree has poor branching structure and the lower branches which provide structural support are being lost. Has recently lost a large limb over the road. The tree's location within a car park makes it hazardous and remedial works are not appropriate. Removal Timeframe: Before next summer.</p>

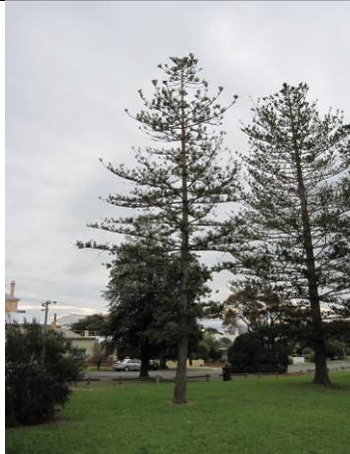
<p>Tree No. 157 <i>Araucaria heterophylla</i>, Norfolk Island Pine Condition: Tree in fair health. Stress mitigation works such as mulch, irrigation and an application of seaweed fertiliser are recommended. A wound is present at the base of the tree. It is recommended that the tree be retained, but that it's structural integrity be monitored, particularly in relation to the wound at the base of the trunk. Removal Timeframe: 10 years plus</p>

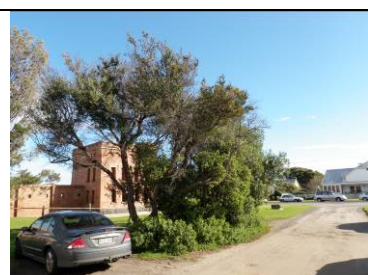
Tree No. 169, 170 and 171

Massed vegetation including *Myoporum insulare* (Boobialla), *Leptospermum laevigatum* (Coast Tea-tree) and other vegetation. These masses have limited longevity and some of the Tea-tree has already collapsed. The masses are for the most part unsightly rather than dangerous, but in some locations cars part within the drop zone of Tea-tree is at risk of collapse. *Recommended either removal immediately* or at least *removal of Tea-tree at risk of failing over cars* (or removal of parked cars). If the second option is taken then the vegetation mass may be removed within the next 5 years.

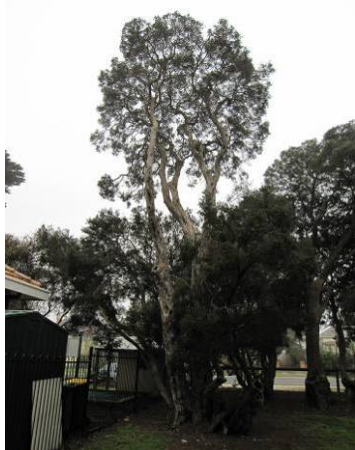
<p>Tree No. 1 <i>Melaleuca lanceolata</i>, Moonah</p> <p>Condition: Over-mature, works not urgent. Would fall towards centre if tree were to fail. <i>Recommend removal of sand pit to reduce hazard risk of tree before next summer.</i> Decay present. It is recommend that regular inspections and maintenance work be carried out to aid retention of the tree and manage risk. Tree should be coppiced if inspections indicate it poses an unacceptable risk to the public; even if within the 10 year retention period. Tree is located within a "Potential Moonah Reserve". If this reserve is adopted than the tree should be fenced rather than coppiced.</p> <p>Coppice Timeframe: 10 years plus or retain in "Moonah Reserve"</p>

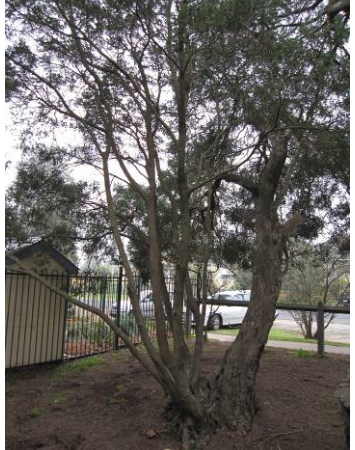
<p>Tree No. 2 <i>Melaleuca lanceolata</i>, Moonah</p> <p>Condition: Mature with epicormic growth. <i>Recommend removal of poorly attached epicormic / lignotuber shoots before next summer. Recommend ongoing management of this growth.</i> Manage in accordance with Section 4.4. Tree is located within a "Potential Moonah Reserve". If this reserve is adopted than the tree should be fenced rather than coppiced.</p> <p>Coppice Timeframe: 10 years plus or retain in "Moonah Reserve"</p>

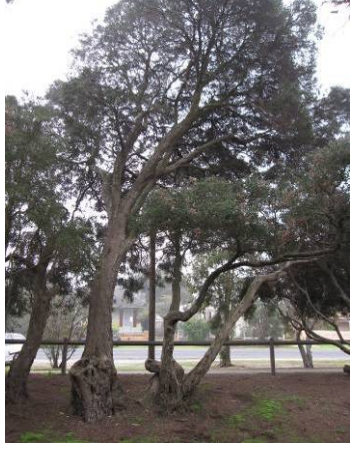
<p>Tree No. 3 <i>Melaleuca lanceolata</i>, Moonah (2 No.)</p> <p>Condition: Mature specimen. Large limb has been removed. A large limb over the footpath is rubbing on a lower leader, but attachment appears to be reasonably solid. This limb should be carefully monitored due to its location over the footpath. It is recommend that regular inspections and maintenance work be carried out to aid retention of the tree and manage risk. Tree should be coppiced if inspections indicate it poses an unacceptable risk to the public; even if within the 10 year retention period. Tree is located within a "Potential Moonah Reserve". If this reserve is adopted than the tree should be fenced rather than coppiced.</p> <p>Coppice Timeframe: 10 years plus or retain in "Moonah Reserve"</p>

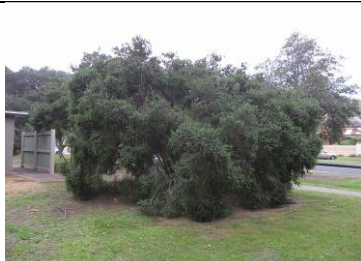
<p>Tree No. 9 <i>Melaleuca lanceolata</i>, Moonah</p> <p>Condition: Completely comprised of a mass of young regrowth from a mature base. Recommend managing coppice growth to develop new tree.</p> <p>Coppice Timeframe: 10 years plus</p>

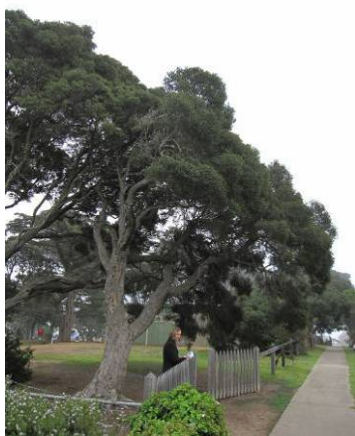
<p>Tree No. 10 <i>Melaleuca lanceolata</i>, Moonah</p> <p>Condition: Mature. Monitor due to potential issues involving limb loss and possible dieback down trunk. Tree has lost a moderately sized limb. <i>Recommend removal of entrance gate away from drop zone and replacement with a solid fence before next summer.</i> Manage in accordance with Section 4.4.</p> <p>Tree is located within a "Potential Moonah Reserve". If this reserve is adopted than the tree should be fenced rather than coppiced.</p> <p>Coppice Timeframe: 10 years plus or retain in "Moonah Reserve"</p>

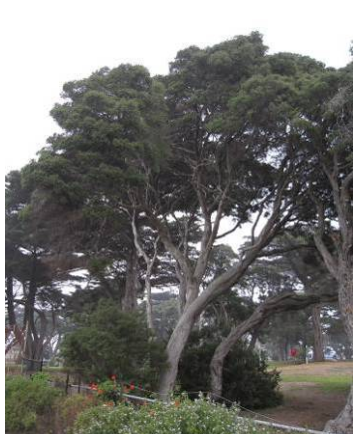
<p>Tree No. 11 <i>Melaleuca lanceolata</i>, Moonah</p> <p>Condition: A group of mature trees with no camping sites in the immediate area. <i>Recommend removal of the small tree to the south-east of the rear trunk before summer as it is mostly dead.</i> It is recommended that regular inspections and maintenance work be carried out to aid retention of the tree and manage risk. Particular attention should be paid to the horizontal leader, and epicormic / lignotuber growth should be managed. Tree should be coppiced if inspections indicate it poses an unacceptable risk to the public; even if within the 10 year retention period. It is recommended that no new campsites be allocated in this area. Tree is located within a "Potential Moonah Reserve". If this reserve is adopted than the tree should be fenced rather than coppiced.</p> <p>Coppice Timeframe: 10 years plus or retain in "Moonah Reserve"</p>

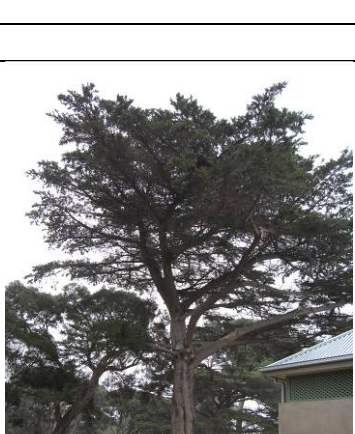
<p>Tree No. 12 <i>Cupressus macrocarpa</i>, Monterey Cypress</p> <p>Condition: Fill around base as a result of works to the new toilet block is highly problematic due to alteration of soil air and water permeation and the risk of rot to the base of the tree. Works may also have resulted in root loss and there is the potential for the tree to become stressed or die. Furthermore, increased stress levels may increase the chance of limb shed. Removal of this fill is unlikely to be practical as a retaining wall would need to be installed instead, resulting in further root damage.</p> <p>The tree is leaning towards the toilets and has a number of limbs at risk of failure. Given past damage, the tree's poor branching structure, evidence of large limb loss (the tree will continue to shed limbs over time) and its location in a high traffic area, removal is recommended in the short term. It is recommend that regular inspections and maintenance work be carried out to aid retention of the tree and manage risk in the short term. Tree should be removed if inspections indicate it poses an unacceptable risk to the public; even if within the 2-3 year retention period.</p> <p>Removal Timeframe: 2-3 years</p>

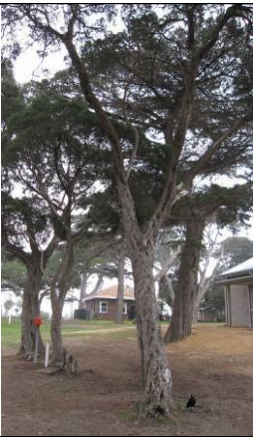
<p>Tree No. 13 <i>Melaleuca lanceolata</i>, Moonah</p> <p>Condition: Tree is not especially large and has lost a large limb. The base of the tree is damaged, probably due to impact from vehicles. Recommend coppicing as tree is relatively small, and the risk posed by the tree outweighs its limited amenity value.</p> <p>Coppice Timeframe: Before next summer</p>

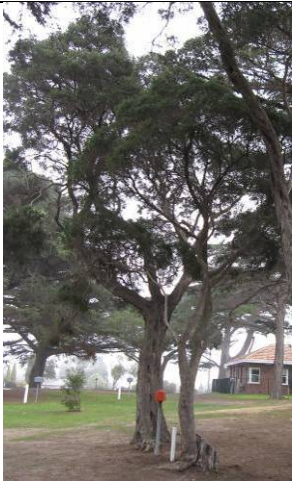
<p>Tree No. 14 <i>Melaleuca lanceolata</i>, Moonah (smaller tree, on right of image)</p> <p>Condition: Semi-mature regrowth on an old tree. Recommend ongoing management of epicormic / lignotuber shoots. It is recommend that regular inspections and maintenance work be carried out to aid retention of the tree and manage risk. Tree should be coppiced if inspections indicate it poses an unacceptable risk to the public; even if within the 10 year retention period. The tree may require removal when adjacent Cypress (Tree 12) is removed due to changed wind loading.</p> <p>Coppice Timeframe: 10 years plus</p>

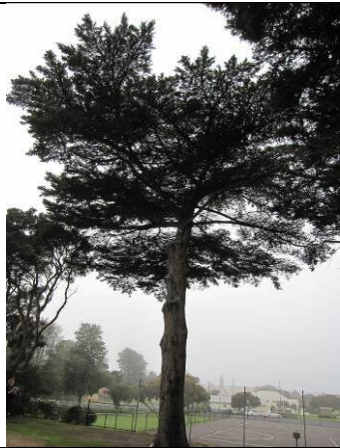
<p>Tree No. 16 Species: <i>Cupressus macrocarpa</i>, Monterey Cypress Condition: Structure compromised by a tract of decay at base of tree. Typical over mature Monterey Cypress branching structure. The canopy structure of the tree is defective. The main concern with this specimen is extensive end weight on branches with the tree's location meaning that failure could potentially result in a fatality. Removal Timeframe: Before next summer</p>

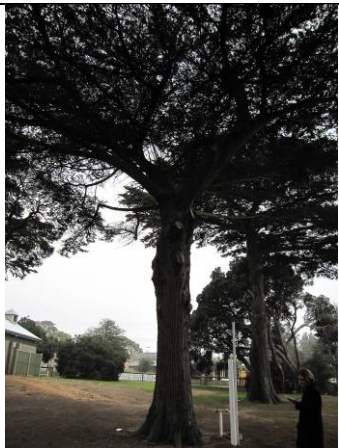
<p>Tree No. 17 <i>Cupressus macrocarpa</i>, Monterey Cypress Condition: Location makes retention of this specimen undesirable as tree is over mature and at increased risk of failure and is located within a caravan park. Poor branching structure. Moderate deadwood. Recommend that tree is monitored carefully, required works are carried out and measures are put in place to allow for replacement of the tree in the short term. Standard issues with over mature Monterey Cypress (see notes). Removal Timeframe: Before next summer</p>

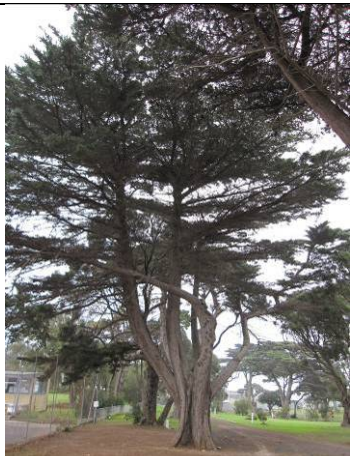
<p>Tree No. 18 <i>Cupressus macrocarpa</i>, Monterey Cypress Condition: I concur with all the observations made in Bellarine Tree's report. <i>I would however recommend the removal of the tree prior to site occupation next summer as failure of this tree could potentially cause a fatality.</i> One limb in particular is at risk of imminent failure as it is very poorly attached and is overhanging the basket ball courts. Removal Timeframe: Immediately</p>

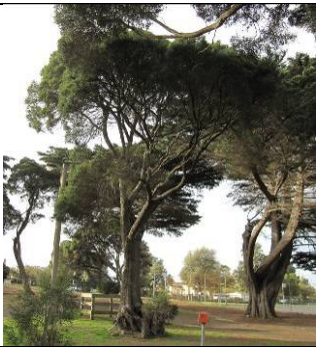
<p>Tree No. 19 <i>Melaleuca lanceolata</i>, Moonah</p> <p>Condition: Large tract of decay. Fungal growth (white type with foul odour seen on other Moonahs). Poor attachment at base of tree.</p> <p>Coppice Timeframe: Cut off tree to base to coppice growth before next summer. Manage coppice growth to develop new tree.</p>

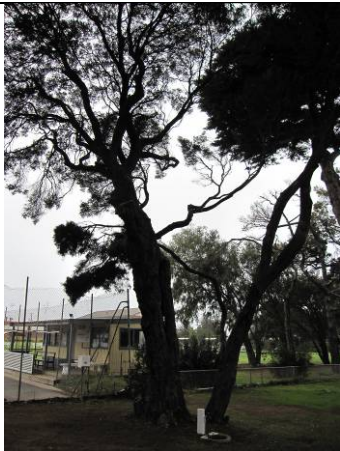
<p>Tree No. 20 <i>Melaleuca lanceolata</i>, Moonah</p> <p>Condition: Lost limb high. Two leaders from base. Low SULE. Recommend urgent pruning of the limb over the tennis court and van. Extensive dieback present. <i>Highly unstable limb to the north recommended for removal immediately. This limb is heavy and damaged in the branch union with dieback above. Potentially very dangerous, especially given that a caravan was placed within the drop zone of this limb last summer.</i> A cavity is present in the trunk which light shines through. The second leader may be retained after the removal of the first, but should be carefully monitored, especially with the increased exposure.</p> <p>Recommend coppicing due to failure risk and location.</p> <p>Coppice Timeframe: Coppice main tree before next summer and retain front leader for 10 years plus.</p>

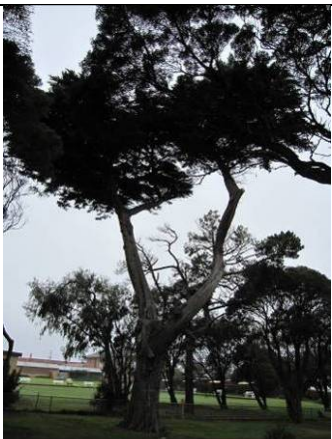
<p>Tree No. 21 <i>Cupressus macrocarpa</i>, Monterey Cypress</p> <p>Condition: An over mature “y” shaped tree with no supporting branches for canopy. Very large limbs have been removed. One limb with fissure, another with multiple weak points. Significant tear on western leader. Extensive weight on leaders. Standard issues with over mature Cupresses and pruning not a practical option. Tree could potentially be fatal if it were to fail. <i>Recommend removal immediately.</i></p> <p>Removal Timeframe: Immediately</p>

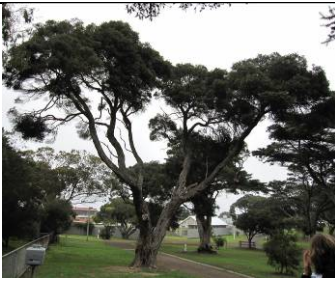
<p>Tree No. 23 <i>Melaleuca lanceolata</i>, Moonah</p> <p>Condition: A very large mature tree and a handsome specimen. This tree has high retention value, but public safety must be given due consideration in determining management regime. The structure of the tree is compromised by a stub within a branch union. This limb overhangs the access road. It is recommended that a tomograph be used to check for internal decay, especially in the central leaders. It is recommend that regular inspections and maintenance work be carried out to aid retention of the tree and manage risk. In particular, attention should be given to the branch union with the branch stub. The tree should be coppiced if inspections indicate it poses an unacceptable risk to the public; even if within the 10 year retention period. Cabling of the tree should be investigated to determine if it is a feasible management option.</p> <p>Coppice Timeframe: 10 years plus</p>

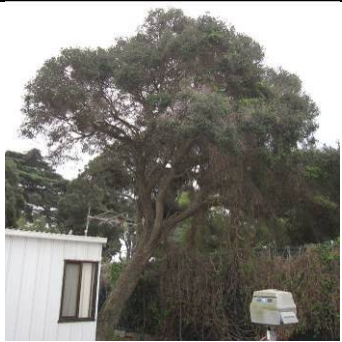
<p>Tree No. 27 <i>Melaleuca lanceolata</i>, Moonah</p> <p>Condition: In early maturity. Extensive lean towards the path but not overhanging any camping sites. Recommend removal of clothes line as it is a safety risk if the tree were to fail. Manage in accordance with Section 4.4. Recommend removal of <i>Dipogon lignosus</i> in canopy.</p> <p>Coppice Timeframe: 10 years plus</p>

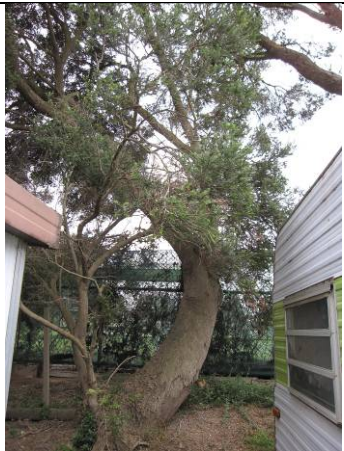
<p>Tree No. 29 <i>Melaleuca lanceolata</i>, Moonah</p> <p>Condition: Tree is leaning but weighted back on itself. Manage in accordance with Section 4.4.</p> <p>Coppice Timeframe: 10 years plus</p>

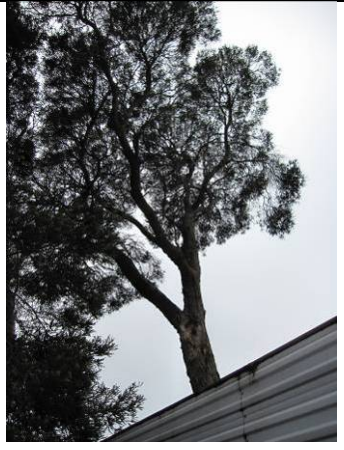
<p>Tree No. 30 <i>Melaleuca lanceolata</i>, Moonah</p> <p>Condition: A mature tree in reduced health which is the remaining single leader of what was once a two leader tree. A large limb to the south has been lost with decay present and this combines with dieback in the northern limb's branch union. <i>This leader overhangs the bowling green which is in use, and the tree is therefore recommended for coppicing immediately.</i></p> <p>Note: On the third inspection a vertical crack was noted in this leader, further strengthening the need for coppicing.</p> <p>Coppice Timeframe: Cut off tree to base to coppice growth immediately. Manage coppice growth to develop new tree.</p>

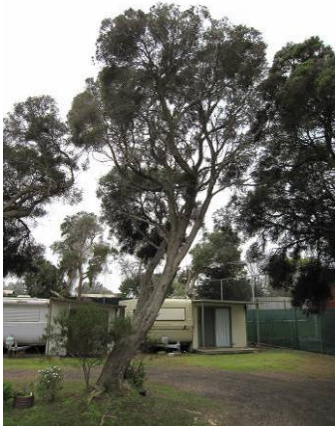
<p>Tree No. 36 <i>Melaleuca lanceolata</i>, Moonah and</p> <p>Condition: Very large mature Moonah. <i>Northern leader is leaning heavily and is weighted at the end, this leader is recommended for immediate removal.</i> A second leader is bifurcated. One root is girdling and has overgrown another. It is recommend that regular inspections and maintenance work be carried out to manage the stability of the tree. Tree should be coppiced if inspections indicate it poses an unacceptable risk to the public; even if within the 10 year retention period.</p> <p>Tree is located within a "Potential Moonah Reserve". If this reserve is adopted than the tree should be fenced rather than coppiced.</p> <p>Coppice Timeframe: 10 years plus or retain in "Moonah Reserve"</p>

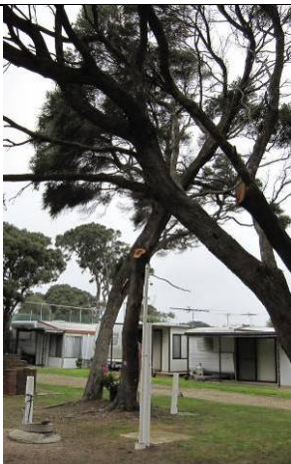
<p>Tree No. 38 <i>Melaleuca lanceolata</i>, Moonah</p> <p>Condition: Mature trees. Be aware of metal hook in trunk when removing tree (potentially problem for tree workers). It is recommend that regular inspections and maintenance work be carried out to aid retention of the tree and manage risk, with particular attention given to the root plate (girdling and damaged). Tree should be coppiced if inspections indicate it poses an unacceptable risk to the public; even if within the 10 year retention period.</p> <p>Tree is located within a "Potential Moonah Reserve". If this reserve is adopted than the tree should be fenced rather than coppiced.</p> <p>Coppice Timeframe: 10 years plus or retain in "Moonah Reserve"</p>

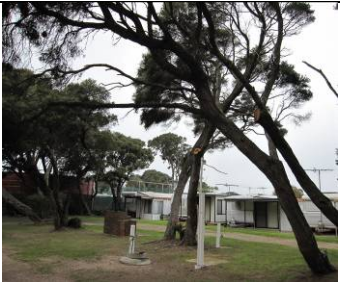
<p>Tree No. 39 <i>Melaleuca lanceolata</i>, Moonah</p> <p>Condition: Decay present opposite lean of tree. <i>Recommend propping of this tree before next summer.</i></p> <p>Tree is located within a "Potential Moonah Reserve". If this reserve is adopted then the tree should be fenced rather than coppiced.</p> <p>Coppice Timeframe: 10 years plus or retain in "Moonah Reserve"</p>

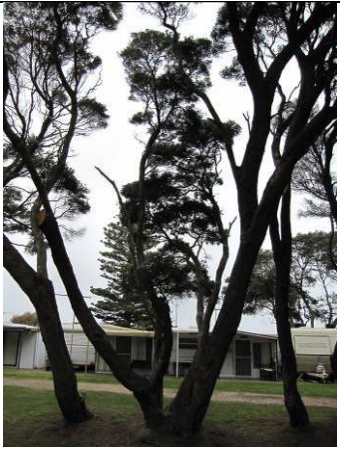
<p>Tree No. 40 <i>Melaleuca lanceolata</i>, Moonah</p> <p>Condition: Bifurcated with included bark. It is recommend that regular inspections and maintenance work be carried out to aid retention of the tree and manage risk. Especially care should be taken following the removal of tree 41 due to changes in wind loading. Tree should be coppiced if inspections indicate it poses an unacceptable risk to the public; even if within the 10 year retention period.</p> <p>Tree is located within a "Potential Moonah Reserve". If this reserve is adopted then the tree should be fenced rather than coppiced.</p> <p>Coppice Timeframe: 10 years plus or retain in "Moonah Reserve"</p>

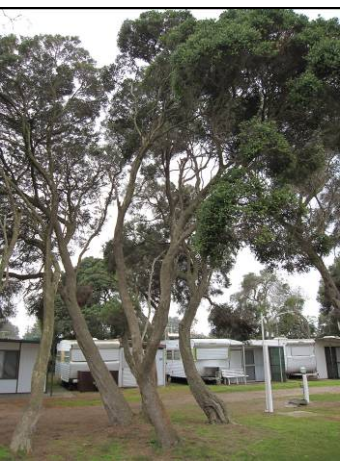
<p>Tree No. 41 <i>Melaleuca lanceolata</i>, Moonah</p> <p>Condition: Limb to north on large lean with decay present. This leader has no viability and possible stability issues. A second leader is senescent, and a third is compromised structurally by a bifurcation with included bark and cracking in the union. <i>Urgent arboricultural works are required to remove these limbs. Recommend coppicing of the tree before next summer, retaining the structurally acceptable leader to the south.</i></p> <p>Recommend management of coppice growth to develop new tree and monitor stability of the retained limb.</p> <p>Tree is located within a "Potential Moonah Reserve", but is still recommended for immediate coppicing.</p> <p>Coppice Timeframe: Partial immediately and remainder in 10 years plus or retain in Moonah Reserve</p>

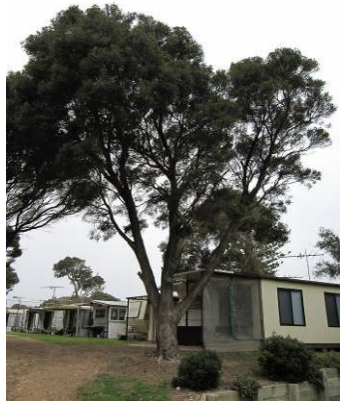
<p>Tree No. 45 <i>Melaleuca lanceolata</i>, Moonah</p> <p>Condition: Young tree should be carefully monitored and it is recommended that formative pruning works take place as required. Bifurcated with included bark. Fungal growth present (white type with foul odour seen on other Moonahs)</p> <p>Coppice Timeframe: 10 years plus</p>

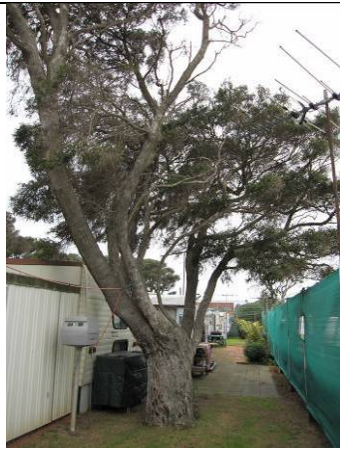
<p>Tree No. 46 <i>Melaleuca lanceolata</i>, Moonah</p> <p>Condition: Large, mature tree with general poor structure and fair health but a lovely form. <i>A very large limb overhangs the bedroom end of the van and is recommended for removal immediately.</i> The tree is weighted towards the van and there are potentially fatal consequences if the tree were to fail. A retaining wall has been constructed next to the tree, which appears to be in historic decline – possibly due to urban pressures. The proximity of this tree to the van is highly inappropriate, and given the size of the tree it is recommended that the van be relocated and the tree isolated in a “Moonah Reserve”. It is recommended that the current situation only be retained if the tree is monitored and managed <u>very</u> carefully and that all maintenance works (including coppicing the tree or removing the van) are carried out as soon as they are recommended. It is recommended that stress reduction works be carried out. The time frame for removal of the van should be determined by council dependant on the level of risk they are willing to accept. It is recommended that the van be retained in its current location for no more than 2-3 years.</p> <p>Coppice Timeframe: Retain in “Moonah Reserve”</p>

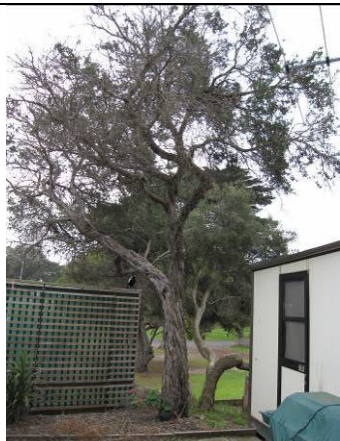
<p>Tree No. 47 <i>Melaleuca lanceolata</i>, Moonah and <i>Leptospermum lanceolata</i>, Coast Tea-tree</p> <p>Condition: Past root severance / fill may be an issue, but tree may be younger than the wall. Monitor stability of the tree and remove if unstable. Coast Tea-Tree in decline.</p> <p>Removal Timeframe: Coast Tea-tree: Before next summer Moonah: 10 years plus</p>

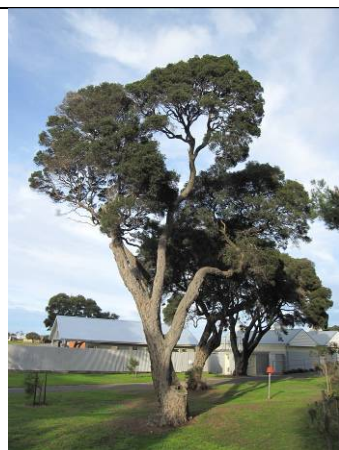
**Tree No. 51***Melaleuca lanceolata*, Moonah**Condition:**

Mature Moonah. Some decay present, but no immediate issues. It is recommend that regular inspections and maintenance work be carried out to aid retention of the tree and manage risk. Particular attention should be paid to the stability of the tree from the base. Tree should be coppiced if inspections indicate it poses an unacceptable risk to the public; even if within the 10 year retention period.

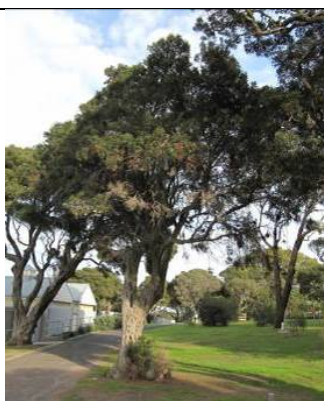
**Tree No. 52***Melaleuca lanceolata*, Moonah**Condition:**

Epicormic growth over van and at risk of failure. Decay in leader. Limited life expectancy with extensive new planting in the vicinity allows for replacement. Retain while inspections indicate it is safe to do so. *Recommend removal of epicormic growth before next summer.* It is recommend that regular inspections and maintenance work be carried out to manage the stability of the tree leading up to removal. Tree should be coppiced if inspections indicate it poses an unacceptable risk to the public; even if within the 5 year retention period.

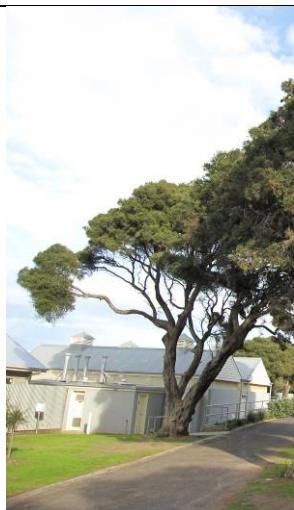
**Tree No. 53***Melaleuca lanceolata*, Moonah**Condition:**

A magnificent specimen, but in a high target rating location. Structure is compromised by a bifurcation that is at risk of failing over the road. Recommend cable / bracing of bifurcation before summer. *It is recommended that the limb overhanging the toilet block be removed before summer (or more immediately) given its high target rating, the branch stubs and decay in the union and poor health.*

Monitor tree for signs of construction damage. It is recommend that regular inspections and maintenance work be carried out to aid retention of the tree and manage risk. Especially note should be taken of any signs of construction damage. Tree should be coppiced if inspections indicate it poses an unacceptable risk to the public; even if within the 10 year retention period. Retain and manage tree while safe to do so.

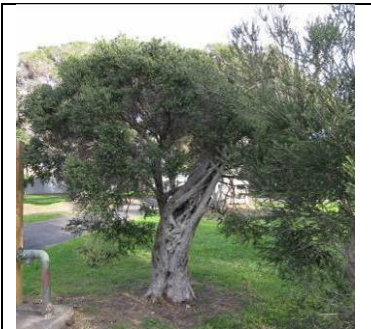
<p>Tree No. 55 <i>Melaleuca lanceolata</i>, Moonah</p> <p>Condition: New regrowth from an old stump. It is recommended that the stump be coppiced back to encourage additional regrowth and that the stability of the existing growth be monitored and managed.</p> <p>Coppice Timeframe: 10 years plus</p>
 	<p>Tree No. 56 Species: <i>Melaleuca lanceolata</i>, Moonah</p> <p>Condition: Young specimen. Manage in accordance with section 4.3.2.</p> <p>Coppice Timeframe: 10 years plus</p>

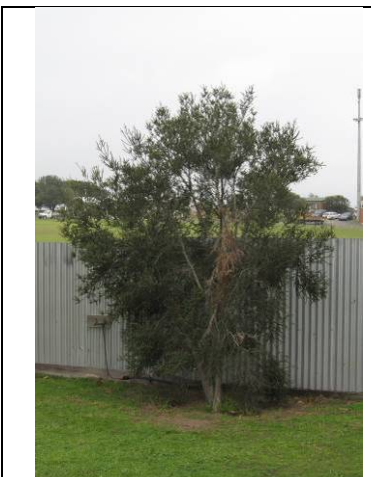
<p>Tree No. 57 Species: <i>Melaleuca lanceolata</i>, Moonah</p> <p>Condition: Very young tree.</p> <p>Coppice Timeframe: 10 years plus</p>

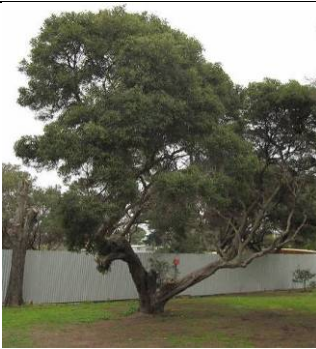
<p>Tree No. 59 <i>Melaleuca lanceolata</i>, Moonah Condition: <i>Remove twisted limb before next summer. Retain northern limb, but only if propped and deadwooded before next summer.</i> This leader is leaning with damage opposite the lean, and therefore is only suitable for retention in a camp site if propped. It is recommend that regular inspections and maintenance work be carried out to aid retention of the northern limb and manage risk. Tree should be coppiced if inspections indicate it poses an unacceptable risk to the public; even if within the 10 year retention period. Coppice Timeframe: 10 years plus (northern limb only)</p>

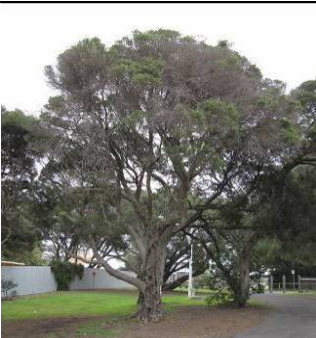
<p>Tree No. 60 <i>Melaleuca lanceolata</i>, Moonah Condition: Mature specimen. Retain and manage to reduce number of removals in this area. Manage in accordance with section 4.3.2. Coppice Timeframe: 10 years plus</p>

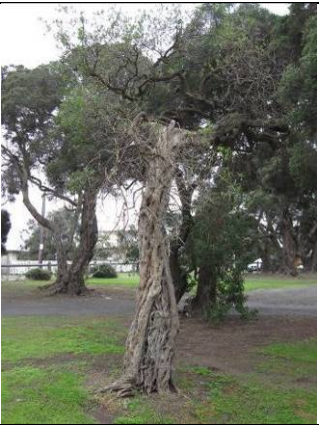
<p>Tree No. 61 <i>Melaleuca lanceolata</i>, Moonah</p> <p>Condition: Serious damage has been caused by the Boobialla (Tree 62). The structure of this tree has been compromised by extensive dieback and with end weight opposite this. The tree has no long term viability. Extensive decay in the southern side of the trunk. Tree may be partially supported by the Boobialla and should not be retained if the Boobialla is removed – even for a short period of time. A large branch has broken off the trunk exposing severe internal decay.</p> <p>Coppice Timeframe: Immediately</p>

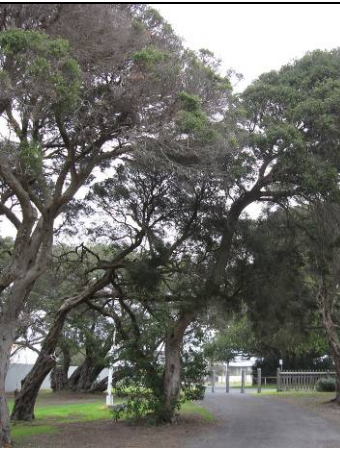
<p>Tree No. 62 <i>Melaleuca lanceolata</i>, Moonah and <i>Myoporum insulare</i>, Boobialla</p> <p>Condition: Two trees very close to each other. <i>The Boobialla has no long term viability and removal is recommended prior to next summer.</i> This tree is intertwined with the Tree 61 (a Moonah). The Boobialla has suffered major trunk damage through the loss of a branch and has damaged Tree 61 through branch rubbing. <i>Remove Tree 61 and Boobialla at the same time.</i> Following removal of the Boobialla reassessment is recommended for the Moonah to the front of the site due to the increased risk of failure with the changed wind loading. This tree has been badly damaged by vehicles and has decay in the trunk. It is recommended that the tree be carefully monitored and removed as necessary. It is recommended that regular inspections and maintenance work be carried out to manage the stability of the tree leading up to removal. Tree should be coppiced if inspections indicate it poses an unacceptable risk to the public; even if within the 5 year retention period.</p> <p>Removal / Coppice Timeframe: Moonah: 5 years Boobialla: Immediately</p>

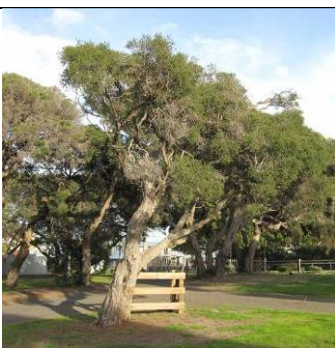
<p>Tree No. 63 <i>Melaleuca lanceolata</i>, Moonah</p> <p>Condition: Decay present and trunk split. Structurally problematic limbs with one moving from beneath the point of attachment and one with dieback in the branch union (both signs of structural weakness). Sounds of cracking / fracture / rubbing heard. Lower target rating than some specimens, but still <i>recommended for removal immediately.</i> Has lost a limb high. The moving limb has an active crack in it.</p> <p>Coppice Timeframe: Immediately</p>

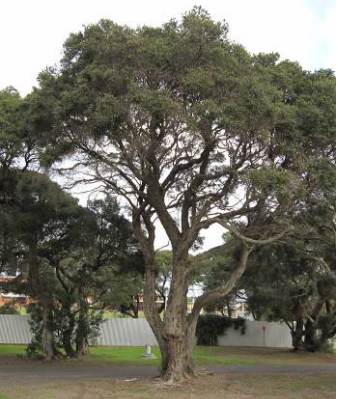
<p>Tree No. 65 <i>Melaleuca lanceolata</i>, Moonah</p> <p>Condition: Damaged roots at base of tree and decay in trunk. One limb with decay and extensive galls. It is recommend that this tree be fenced in a "Moonah Reserve" to exclude public access and that sections which could fail beyond the fence continue to be monitored and managed as detailed in Section 4.4.2.</p> <p>Coppice Timeframe: Retain in "Moonah Reserve"</p>

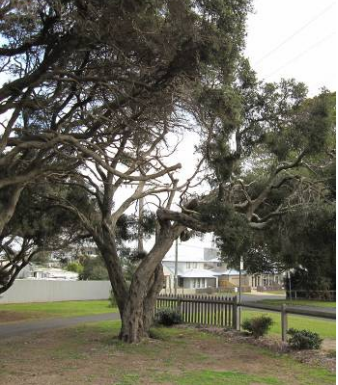
<p>Tree No. 66 <i>Melaleuca lanceolata</i>, Moonah</p> <p>Condition: <i>Extensive decay present and twisted branches.</i> Main leader is not safe to retain within a camping ground.</p> <p>Tree is recommended for fencing within a "Moonah Reserve".</p> <p>The main leader of the tree has significant structural defects and it is recommended that it be removed before next summer if its drop zone can not be contained within the reserve. The remaining two leaders will require careful monitoring if their drop zone is outside the reserve.</p> <p>Coppice Timeframe: Retain in "Moonah Reserve"</p>

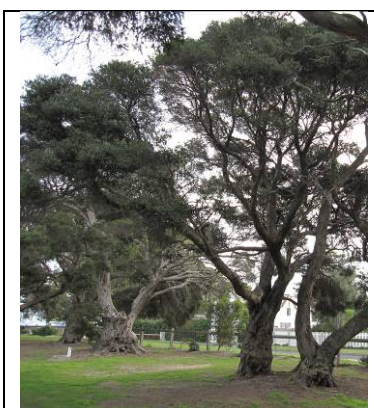
<p>Tree No. 67 <i>Melaleuca lanceolata</i>, Moonah</p> <p>Condition: Limbs with extensive internal decay. Long limb to west is damaged at the union with internal decay and is over extended. Tree heard cracking on one site visit, a sign of considerable instability. Tree's location within a caravan park makes it of especial concern. Tree is recommended for retention within a "Moonah Reserve" with management works to manage parts of the tree with a drop zone outside the fence.</p> <p>Coppice Timeframe: Retain in "Moonah Reserve"</p>
 	<p>Tree No. 68 <i>Melaleuca lanceolata</i>, Moonah</p> <p>Condition: Some dieback high. Tree is recommended for retention within a "Moonah Reserve" with management works to manage parts of the tree with a drop zone outside the fence.</p> <p>Coppice Timeframe: Retain in "Moonah Reserve"</p>
 	<p>Tree No. 69 <i>Melaleuca lanceolata</i>, Moonah</p> <p>Condition: Major dieback to south-west branch. <i>Remove limb to east with wound above immediately.</i> This limb was only weight reduced at the time of previous works. Remove western limb. Extensive rot, bracket fungus and few supporting roots present. At risk of imminent failure with potentially catastrophic results. Crack in tree, dieback in canopy and lack of integrity in the overall structure (dieback and live wood intermingled). Was heard cracking during one site visit – a sign of considerable instability. <i>Recommend immediate fencing to exclude public access.</i> If fencing can not be placed so as to restrict public access within the tree's drop zone than bracing, cabling and / or propping should be considered. Retain tree within "Moonah Reserve".</p> <p>Coppice Timeframe: Retain in "Moonah Reserve"</p>

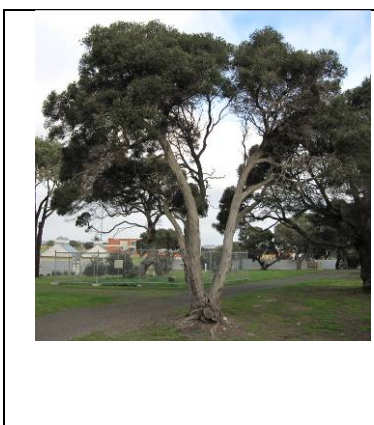
<p>Tree No. 71 <i>Melaleuca lanceolata</i>, Moonah</p> <p>Condition: Dieback in union of major limb. <i>Recommend fencing of the tree to exclude public access before next summer.</i> Tree is recommended for retention within a "Moonah Reserve" with management works to manage parts of the tree with a drop zone outside the fence.</p> <p>Coppice Timeframe: Retain in "Moonah Reserve"</p>

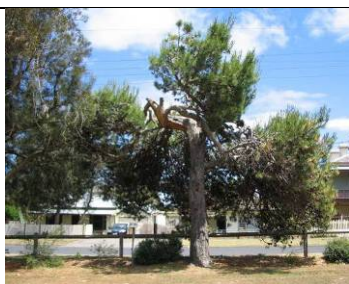
<p>Tree No. 73 <i>Melaleuca lanceolata</i>, Moonah</p> <p>Condition: Tree is in fair-poor health and has little canopy. Structure compromised by bifurcation and poor root plate integrity. The tree is leaning in the opposite direction to the unstable root plate, increasing the failure risk. <i>It is recommended that this tree be immediately coppiced.</i> While it is adjacent to the area set aside for a "Moonah Reserve" it is in poor health, and coppicing of this tree allows the establishment of new growth in an area where existing trees are single generation.</p> <p>Coppice Timeframe: Immediately</p>
 	<p>Tree No. 74 <i>Eucalyptus leucoxylon</i>, Yellow Gum</p> <p>Condition: Tree has been lopped is unsightly. Recommend removal and replacement with a Moonah.</p> <p>Removal Timeframe: 2-3 years</p>
 	<p>Tree No. 75 <i>?Allocasuarina sp.</i>, Sheoak</p> <p>Condition: Structural integrity compromised by tree being bifurcated with included bark. Lopped for power line clearance. Manage in accordance with section 4.3.2.</p> <p>Removal Timeframe: 10 years plus</p>

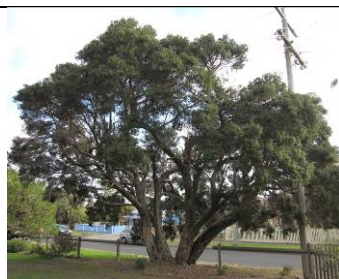
**Tree No. 76***Pinus pinea*, Stone Pine**Condition:**

A sizeable branch has failed in the upper canopy causing extensive damage to the trunk and branches. *Another major limb has a crack and was recommended for removal immediately.* This has been weight reduced, but is still problematic. The tree is exhibiting signs of very heavy fruit set, and this is likely to increase the risk of all limbs failing. The tree is located beneath powerlines and can not develop well, to the contrary it is likely to continue to fail and is therefore hazardous.

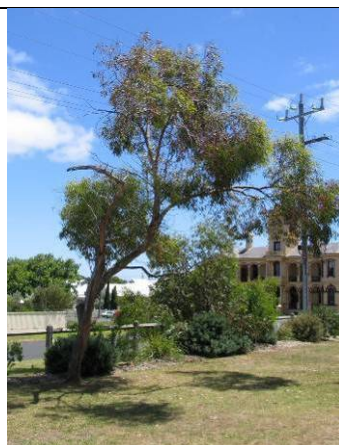
**Tree No. 77***Melaleuca lanceolata*, Moonah**Condition:**

A beautiful mature specimen which is too good to remove but is not safe to retain in the current situation.

The upright leader below the powerlines has a cracked limb high which is recommended for removal immediately. One limb over the nature strip is moving from the centre of the limb and is at real risk of failure at this point. *Management of this leader is recommended immediately.* Decay in leader and a fungal growth in another (white type with foul odour seen on other Moonahs). Dieback present.

It is recommended that this tree be fenced off in a "Moonah Reserve" to aid its retention as it is not structurally sound, but very handsome, old and in a prominent location. It is also recommended that a traffic engineer be contacted to determine if pedestrian access to the foot path is required. If this is the case then the tree may need to be pruned away from the road to allow pedestrians to walk past the tree without stepping onto the roadway. Recommend planting out the area under the canopy with indigenous species.

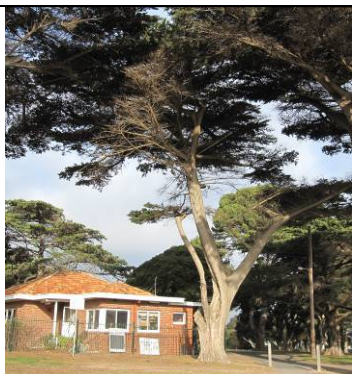
<p>Tree No. 81 <i>Cupressus macrocarpa</i>, Monterey Cypress</p> <p>Condition: I concur with nearly all the observations made in Bellarine Tree's report, and make the following comments: Lower limb with decay at point of attachment is at risk of failing and may damage the community centre (note, the second inspection indicated that this limb had been removed). The tree has been extensively pruned in the past and major branches are now exposed, with limited to no structural support provided to these large branches. <i>The structure of these branches and the failure history of the specimen is such that outright removal is recommended immediately.</i> The tree has severe structural defects and is extremely close to the community centre, and poses a risk to this asset.</p> <p>Removal Timeframe: Immediately</p>

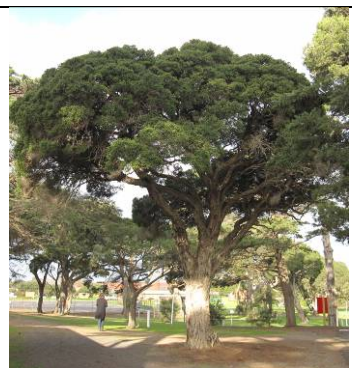
**Tree No. 82****Species:**

This specimen is likely to bear the brunt of the weather from the south-west and decay in the lower trunk is likely to have extended into the root system. The tree has been extensively pruned in the past and major branches are now exposed, with limited to no structural support provided to these large branches. *The structure of these branches and the failure history of the specimen is such that outright removal is recommended before next summer.*

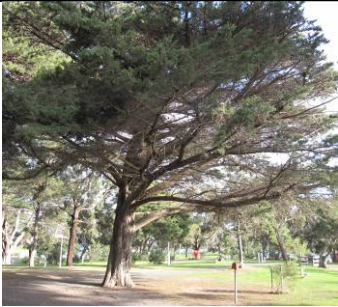
**Tree No. 83**

A mature tree in good condition. One of the better Moonahs.

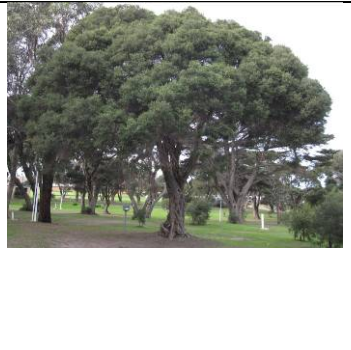
<p>Tree No. 87 <i>Melaleuca lanceolata</i>, Moonah</p> <p>Condition: <i>Remove damaged limb over path immediately.</i> This limb is damaged on top and bark is showing compression stress beneath. Hollow in trunk. It is recommend that regular inspections and maintenance work be carried out to manage the stability of the tree. Especial attention should be taken to the basal integrity of the tree. Tree should be coppiced if inspections indicate it poses an unacceptable risk to the public; even if within the 10year retention period. Extensive replanting which has taken place in the area is beneficial.</p> <p>Coppice Timeframe: 10 years plus</p>

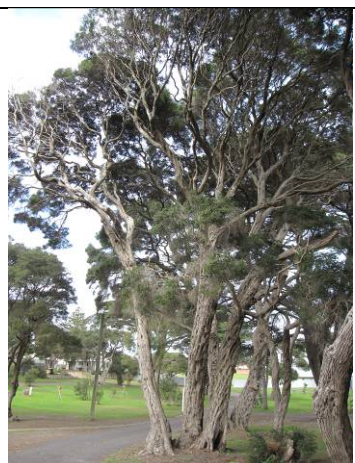
**Tree No. 93***Melaleuca lanceolata*, Moonah**Condition:**

Very beautiful mature tree. Damaged roots. Manage epicormic / lignotuber growth. Fused leaders. *Recommend removal of both branches to west with dieback in the union and extended northern leader before summer.* It is recommend that regular inspections and maintenance work be carried out to aid retention of the tree and manage risk. Tree should be coppiced or fenced if inspections indicate it poses an unacceptable risk to the public; even if within the 10 year retention period. Retain in current location while safe to do so.

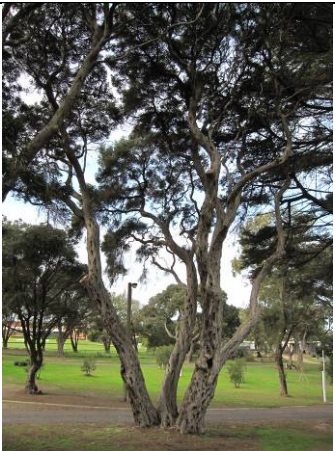
**Tree No. 94***Melaleuca lanceolata*, Moonah (2No.)**Condition:**

The main leader is bifurcated and damaged at the union. Extensive dieback at base of tree, probably where a leader has been lost. One limb is dead and has died back to the base of its leader. Manage epicormics on the rear tree.

Removal of this tree has the potential to impact the surrounding vegetation, and therefore this specimen is recommended for fencing off within a "Moonah Reserve". *It is recommended that the front limb (east) be removed before next summer and that the remainder of the tree is fenced to aid retention.* Retention is only recommended if the tree is fenced, otherwise coppicing is strongly recommended as the tree is structurally unsound. Recommend management of epicormic / lignotuber growth on the tree to the rear to encourage the formation of new, structurally sound leaders.
