TREE MANAGEMENT, REMOVAL AND REPLACEMENT STRATEGY FOR PRINCESS, CITIZENS AND VICTORIA PARKS BOROUGH OF QUEENSLIFFE

SEPTEMBER 2009

Produced By:

JOHN PATRICK PTY LTD

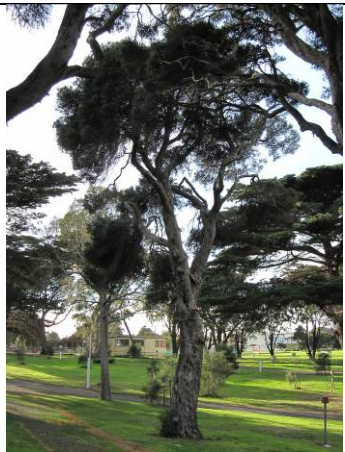
<p>Tree No. 102 <i>Melaleuca lanceolata</i>, Moonah</p> <p>Condition: Structure compromised by poor basal attachment. Tree is not shielding other specimens (open location). A very large dead leader moves when pressured and two lower limbs also move from the point of attachment. <i>These leaders are recommended for removal immediately.</i> The remaining limb is at a heavy angle and has poor attachment. <i>This limb is recommended for propping before next summer.</i></p> <p>Tree is located within a "Potential Moonah Reserve". If this reserve is adopted than the tree should be fenced rather than coppiced.</p> <p>Coppice Timeframe: 10 years plus or retain in "Moonah Reserve"</p>
 	<p>Tree No. 103 <i>Brachychiton populneus</i>, Kurrajong</p> <p>Condition: Bifurcated with included bark and very little canopy. Tree has either been possum grazed or wind scorched (probably the former). Many bifurcations in canopy. Recommend replacing "like for like" in the short term.</p> <p>Removal Timeframe: 5 years</p>

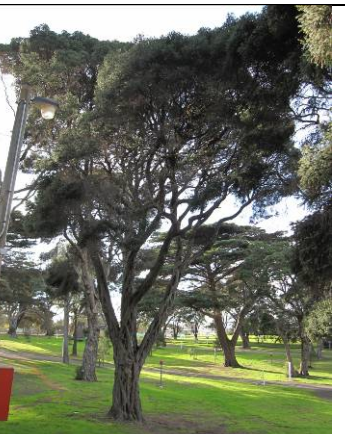
<p>Tree No. 105 <i>Melaleuca lanceolata</i>, Moonah</p> <p>Condition: Mature, bifurcated tree. One tract of decay. It is recommend that regular inspections and maintenance work be carried out to aid retention of the tree and manage risk. Particular attention should be paid to the decayed limb, with this being removed when inspections indicate it is necessary. Tree should be coppiced if inspections indicate it poses an unacceptable risk to the public; even if within the 10 year retention period.</p> <p>Tree is located within a "Potential Moonah Reserve". If this reserve is adopted than the tree should be fenced rather than coppiced.</p> <p>Coppice Timeframe: 10 years plus or retain in "Moonah Reserve"</p>

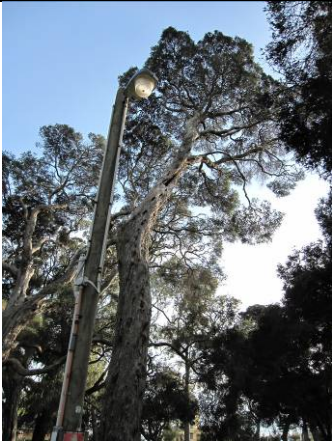
<p>Tree No. 106 <i>Melaleuca lanceolata</i>, Moonah</p> <p>Condition: An upright, mature specimen, with some decay present. It is recommend that regular inspections and maintenance work be carried out to manage the stability of the tree leading up to removal. Tree should be coppiced if inspections indicate it poses an unacceptable risk to the public; even if within the 2-3 year retention period.</p> <p>Tree is located within a "Potential Moonah Reserve". If this reserve is adopted than the tree should be fenced rather than coppiced.</p> <p>Coppice Timeframe: 2-3 years plus or retain in "Moonah Reserve"</p>

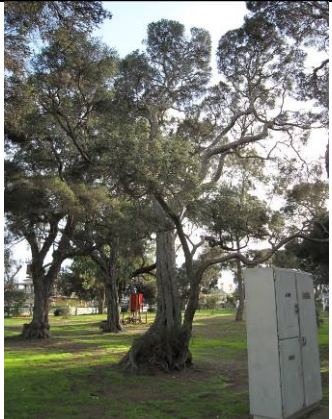
<p>Tree No. 107 <i>Melaleuca lanceolata</i>, Moonah</p> <p>Condition: Tall thin tree with large branch failure in the past. Roots and fibres under tension. Leans over path, not campsite but would reach sites 93/94 if it were to fail at the base. The limb to the east is cracked and hanging. The bifurcation at the top of the tree has a fresh crack in it and dieback in the union. Extremely structurally unsound. <i>Recommend coppicing of the entire tree immediately.</i> Tree is located within a "Potential Moonah Reserve". If this reserve is adopted than the tree should be fenced rather than coppiced.</p> <p>Coppice Timeframe: 10 years plus or retain in "Moonah Reserve"</p>

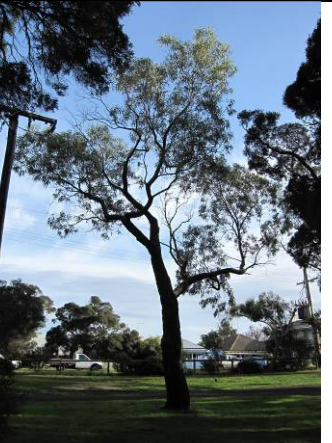
<p>Tree No. 108 <i>Melaleuca lanceolata</i>, Moonah</p> <p>Condition: <i>Recommend pruning off of both deadwood and decayed limb to east immediately.</i> Actively manage epicormics / lignotuber shoots to encourage development of stable new leaders. Specimen is touching the tree to the north, and may be gaining some support from this specimen, although it does not appear to be putting much pressure on it. <i>Small hanging deadwood to the west recommended for removal immediately (prune this limb right off as it is dying back).</i> It is recommend that regular inspections and maintenance work be carried out to aid retention of the tree and manage risk. Tree should be coppiced if inspections indicate it poses an unacceptable risk to the public; even if within the 10 year retention period.</p> <p>Tree is located within a "Potential Moonah Reserve". If this reserve is adopted than the tree should be fenced rather than coppiced.</p> <p>Coppice Timeframe: 10 years plus or retain in "Moonah Reserve"</p>

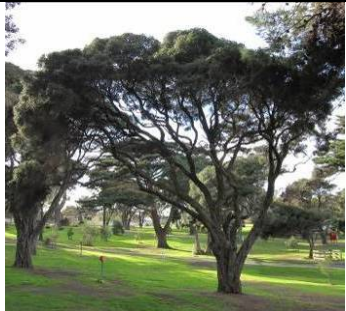
<p>Tree No. 112 Species: <i>Melaleuca lanceolata</i>, Moonah</p> <p>Condition: Tree has fair-poor health and a reasonable amount of decay present (shaded by adjacent Stone Pine). Recommend removal as tree is in poor condition, and the risk posed by the tree is not appropriately balanced by benefits provided by the tree. It is recommend that regular inspections and maintenance work be carried out to manage the stability of the tree leading up to removal. Tree should be coppiced if inspections indicate it poses an unacceptable risk to the public; even if within the 2-3 year retention period. <i>Recommend removal of deadwood before summer.</i> Additional damage present at base of tree. Tree is located within a "Potential Moonah Reserve". If this reserve is adopted than the tree should be fenced rather than coppiced.</p> <p>Coppice Timeframe: 2-3 years or retain in "Moonah Reserve"</p>

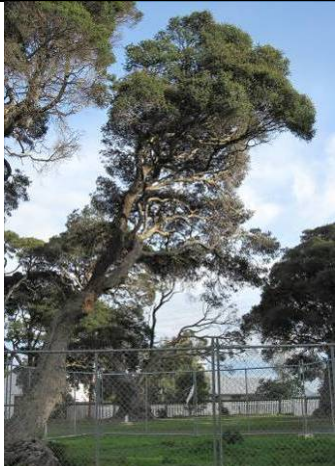
<p>Tree No. 114 <i>Melaleuca lanceolata</i>, Moonah</p> <p>Condition: Not an especially healthy tree and has limited viability. Tree may senesce within the 10 year timeframe, but given the species it is recommended for retention for as long as it is safe to do so.</p> <p>Coppice Timeframe: 10 years plus</p>

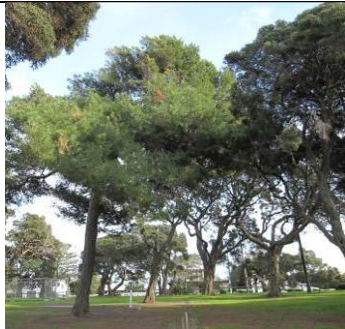
<p>Tree No. 115 <i>Melaleuca lanceolata</i>, Moonah</p> <p>Condition: Tree has exposed roots which offer little support to an exposed, leaning and moderately large tree. Coppice recommended before summer.</p> <p>Coppice Timeframe: Before next summer.</p>

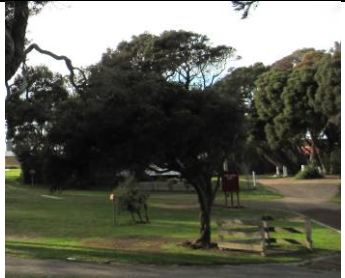
<p>Tree No. 116 <i>Pinus pinea</i>, Stone Pine Condition: Mature tree. Damaged trunk callusing. Uneven branching possibly due to prevailing winds. Retain. Removal Timeframe: 10 years plus</p>
 	<p>Tree No. 117 <i>Melaleuca lanceolata</i>, Moonah Condition: Fair health, twisted limbs, decay in union of large limb, fissure in the union of another limb. Tree has heavy branches with decay in the unions. Coppice Timeframe: Before next summer.</p>

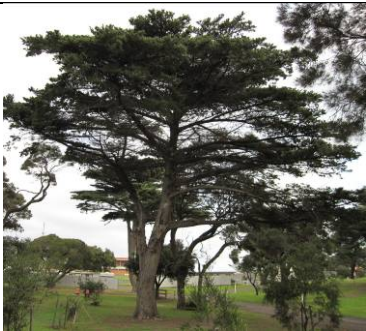
<p>Tree No. 118 <i>Melaleuca lanceolata</i>, Moonah Condition: A young tree. Work may have occurred within the root zone of the tree. It is recommended that the tree be monitored, with especial note taken of any stress possibly related to root loss. Recommend ongoing management in accordance with 4.3.2 and formative pruning. Coppice Timeframe: 10 years plus</p>
 	<p>Tree No. 119 <i>Melaleuca lanceolata</i>, Moonah Condition: Large tree with decay. Limited life expectancy. Damage (possibly caused by rubbing) in bifurcation and rot in leader. Some rot at base of smaller limb. Monitor carefully and plan for replacement. A smaller stem is senescent and is recommended for removal before next summer. It is recommended that regular inspections and maintenance work be carried out to manage the stability of the tree leading up to removal. Tree should be coppiced if inspections indicate it poses an unacceptable risk to the public; even if within the 5 year retention period. Tree is not an appropriate candidate for fencing. Coppice Timeframe: 5 years</p>

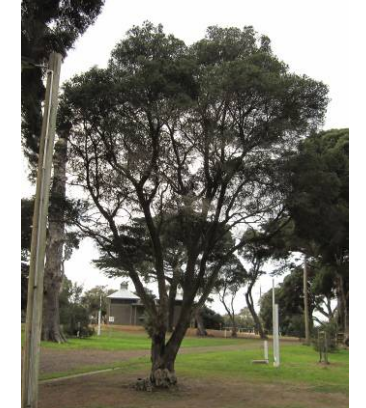
<p>Tree No. 121 <i>?Allocasuarina sp.</i>, Sheoak</p> <p>Condition: Tree has a major structural defect and is in a high target area adjacent to a tap.</p> <p>Removal Timeframe: Before next summer</p>

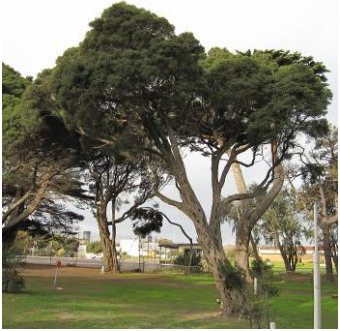
<p>Tree No. 122 <i>Melaleuca lanceolata</i>, Moonah</p> <p>Condition: Youngish regrowth. Monitor the structural integrity of the tree as it is comprised of lignotuber shoots coming from an older stump. It is recommended that this growth be actively managed to develop stable new leaders.</p> <p>Coppice Timeframe: 10 years plus</p>

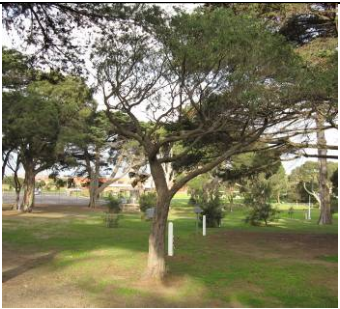
<p>Tree No. 125 <i>Cupressus macrocarpa</i>, Monterey Cypress</p> <p>Condition: Leans away from the fire hydrant (recommend investigation of age of service to determine whether destabilising root loss has occurred). It is recommend that regular inspections and maintenance work be carried out to aid retention of the tree and manage risk. Special attention should be paid to the stability of the limbs, especially those with branch collars. Tree should be removed if inspections indicate it poses an unacceptable risk to the public; even if within the 10 year retention period.</p> <p>Removal Timeframe: 10 years plus</p>

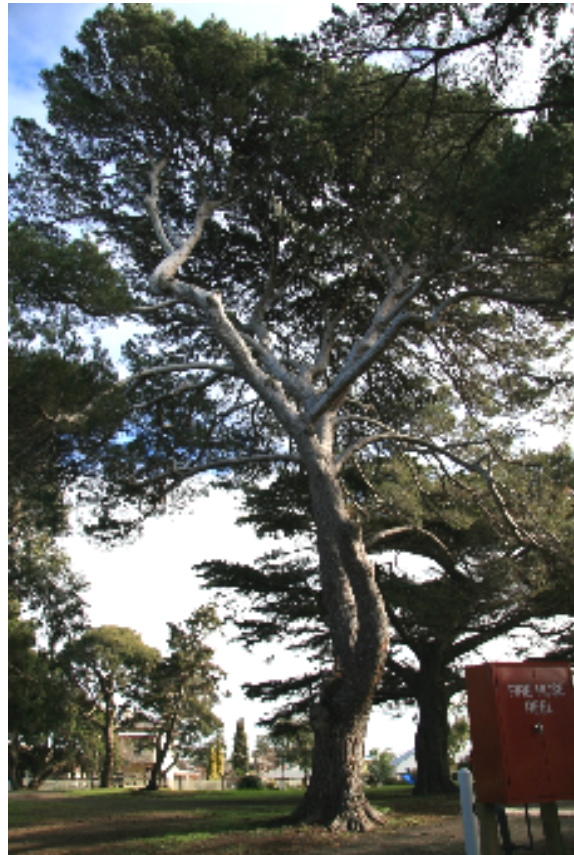
Aleppo Pine (*Pinus halepensis*)

- It is a mature tree exhibiting good health and vigour.
- The trunk bifurcates at approximately 2.5 metres above ground level. Debris has accumulated in the hollow on top of the bifurcation union but the union appears to be sound.
- All major branch unions appear to be sound. There are some short delamination cracks in medium-sized branches (100 to 200 mm in diameter) but all those observed appeared stable.
- Many of the lower branches are heavy and extended with sufficient foliage to allow them to be effectively weight reduced.
- There is some scarring in the bark on top of branches but no decay was observed. The scarring could have been caused by cockatoos or could be damage resulting from falling branches during pruning.
- There are many stubs resulting from poor pruning cuts.

Recommendations:

- Remove the dead wood and stubs down to 25 mm in diameter.
- Weight reduce the extended branches, especially those few that have stable delamination cracks in them.

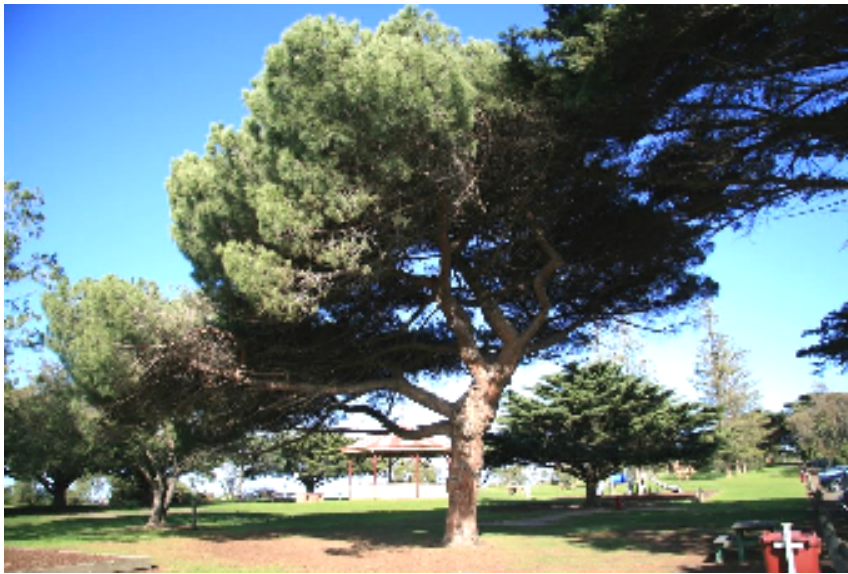
- It is a mature tree exhibiting good health and vigour.

- The trunk and all major branch unions appear to be sound.
- There are some extended branches towards the east in the mid-canopy that have slowly descended onto the large low branches. Some branch grafting has taken place between the upper and lower branches.
- The low, large branches to the north and east are very extended and are probably slowly dropping.
- There is evidence of minor branch failure, up to 100 mm in diameter, in the lower and mid-canopy.
- There are many old pruning cuts resulting in stubs. The more recent pruning cuts appear to be good.

Recommendations:

- Weight reduce the extended branches.
- Remove the dead wood and stubs down to approximately 25 mm in diameter but retain the dead branches that are supporting other live branches.

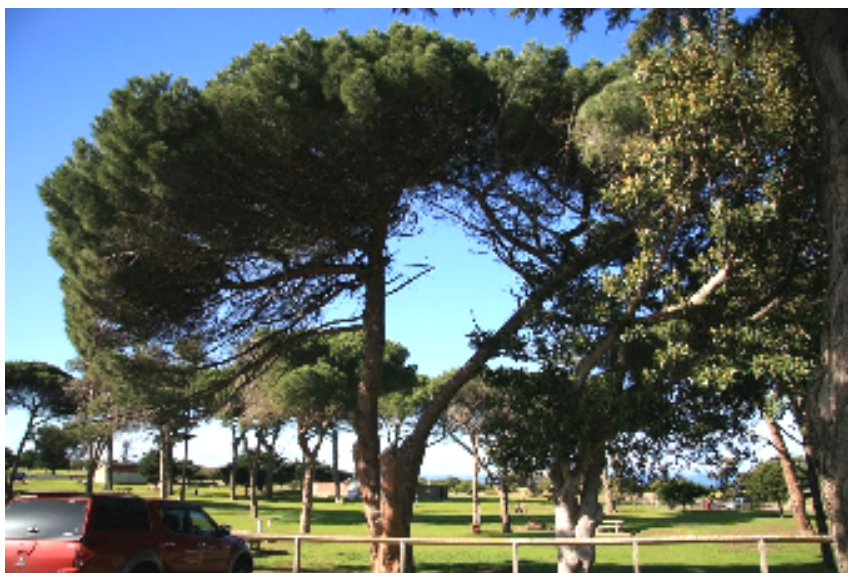
- It is a mature tree exhibiting good health and vigour.
- The trunk trifurcates between 1.5 and 2.0 metres above ground level.
- The smallest fork towards the west has been cut off, presumably because of extensive branch failures. The union appears to be sound.

- Approximately half of the trunk to the south has been removed fairly recently due to large branch failure. The remainder of this trunk grows into the adjacent Moreton Bay Fig (*Ficus macrophylla*).
- The largest trunk and its major branches appear to be sound.
- Two branches, both approximately 150 mm in diameter, on the northern side of the canopy have delamination splits in them and are being held up by adjacent major branches.
- There is extensive dead wood up to 150 mm in diameter throughout the canopy. Some of the dead wood on the northern side of the canopy is broken and is being held up by surrounding branches.
- The major lateral branches are very extended and the tree appears to have a history of large branch failure.

Recommendations:

- Remove the dead wood and stubs down to 25 mm in diameter.
- Weight reduce the extended branches except where they are entwined in the Moreton Bay Fig.
- Remove the two branches with the delamination splits.

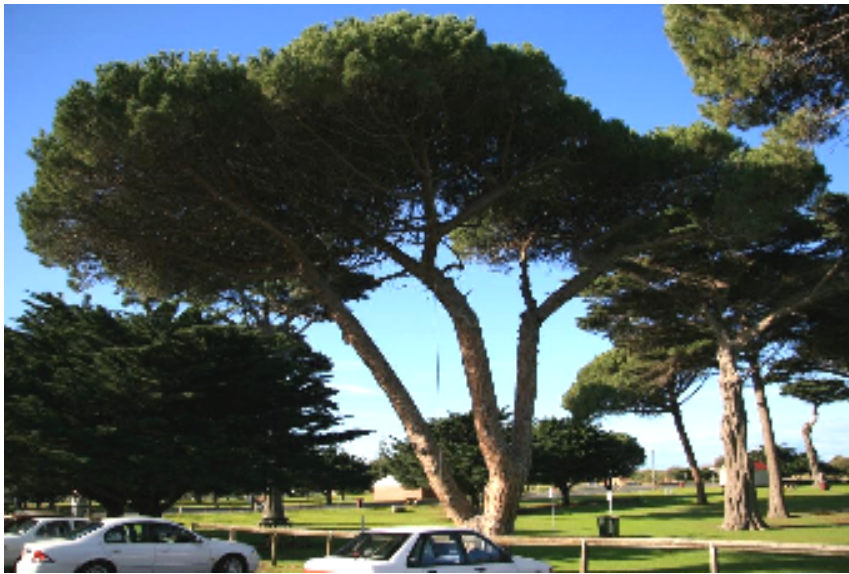
- It is a mature tree exhibiting good health and vigour.
- The trunk bifurcates at approximately 1.5 metres above ground level and then the larger trunks bifurcates at approximately 2.8 metres above ground level. Both bifurcation unions appear to be sound.

- The lowest branch to the south east from the eastern fork has an old delamination split close to its union. The split has stabilised as it has obvious wound wood around it.
- The forks to the east and west are heavy with the larger lateral branches being quite extended.
- There is extensive dead wood up to 150 mm in diameter (though most is up to 100 mm in diameter). Some of the dead wood is broken and resting in the upper canopy.
- The tree appears to have a history of large branch failures.

Recommendations:

- Remove the branch with the stable delamination split or substantially weight reduce it.
- Weight reduce the extended branches.
- Remove the dead wood down to 25 mm in diameter.
- Install an 11 mm steel cable from each of the eastern and western forks to the central trunk (two cables in total) to reduce the risk of whole trunk failure.
