Health and Condition Report

Assessment of the Queenscliff Avenue of Honour.

Friday, 1 March 2024

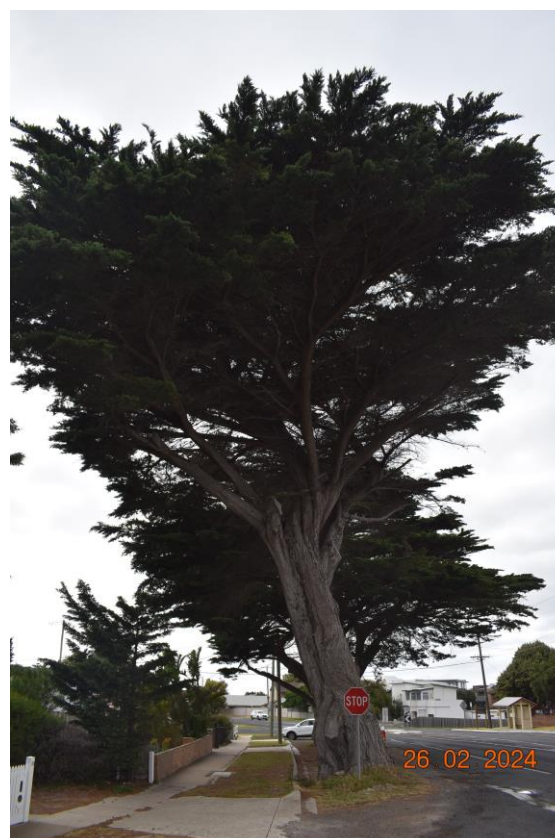
Asset ID: 10

Priority: Low

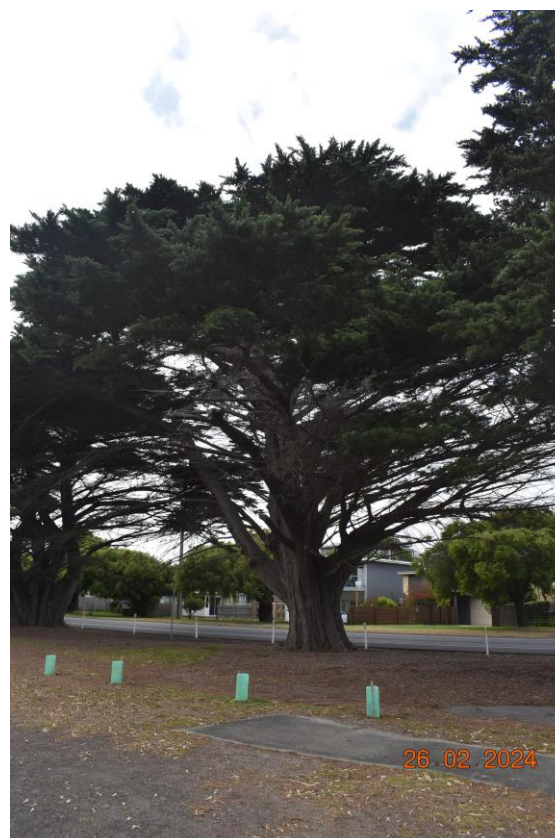
16	<i>Hesperocyparis macrocarpa</i>	16 x 21	260	Fair	Poor	Mature	5-10	Risk reduction pruning, Deadwood removal	Moderate	20% reduction over road, max diameter cut of 70mm
17	<i>Hesperocyparis macrocarpa</i>	15 x 22	300	Fair	Poor	Mature	5-10	Mulch rootzone, Deadwood removal	Moderate	
18	<i>Hesperocyparis macrocarpa</i>	15 x 19	185	Fair	Fair	Mature	10-20	Broken branch removal, Deadwood removal	Moderate	Small hanging branch
20	<i>Hesperocyparis macrocarpa</i>	13 x 20	200	Fair	Poor	Mature	5-10	Risk reduction pruning, Deadwood removal	Moderate	20% reduction of exposed branch over path, max diameter cut 70mm

Asset ID:	17
Botanical Name:	<i>Hesperocyparis macrocarpa</i>
Common Name:	Monterey Cypress
Origin:	Exotic
DBH (cm):	300
Height & Width (m):	15 x 22
Maturity:	Mature
Health:	Fair
Structure:	Poor
ULE:	5 to 10 years
Retention Value:	High
Works:	Mulch rootzone, Deadwood removal
Priority:	Moderate
Comments:

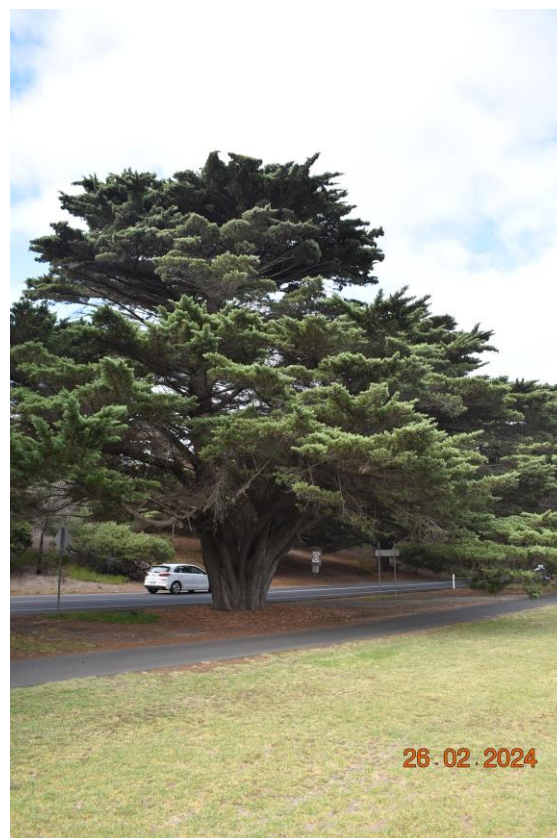
Asset ID:	23
Botanical Name:	<i>Hesperocyparis macrocarpa</i>
Common Name:	Monterey Cypress
Origin:	Exotic
DBH (cm):	190
Height & Width (m):	12 x 19
Maturity:	Mature
Health:	Fair
Structure:	Poor
ULE:	5 to 10 years
Retention Value:	High
Works:	Deadwood removal
Priority:	Low
Comments:

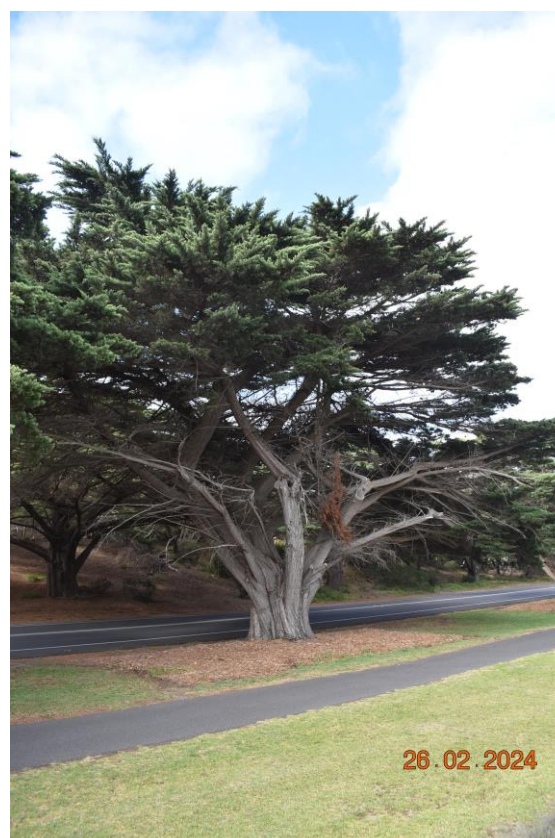
Asset ID:	25
Botanical Name:	<i>Hesperocyparis macrocarpa</i>
Common Name:	Monterey Cypress
Origin:	Exotic
DBH (cm):	175
Height & Width (m):	10 x 18
Maturity:	Mature
Health:	Fair
Structure:	Fair
ULE:	10 to 20 years
Retention Value:	High
Works:	Deadwood removal
Priority:	Low
Comments:

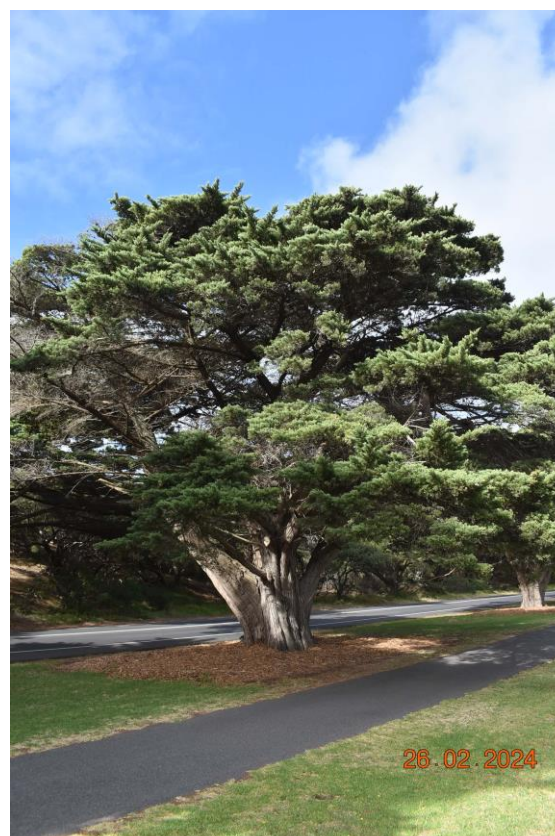
Asset ID:	26
Botanical Name:	<i>Hesperocyparis macrocarpa</i>
Common Name:	Monterey Cypress
Origin:	Exotic
DBH (cm):	105
Height & Width (m):	10 x 15
Maturity:	Mature
Health:	Fair
Structure:	Poor
ULE:	5 to 10 years
Retention Value:	High
Works:	Deadwood removal
Priority:	Moderate
Comments:

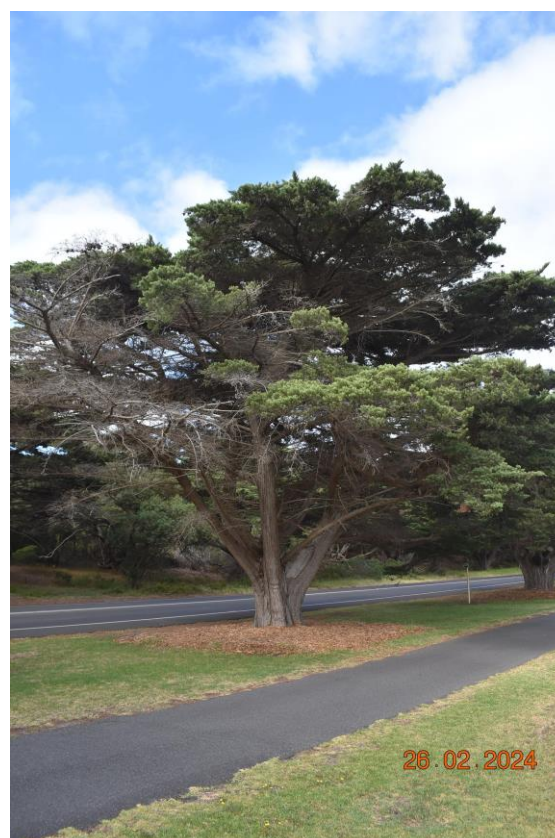
Asset ID:	27
Botanical Name:	<i>Hesperocyparis macrocarpa</i>
Common Name:	Monterey Cypress
Origin:	Exotic
DBH (cm):	180
Height & Width (m):	10 x 15
Maturity:	Mature
Health:	Fair
Structure:	Poor
ULE:	5 to 10 years
Retention Value:	High
Works:	Deadwood removal
Priority:	Low
Comments:

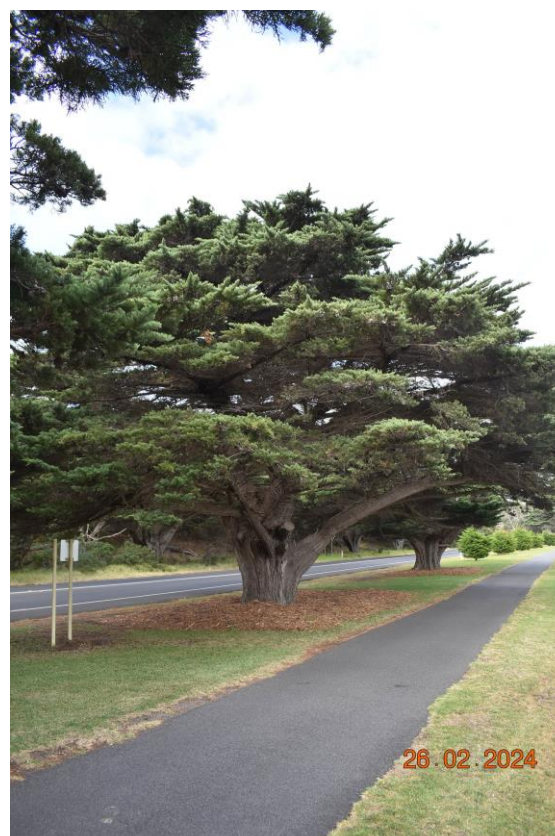
Asset ID:	28
Botanical Name:	<i>Hesperocyparis macrocarpa</i>
Common Name:	Monterey Cypress
Origin:	Exotic
DBH (cm):	180
Height & Width (m):	10 x 13
Maturity:	Mature
Health:	Fair
Structure:	Poor
ULE:	5 to 10 years
Retention Value:	High
Works:	Deadwood removal
Priority:	Low
Comments:

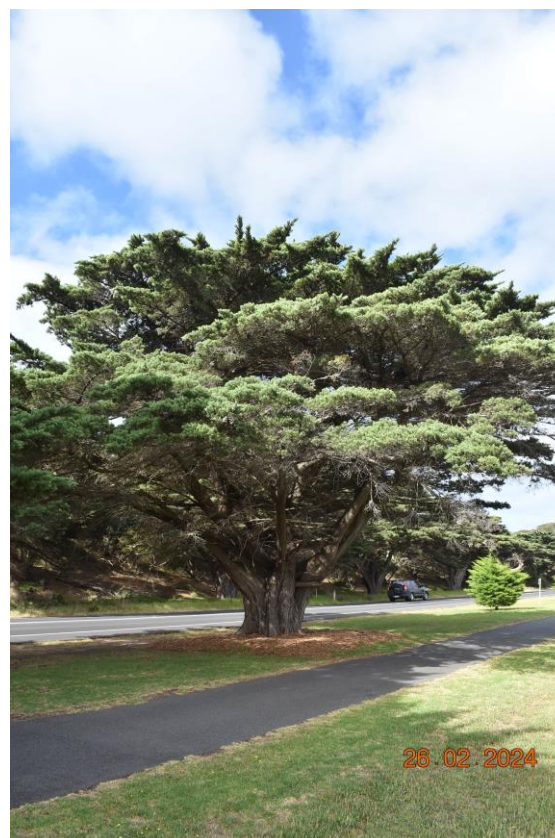
Asset ID:	30
Botanical Name:	<i>Hesperocyparis macrocarpa</i>
Common Name:	Monterey Cypress
Origin:	Exotic
DBH (cm):	92
Height & Width (m):	10 x 13
Maturity:	Mature
Health:	Fair
Structure:	Fair
ULE:	10 to 20 years
Retention Value:	High
Works:	No works
Priority:	None
Comments:

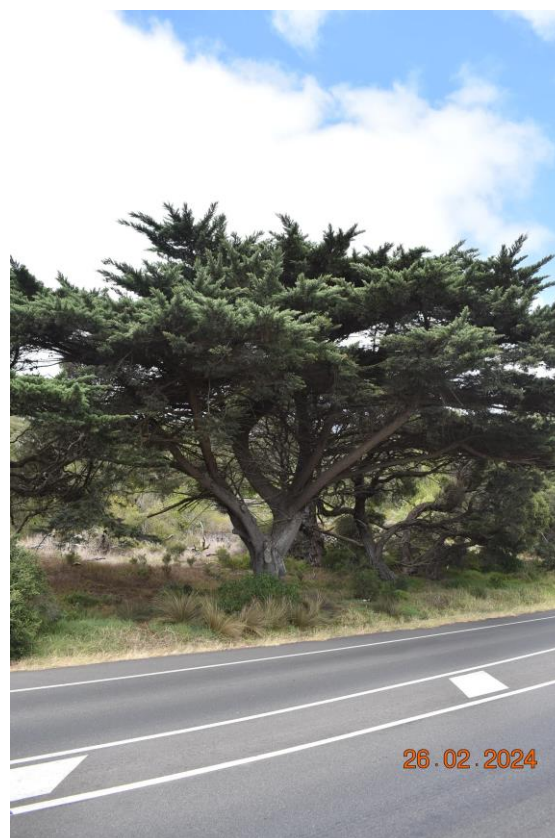
Asset ID: 31

Priority: None

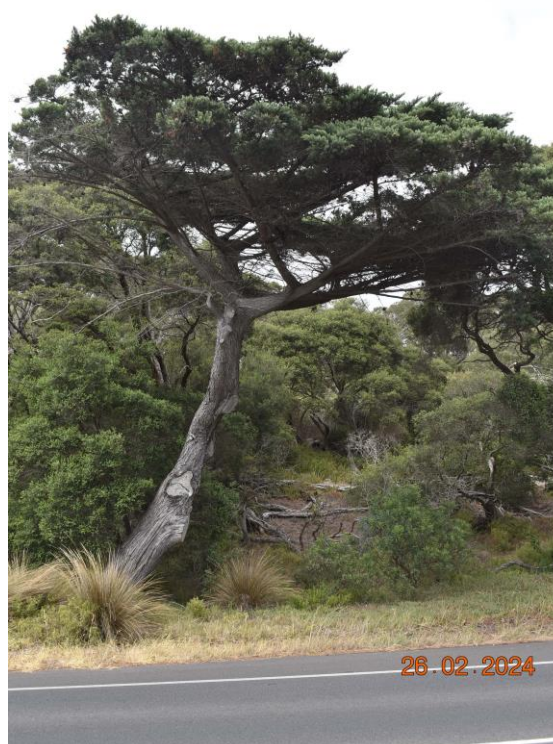
Asset ID: 32

Priority: None

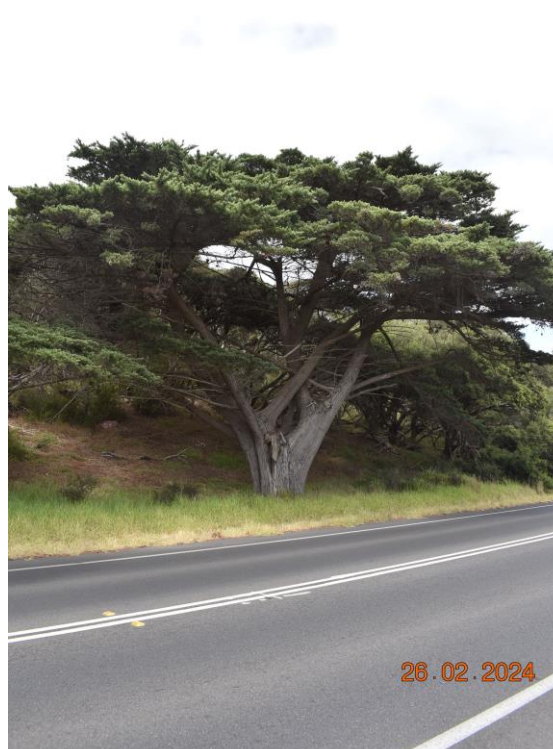
Asset ID:	33
Botanical Name:	<i>Hesperocyparis macrocarpa</i>
Common Name:	Monterey Cypress
Origin:	Exotic
DBH (cm):	185
Height & Width (m):	12 x 18
Maturity:	Mature
Health:	Fair
Structure:	Fair
ULE:	10 to 20 years
Retention Value:	High
Works:	No works
Priority:	None
Comments:

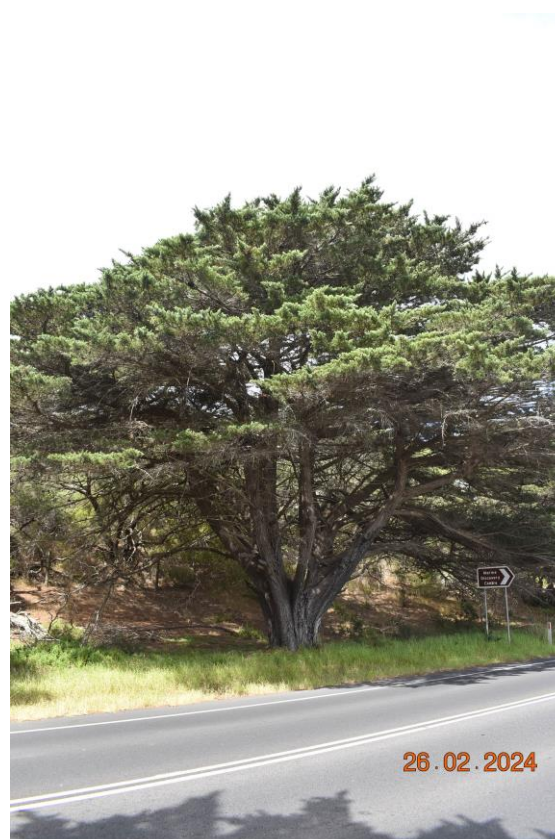
Asset ID: 35

Priority: None

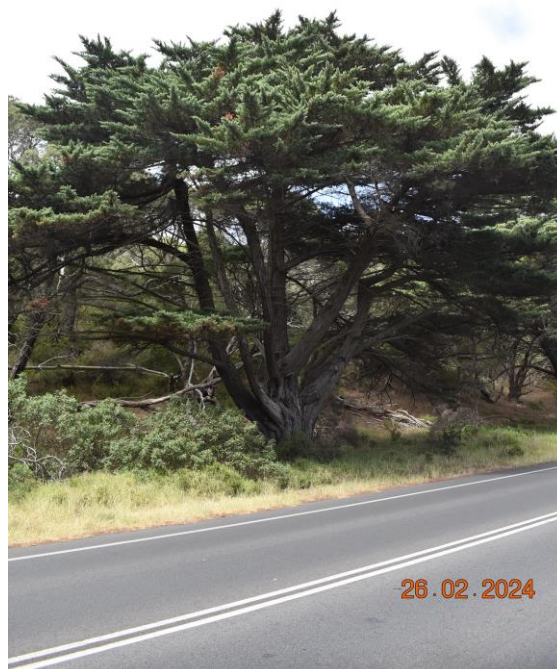
Asset ID: 36

Priority: None

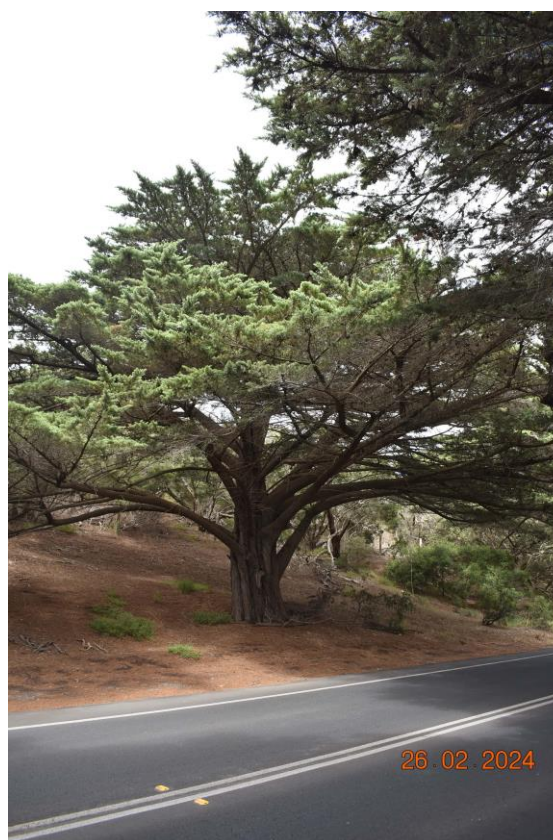
Asset ID:	40
Botanical Name:	<i>Hesperocyparis macrocarpa</i>
Common Name:	Monterey Cypress
Origin:	Exotic
DBH (cm):	195
Height & Width (m):	13 x 18
Maturity:	Mature
Health:	Fair
Structure:	Very poor
ULE:	0 years
Retention Value:	High
Works:	Removal
Priority:	High
Comments:	Trunk splitting on bushland side

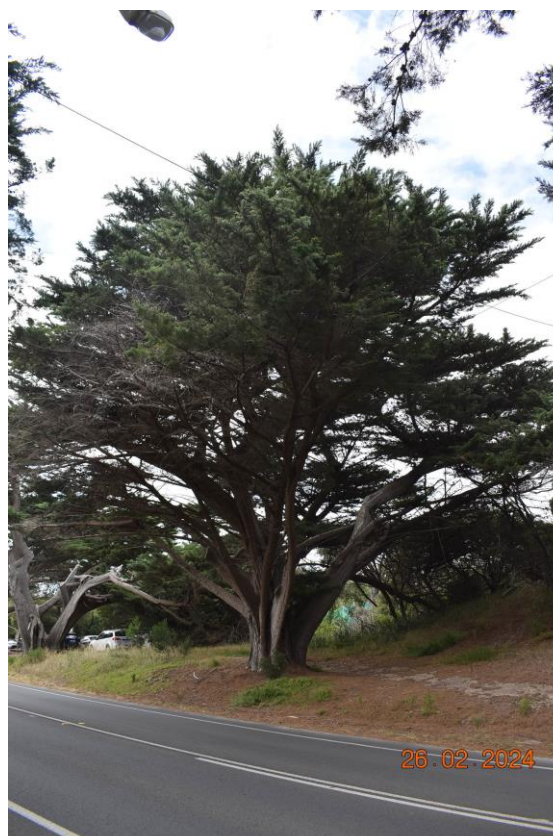
Asset ID:	43
Botanical Name:	<i>Hesperocyparis macrocarpa</i>
Common Name:	Monterey Cypress
Origin:	Exotic
DBH (cm):	230
Height & Width (m):	15 x 20
Maturity:	Mature
Health:	Fair
Structure:	Poor
ULE:	5 to 10 years
Retention Value:	High
Works:	No works
Priority:	None
Comments:	Split limb over dirt footpath already reduced

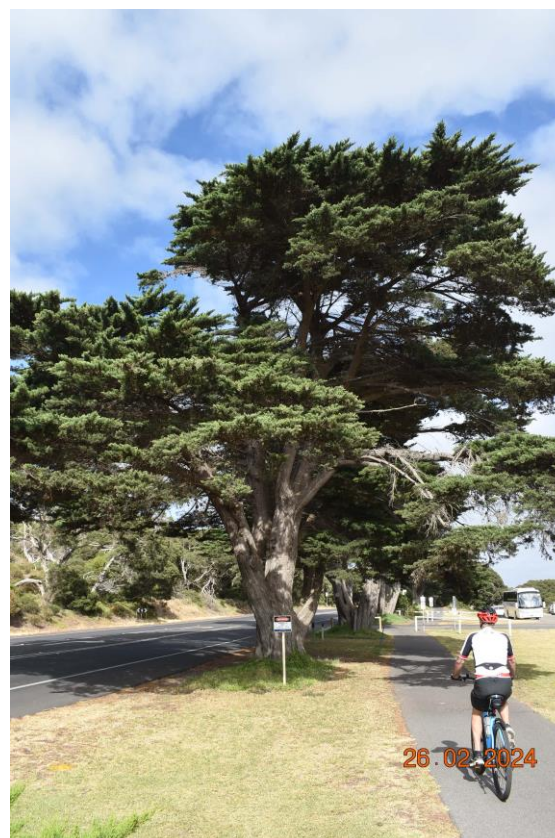
Asset ID:	45
Botanical Name:	<i>Hesperocyparis macrocarpa</i>
Common Name:	Monterey Cypress
Origin:	Exotic
DBH (cm):	250
Height & Width (m):	16 x 20
Maturity:	Mature
Health:	Fair
Structure:	Poor
ULE:	5 to 10 years
Retention Value:	High
Works:	Risk reduction pruning, Mulch rootzone, Deadwood removal
Priority:	Moderate
Comments:	20% reduction over road and footpath, max diameter cut of 70mm

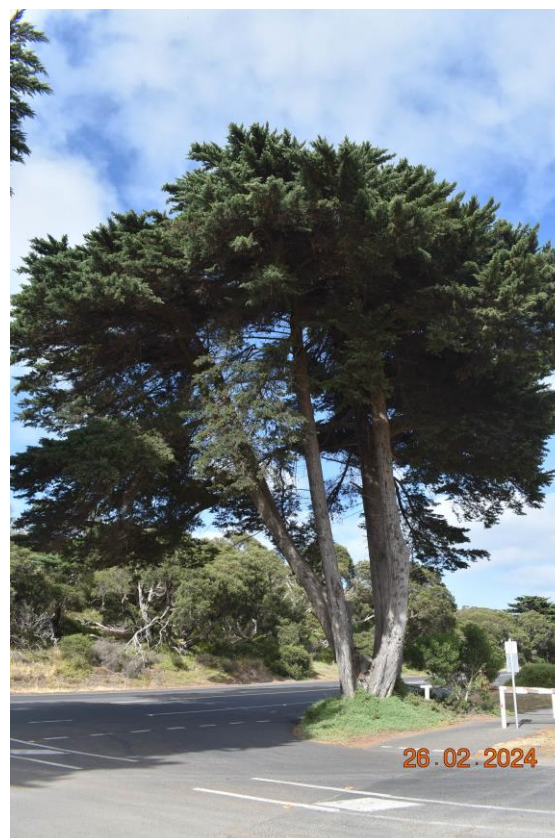
Asset ID:	47
Botanical Name:	<i>Hesperocyparis macrocarpa</i>
Common Name:	Monterey Cypress
Origin:	Exotic
DBH (cm):	190
Height & Width (m):	15 x 16
Maturity:	Mature
Health:	Fair
Structure:	Poor
ULE:	5 to 10 years
Retention Value:	High
Works:	Risk reduction pruning
Priority:	Moderate
Comments:	20% reduction over road, max diameter cut of 70mm

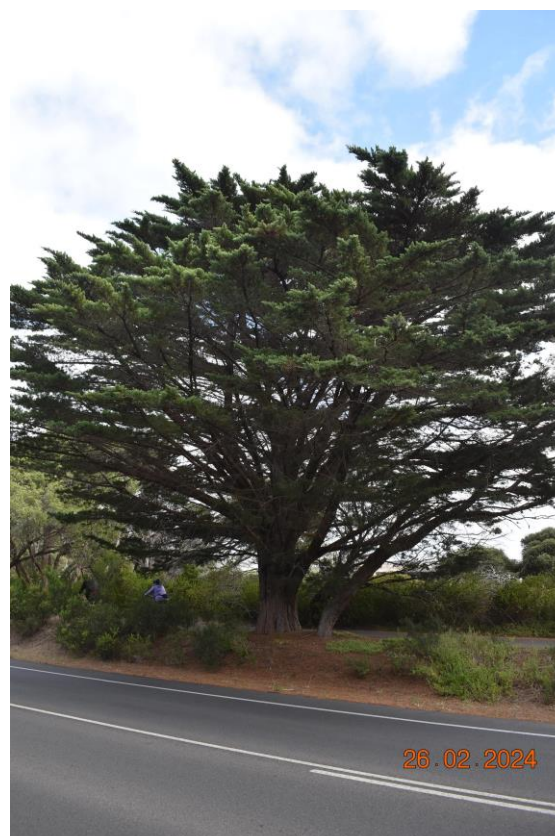
Asset ID: 52

Comments: Browning off from canker

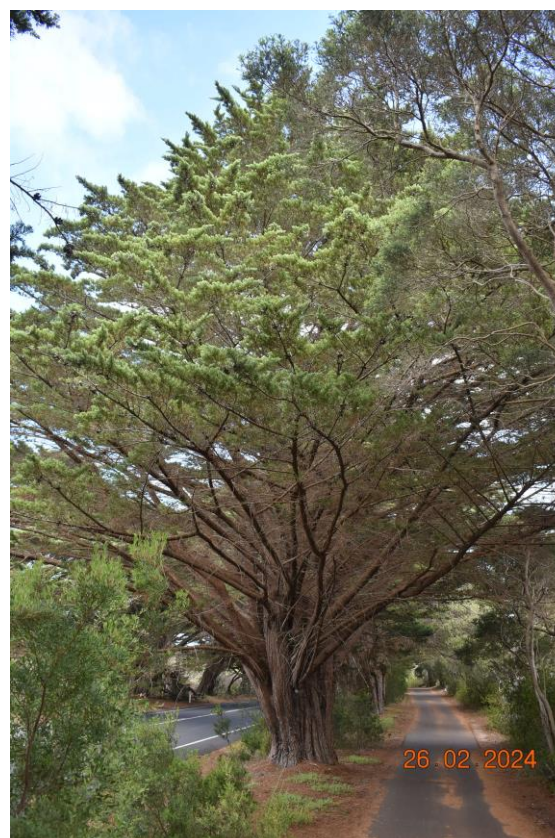
Asset ID: 56

Comments: Browning off from canker

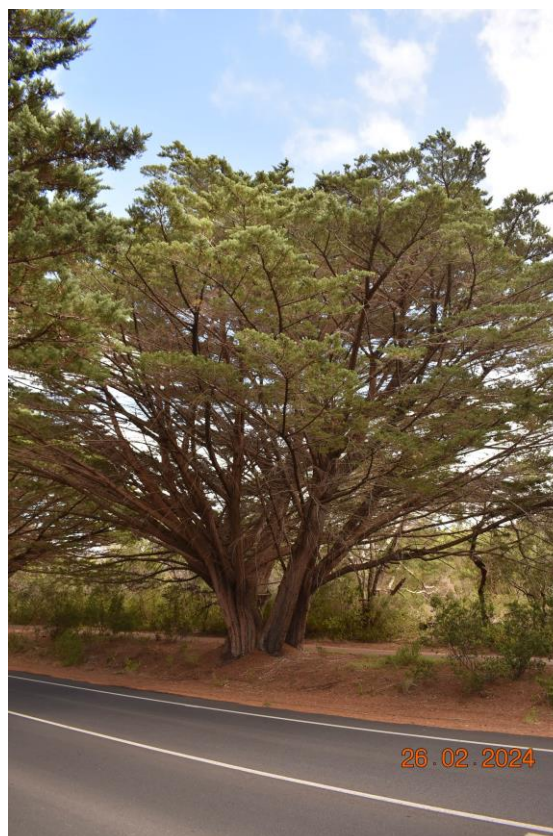
Asset ID: 57

Comments: Browning off from canker

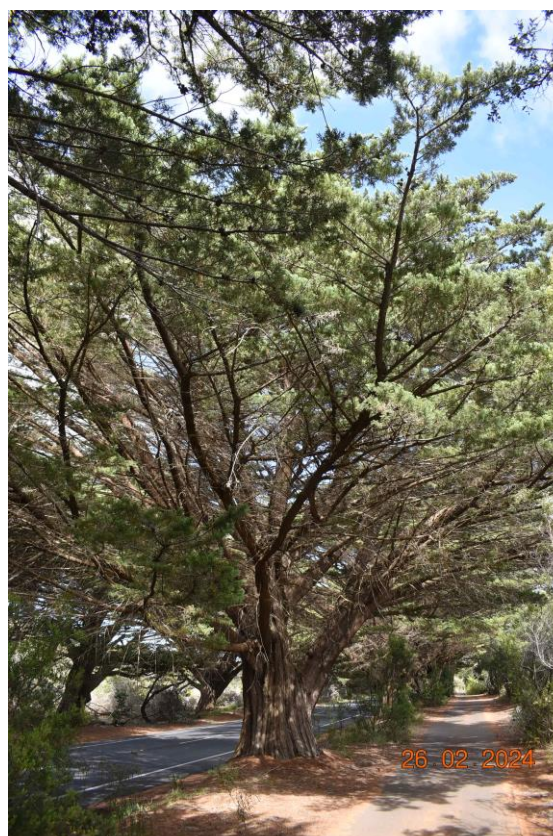
Asset ID:	58
Botanical Name:	<i>Hesperocyparis macrocarpa</i>
Common Name:	Monterey Cypress
Origin:	Exotic
DBH (cm):	120
Height & Width (m):	12 x 16
Maturity:	Mature
Health:	Fair
Structure:	Fair
ULE:	10 to 20 years
Retention Value:	High
Works:	Deadwood removal
Priority:	Low
Comments:	Browning off from canker

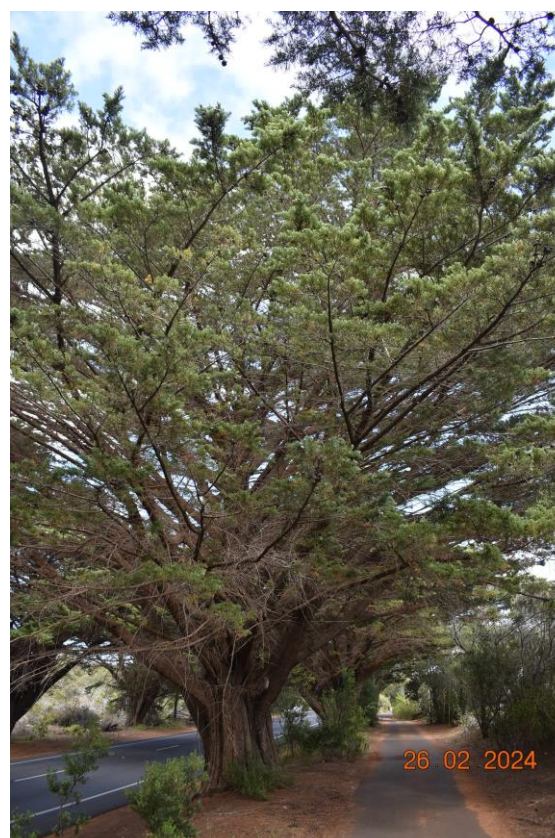
Asset ID:	59
Botanical Name:	<i>Hesperocyparis macrocarpa</i>
Common Name:	Monterey Cypress
Origin:	Exotic
DBH (cm):	145
Height & Width (m):	13 x 16
Maturity:	Mature
Health:	Fair
Structure:	Fair
ULE:	10 to 20 years
Retention Value:	High
Works:	Deadwood removal
Priority:	Low
Comments:	Browning off from canker

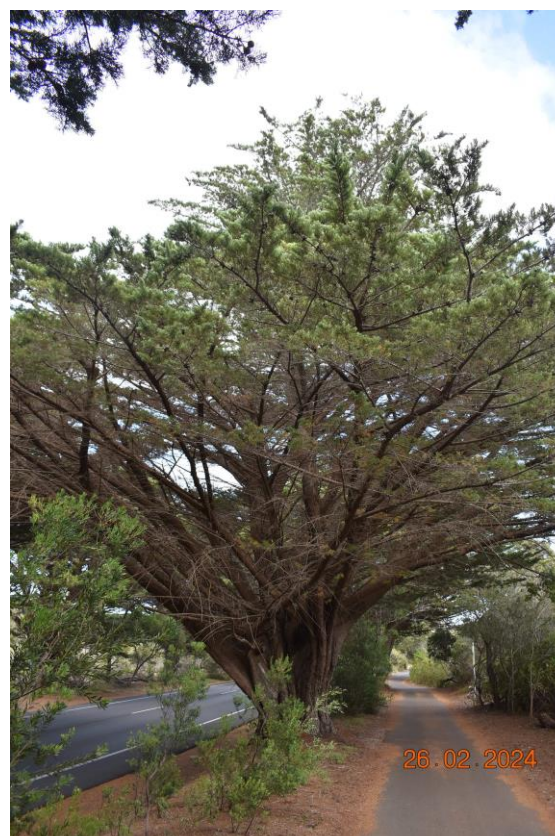
Asset ID:	60
Botanical Name:	<i>Hesperocyparis macrocarpa</i>
Common Name:	Monterey Cypress
Origin:	Exotic
DBH (cm):	160
Height & Width (m):	12 x 14
Maturity:	Mature
Health:	Fair
Structure:	Fair
ULE:	10 to 20 years
Retention Value:	High
Works:	No works
Priority:	None
Comments:	Browning off from canker

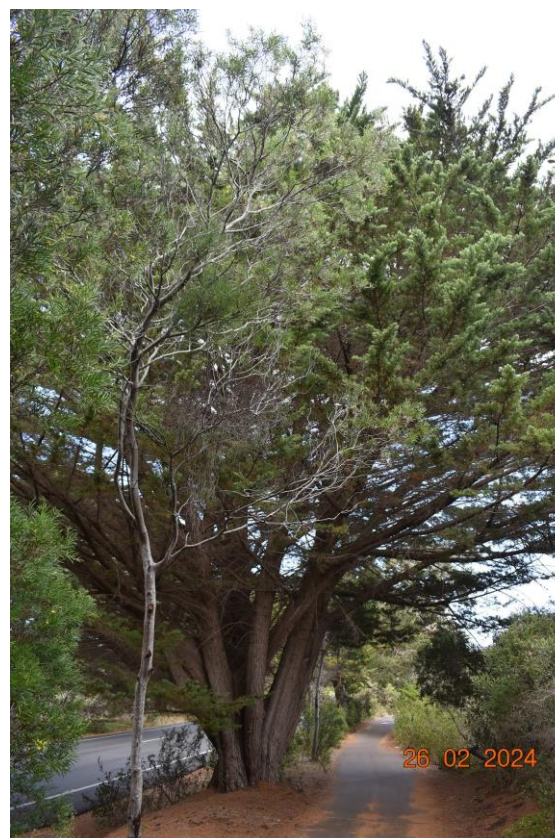
Asset ID:	61
Botanical Name:	<i>Hesperocyparis macrocarpa</i>
Common Name:	Monterey Cypress
Origin:	Exotic
DBH (cm):	16
Height & Width (m):	6 x 4
Maturity:	Semi mature
Health:	Poor
Structure:	Good
ULE:	5 to 10 years
Retention Value:	High
Works:	No works
Priority:	None
Comments:	Browning off from canker

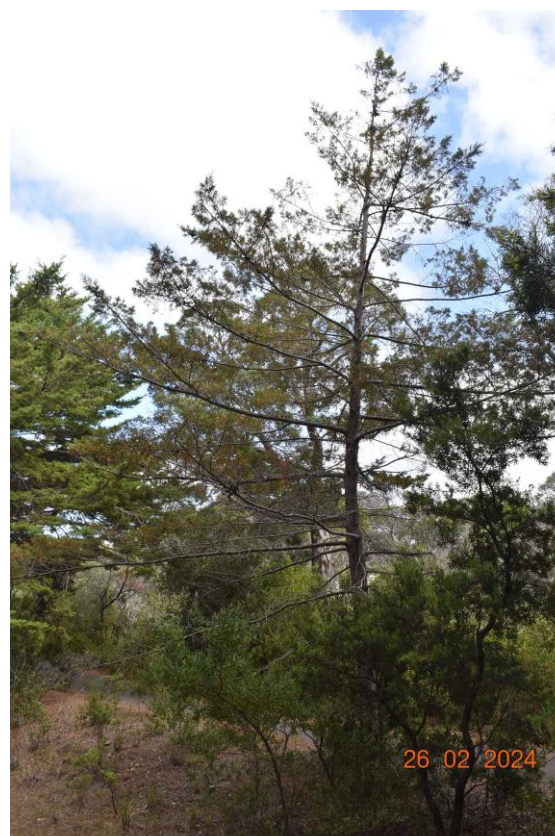
Asset ID:	62
Botanical Name:	<i>Hesperocyparis macrocarpa</i>
Common Name:	Monterey Cypress
Origin:	Exotic
DBH (cm):	62
Height & Width (m):	8 x 10
Maturity:	Mature
Health:	Fair
Structure:	Fair
ULE:	10 to 20 years
Retention Value:	High
Works:	No works
Priority:	None
Comments:	Browning off from canker

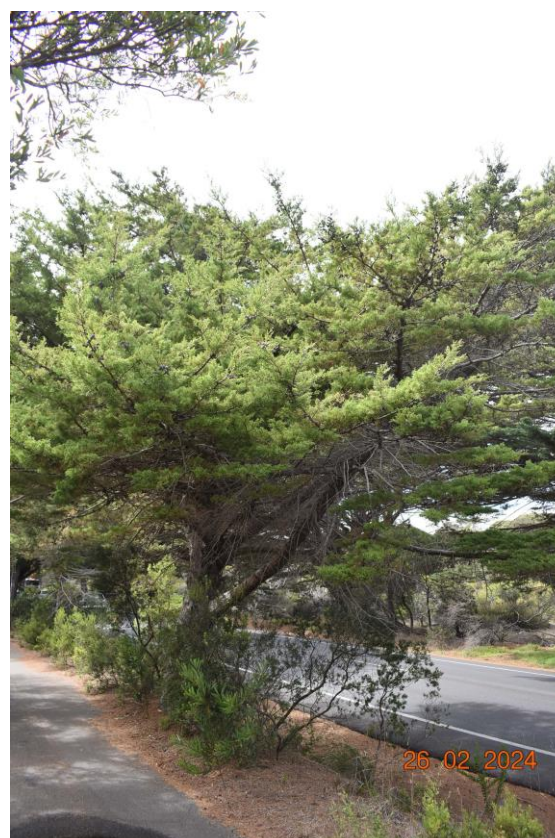
Asset ID:	63
Botanical Name:	<i>Hesperocyparis macrocarpa</i>
Common Name:	Monterey Cypress
Origin:	Exotic
DBH (cm):	105
Height & Width (m):	10 x 12
Maturity:	Mature
Health:	Fair
Structure:	Fair
ULE:	10 to 20 years
Retention Value:	High
Works:	No works
Priority:	None
Comments:	Browning off from canker

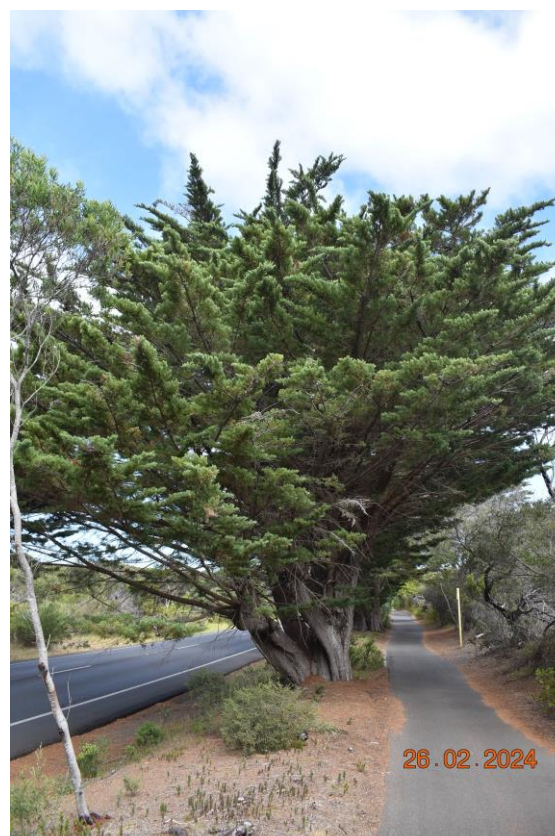
Asset ID: 64

Comments: Browning off from canker

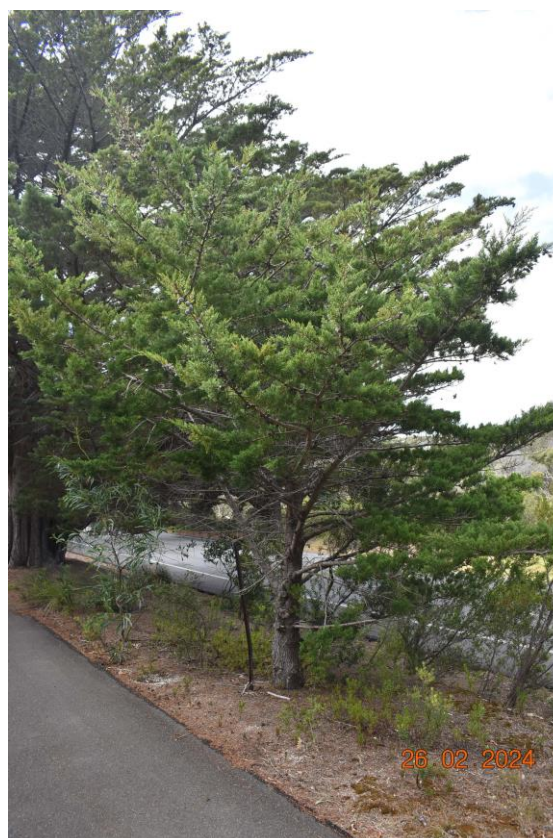
Asset ID:	66
Botanical Name:	<i>Hesperocyparis macrocarpa</i>
Common Name:	Monterey Cypress
Origin:	Exotic
DBH (cm):	45
Height & Width (m):	9 x 8
Maturity:	Mature
Health:	Fair
Structure:	Good
ULE:	10 to 20 years
Retention Value:	High
Works:	No works
Priority:	None
Comments:	Browning off from canker

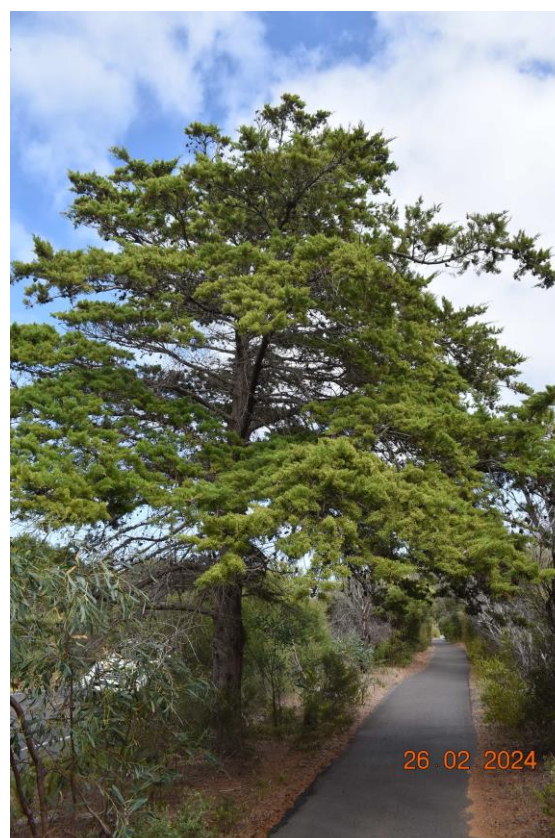
Asset ID:	67
Botanical Name:	<i>Hesperocyparis macrocarpa</i>
Common Name:	Monterey Cypress
Origin:	Exotic
DBH (cm):	105
Height & Width (m):	13 x 16
Maturity:	Mature
Health:	Fair
Structure:	Fair
ULE:	20 to 40 years
Retention Value:	High
Works:	No works
Priority:	None
Comments:	Browning off from canker, small hanging branch on bushland side

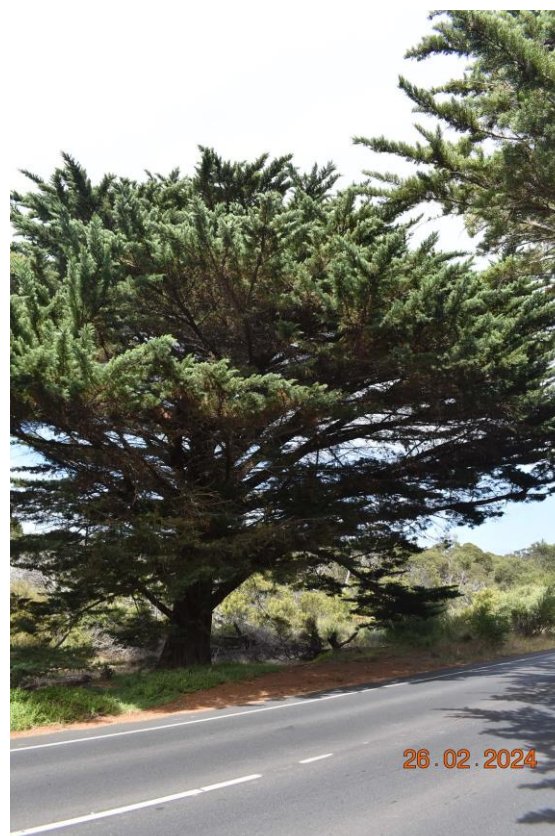
Asset ID: 68

Comments: Browning off from canker

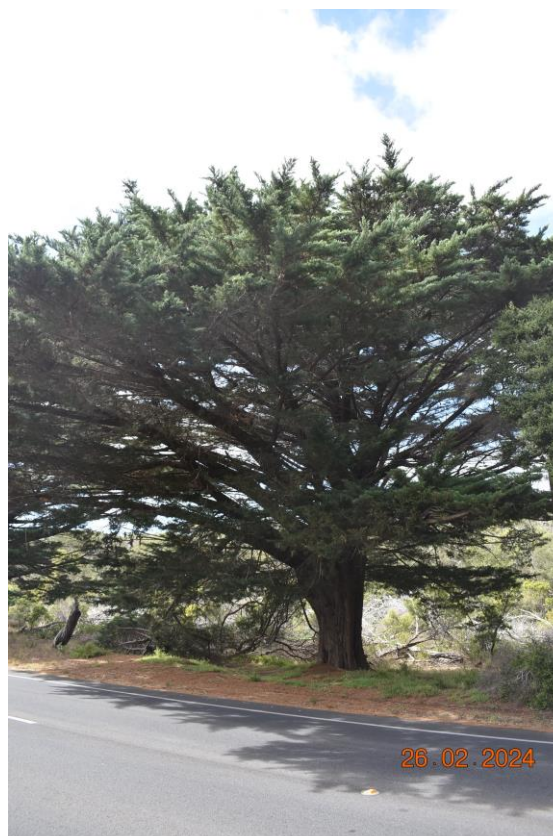
Asset ID: 69

Comments: Browning off from canker

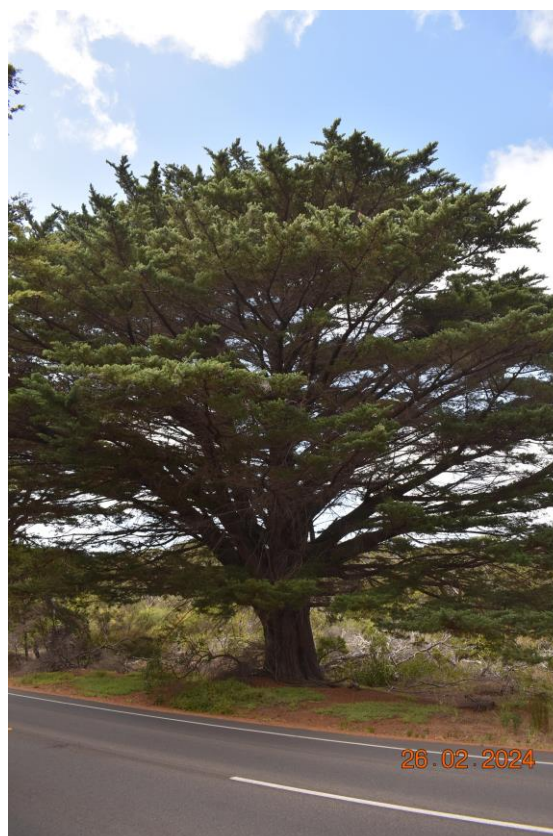
Asset ID: 70

Comments: Browning off from canker

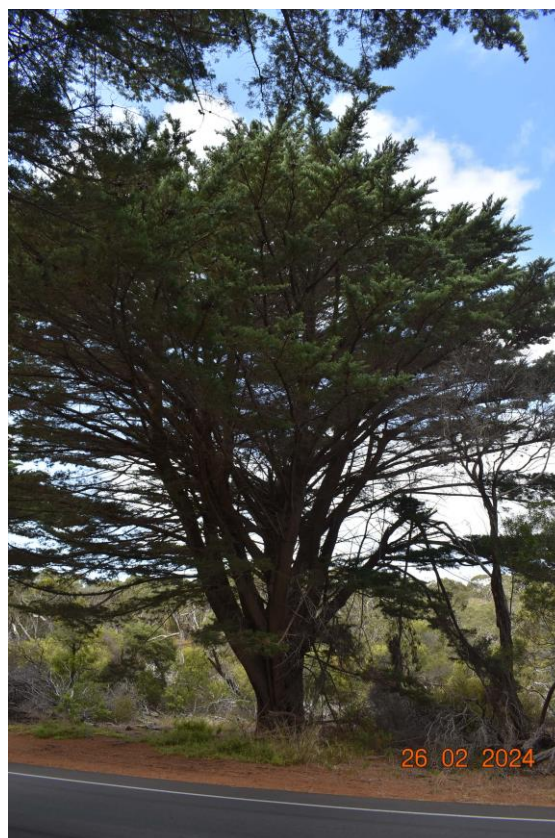
Asset ID: 71

Comments: Browning off from canker

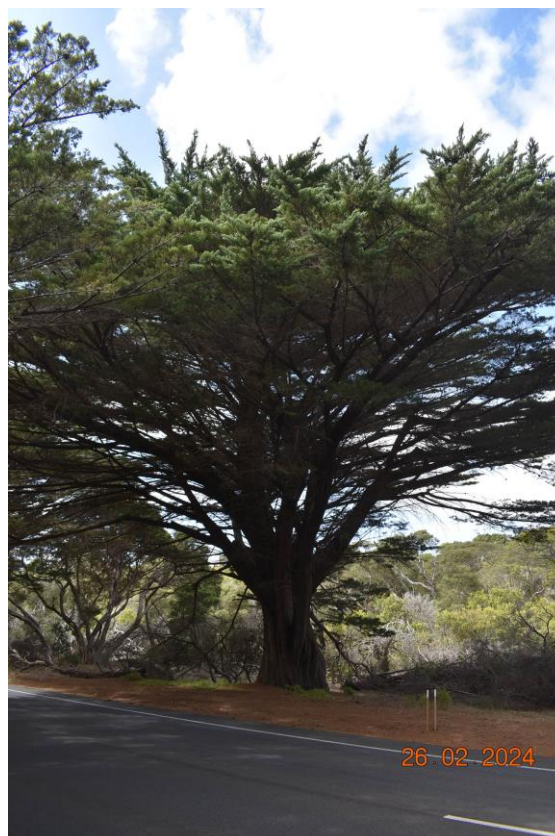
Asset ID: 72

Comments: Browning off from canker

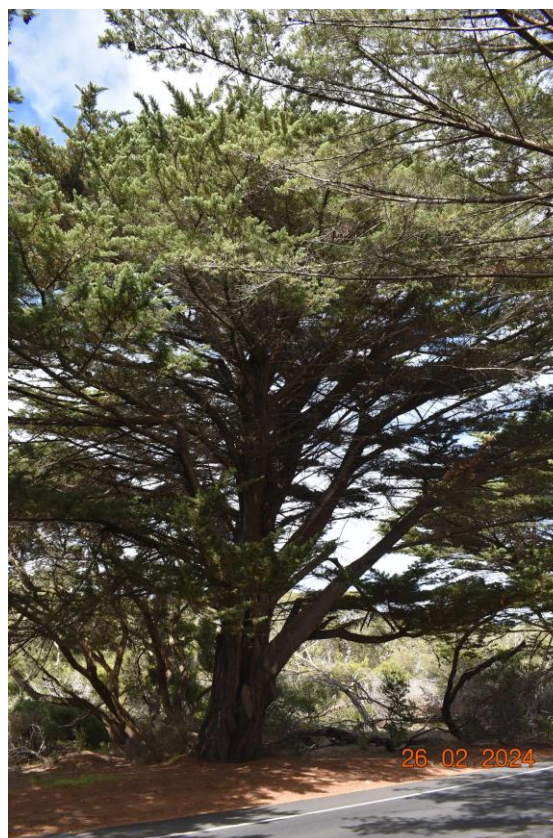
Asset ID: 73

Comments: Browning off from canker

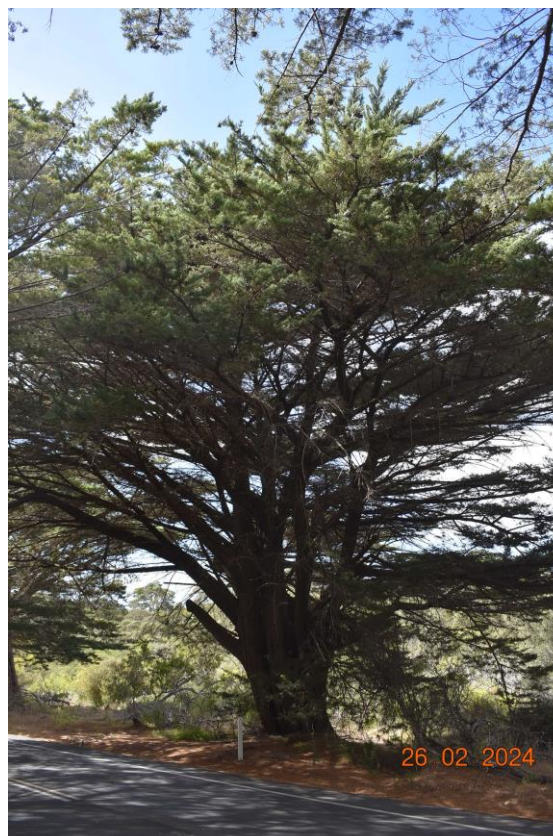
Asset ID: 74

Comments: Browning off from canker

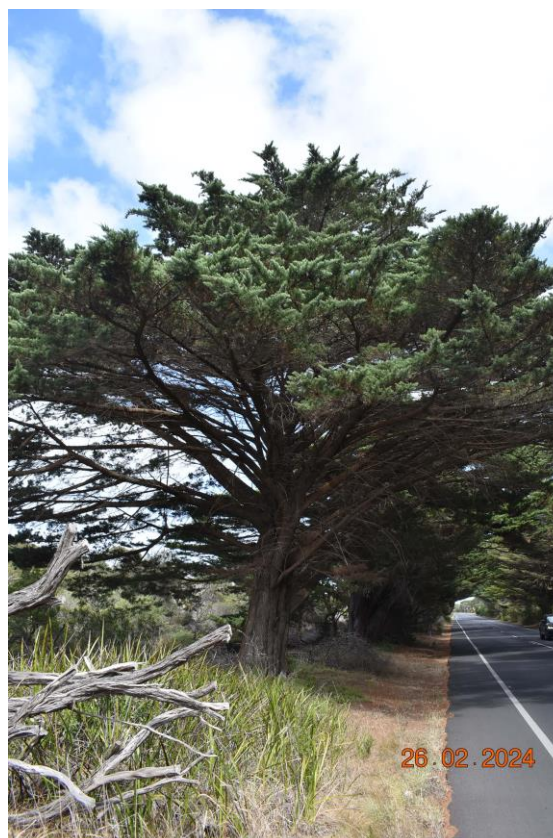
Asset ID: 76

Comments: Browning off from canker

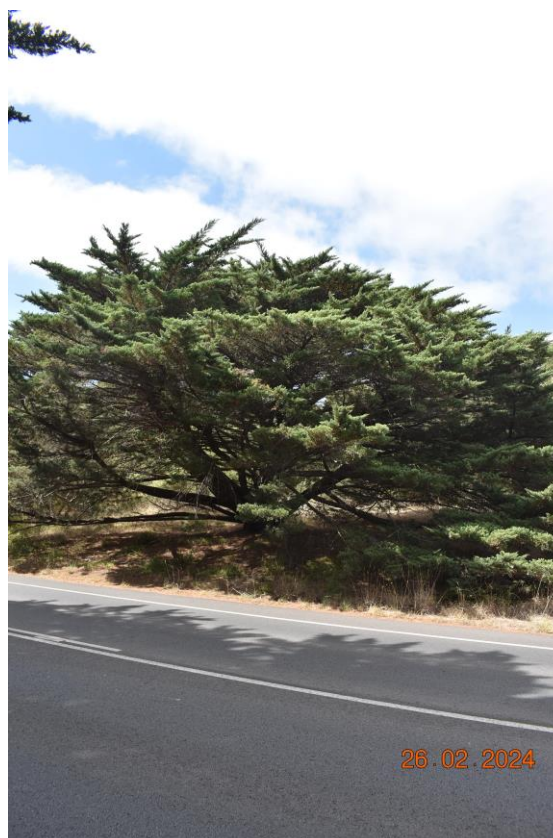
Asset ID: 77

Comments: Browning off from canker

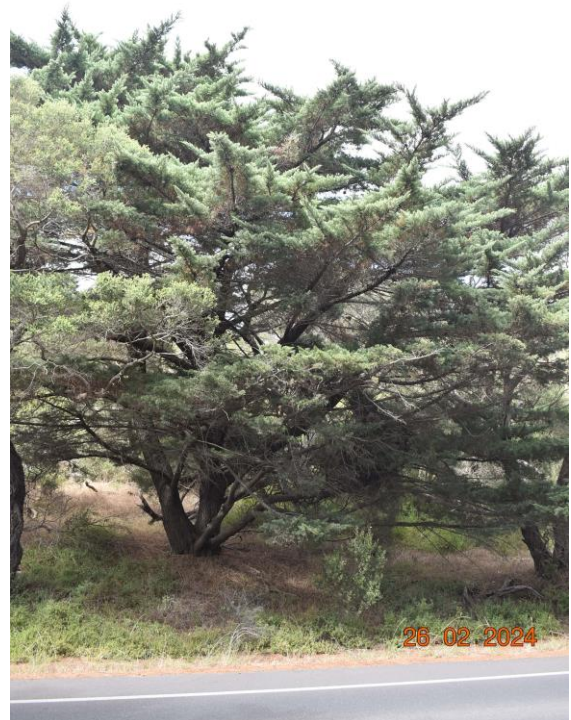
Asset ID: 78

Comments: Lift over footpath

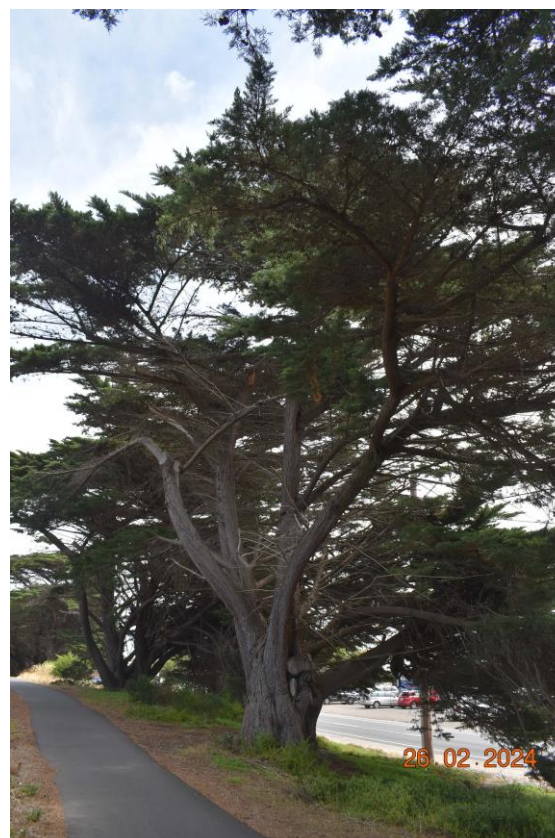
Asset ID:	81
Botanical Name:	<i>Hesperocyparis macrocarpa</i>
Common Name:	Monterey Cypress
Origin:	Exotic
DBH (cm):	210
Height & Width (m):	14 x 16
Maturity:	Mature
Health:	Fair
Structure:	Poor
ULE:	5 to 10 years
Retention Value:	High
Works:	Deadwood removal
Priority:	Low
Comments:

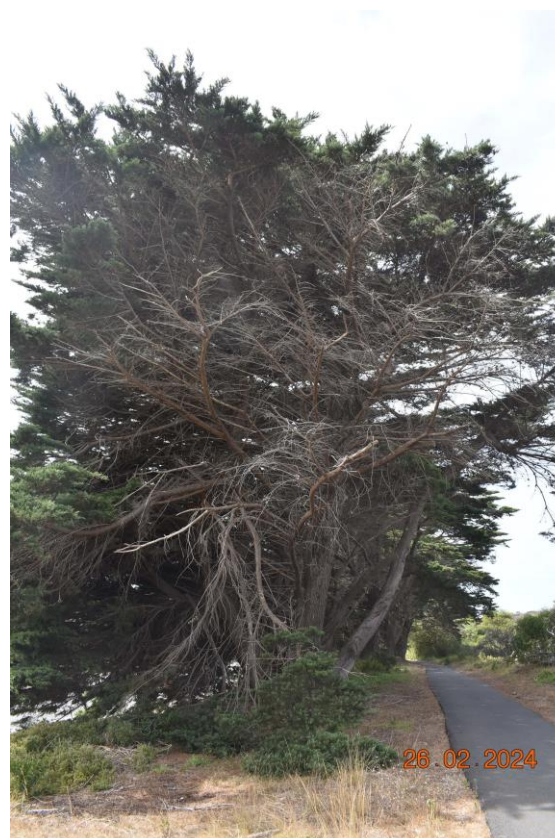
Asset ID:	82
Botanical Name:	<i>Hesperocyparis macrocarpa</i>
Common Name:	Monterey Cypress
Origin:	Exotic
DBH (cm):	190
Height & Width (m):	13 x 20
Maturity:	Mature
Health:	Fair
Structure:	Poor
ULE:	10 to 20 years
Retention Value:	High
Works:	Broken branch removal, Deadwood removal
Priority:	Moderate
Comments:

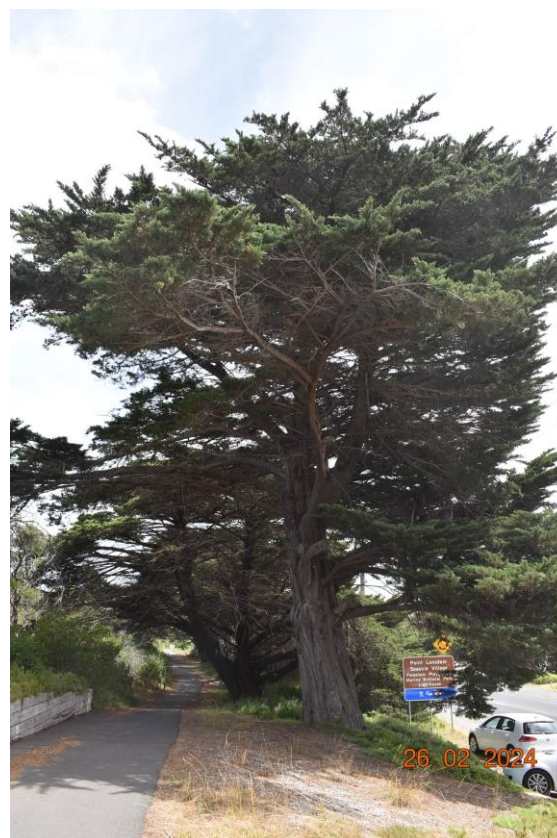
Asset ID:	84
Botanical Name:	<i>Hesperocyparis macrocarpa</i>
Common Name:	Monterey Cypress
Origin:	Exotic
DBH (cm):	120
Height & Width (m):	14 x 14
Maturity:	Mature
Health:	Fair
Structure:	Fair
ULE:	10 to 20 years
Retention Value:	High
Works:	Deadwood removal
Priority:	Low
Comments:

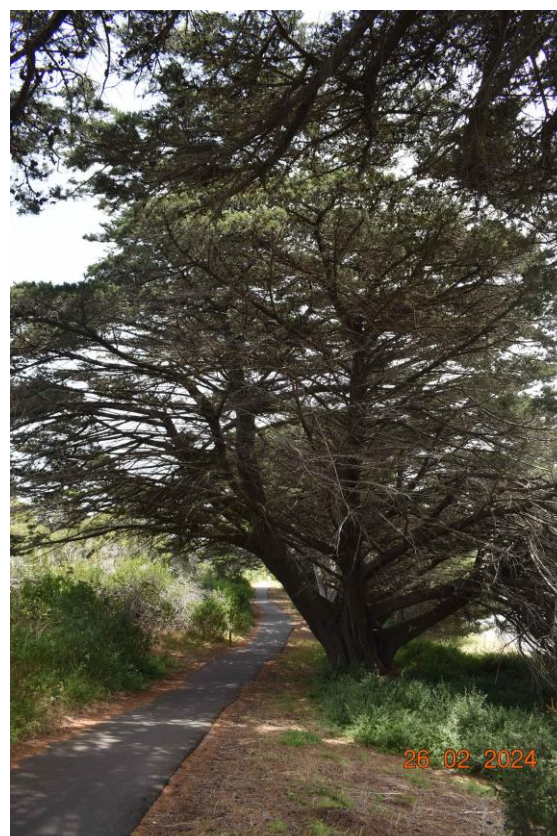
Asset ID:	85
Botanical Name:	<i>Hesperocyparis macrocarpa</i>
Common Name:	Monterey Cypress
Origin:	Exotic
DBH (cm):	215
Height & Width (m):	14 x 25
Maturity:	Mature
Health:	Fair
Structure:	Fair
ULE:	10 to 20 years
Retention Value:	High
Works:	Deadwood removal
Priority:	Low
Comments:

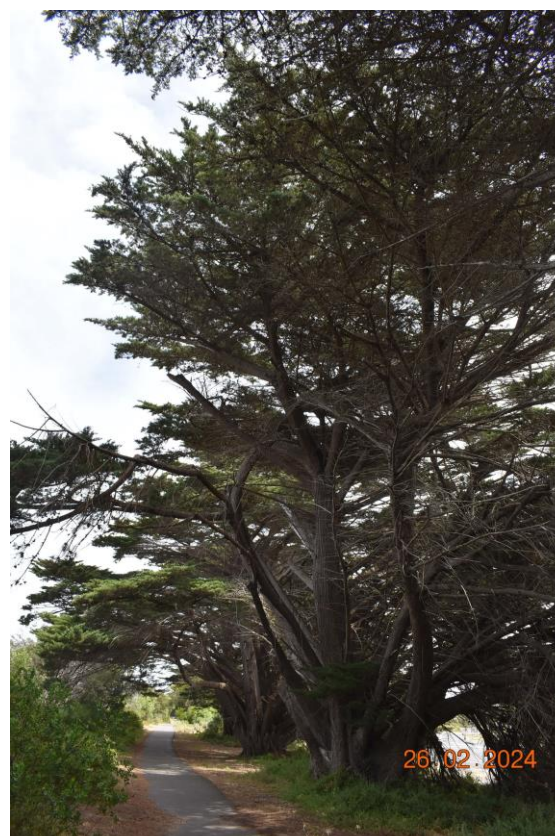
Asset ID:	87
Botanical Name:	<i>Hesperocyparis macrocarpa</i>
Common Name:	Monterey Cypress
Origin:	Exotic
DBH (cm):	220
Height & Width (m):	15 x 23
Maturity:	Mature
Health:	Fair
Structure:	Poor
ULE:	5 to 10 years
Retention Value:	High
Works:	Individual branch removal, Deadwood removal, Other
Priority:	Moderate
Comments:	Clean up larger failure wounds with active splits, above footpath, remove extended and exposed branch over footpath
