Health and Condition Report

Assessment of the Queenscliff Avenue of Honour.

Friday, 1 March 2024

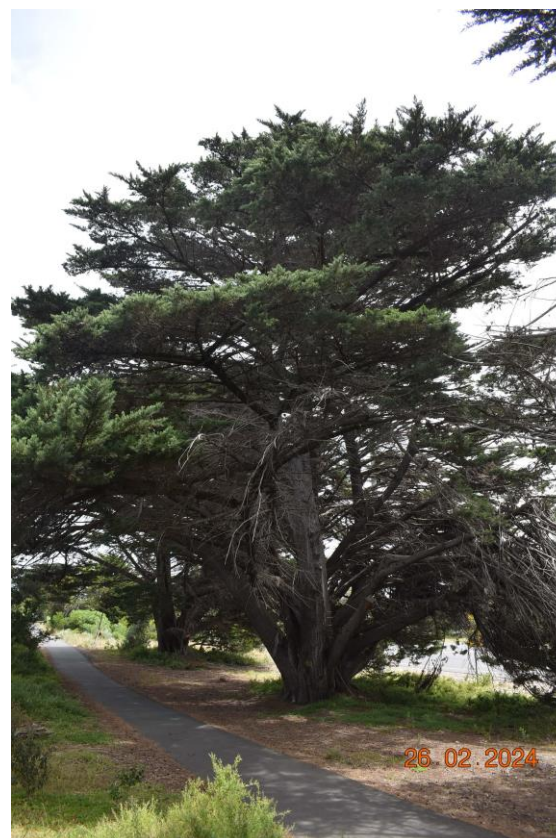
Asset ID:	88
Botanical Name:	<i>Hesperocyparis macrocarpa</i>
Common Name:	Monterey Cypress
Origin:	Exotic
DBH (cm):	230
Height & Width (m):	16 x 21
Maturity:	Mature
Health:	Fair
Structure:	Fair
ULE:	10 to 20 years
Retention Value:	High
Works:	Deadwood removal
Priority:	Low
Comments:

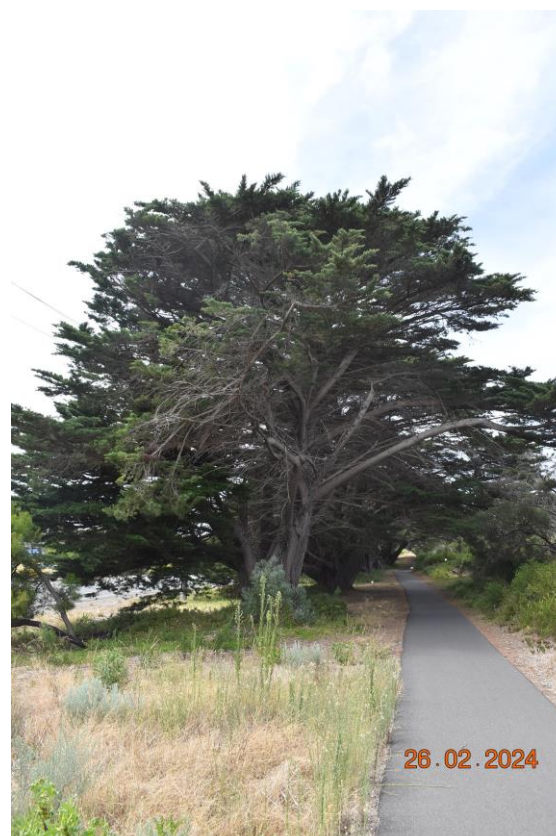
Asset ID:	89
Botanical Name:	<i>Hesperocyparis macrocarpa</i>
Common Name:	Monterey Cypress
Origin:	Exotic
DBH (cm):	190
Height & Width (m):	14 x 19
Maturity:	Mature
Health:	Fair
Structure:	Fair
ULE:	10 to 20 years
Retention Value:	High
Works:	Deadwood removal
Priority:	Low
Comments:

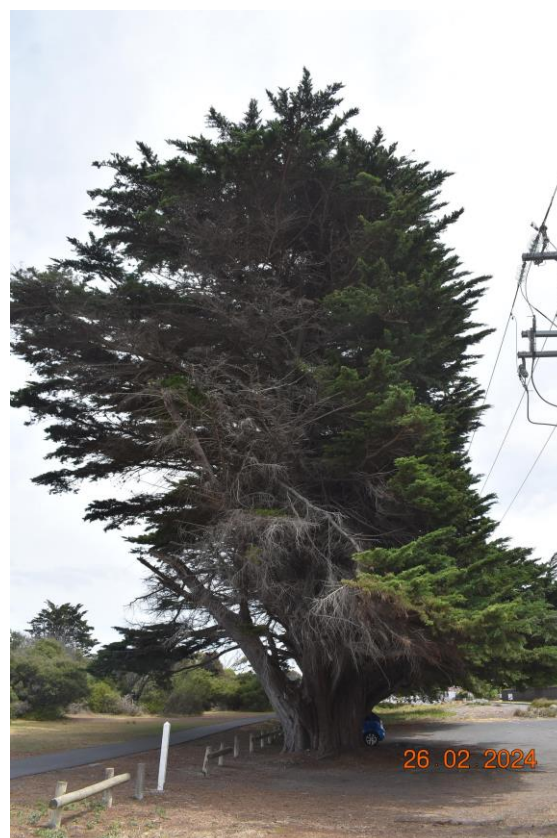
Asset ID:	96
Botanical Name:	<i>Hesperocyparis macrocarpa</i>
Common Name:	Monterey Cypress
Origin:	Exotic
DBH (cm):	275
Height & Width (m):	17 x 20
Maturity:	Mature
Health:	Fair
Structure:	Poor
ULE:	5 to 10 years
Retention Value:	High
Works:	Other, Deadwood removal
Priority:	Moderate
Comments:	Clean up large failure wounds over footpath

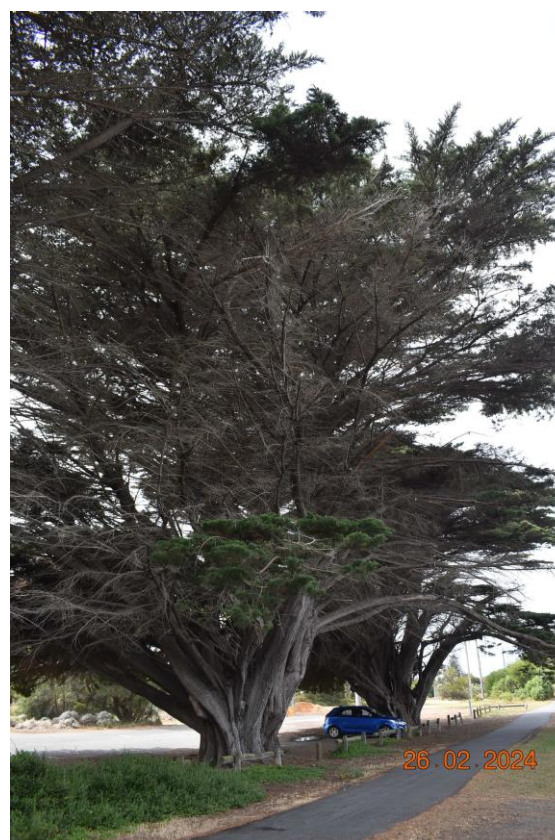
Asset ID:	97
Botanical Name:	<i>Hesperocyparis macrocarpa</i>
Common Name:	Monterey Cypress
Origin:	Exotic
DBH (cm):	280
Height & Width (m):	16 x 20
Maturity:	Mature
Health:	Fair
Structure:	Fair
ULE:	10 to 20 years
Retention Value:	High
Works:	Deadwood removal
Priority:	Moderate
Comments:

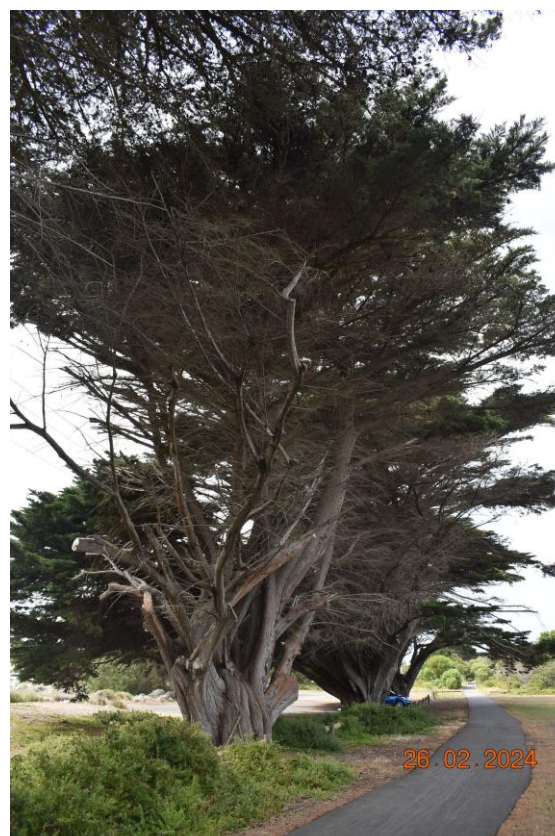
Asset ID:	98
Botanical Name:	<i>Hesperocyparis macrocarpa</i>
Common Name:	Monterey Cypress
Origin:	Exotic
DBH (cm):	285
Height & Width (m):	15 x 18
Maturity:	Mature
Health:	Fair
Structure:	Poor
ULE:	5 to 10 years
Retention Value:	High
Works:	Deadwood removal
Priority:	Moderate
Comments:

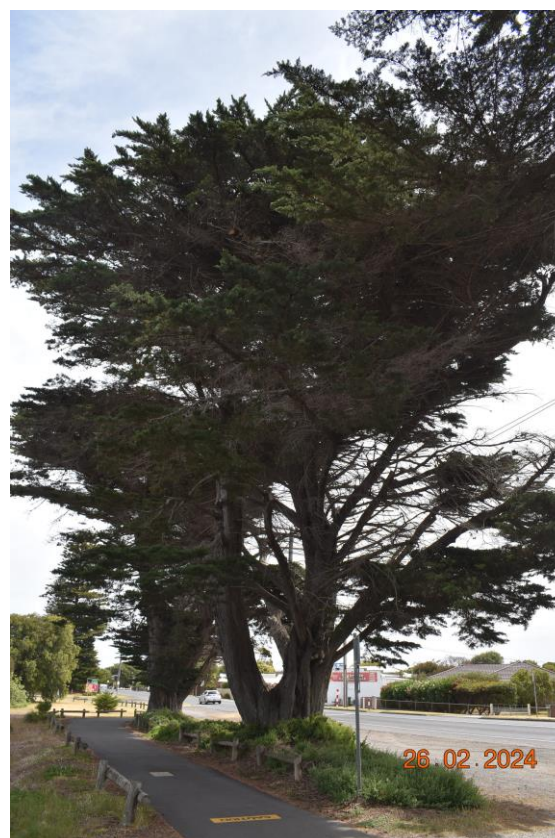
Asset ID:	102
Botanical Name:	<i>Hesperocyparis macrocarpa</i>
Common Name:	Monterey Cypress
Origin:	Exotic
DBH (cm):	175
Height & Width (m):	15 x 17
Maturity:	Mature
Health:	Fair
Structure:	Poor
ULE:	5 to 10 years
Retention Value:	High
Works:	Deadwood removal, Codominant reduction
Priority:	Low
Comments:	Continue reduction of canopy stem with longitudinal crack

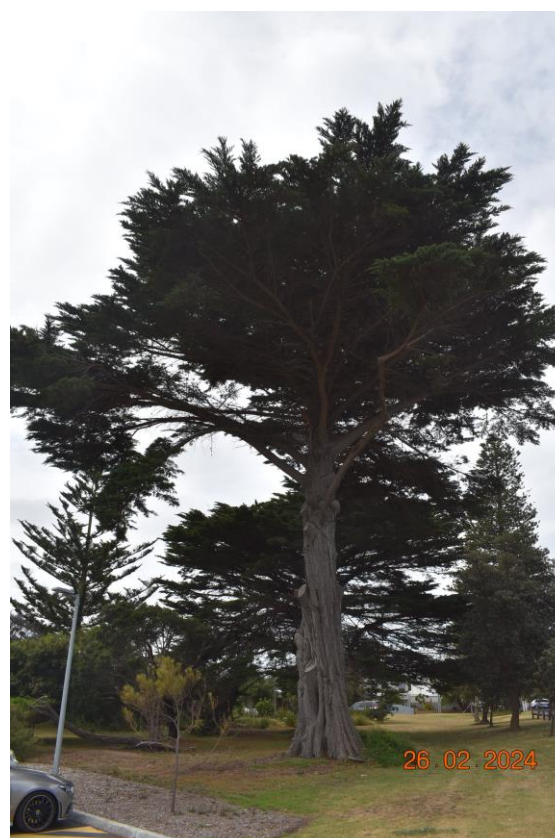
Asset ID:	106
Botanical Name:	<i>Hesperocyparis macrocarpa</i>
Common Name:	Monterey Cypress
Origin:	Exotic
DBH (cm):	155
Height & Width (m):	16 x 17
Maturity:	Mature
Health:	Fair
Structure:	Poor
ULE:	5 to 10 years
Retention Value:	High
Works:	Individual branch removal
Priority:	High
Comments:	Remove historically split canopy branch bent and resting upon two supporting failure stubs over carparking

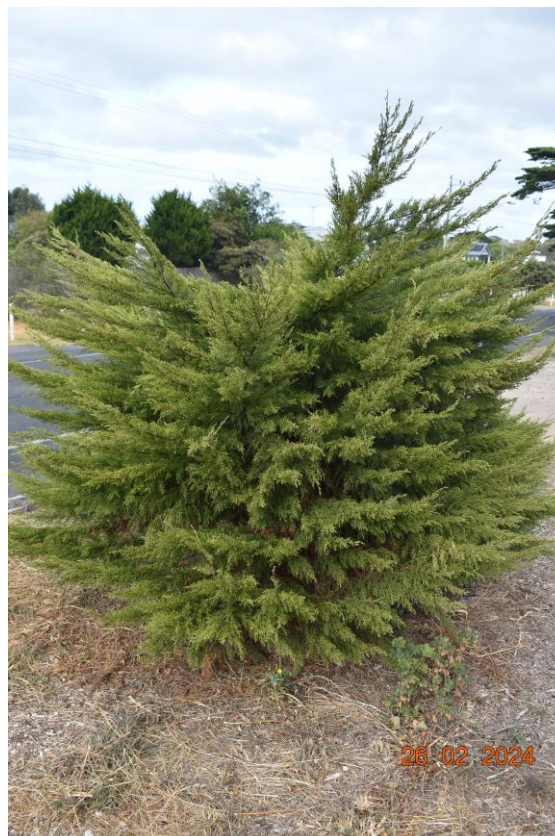
Asset ID: 126

Comments: Slightly chlorotic
