Avenue of Honour Tree Management and Replacement Plan

Homewood Consulting Pty Ltd

May 2015

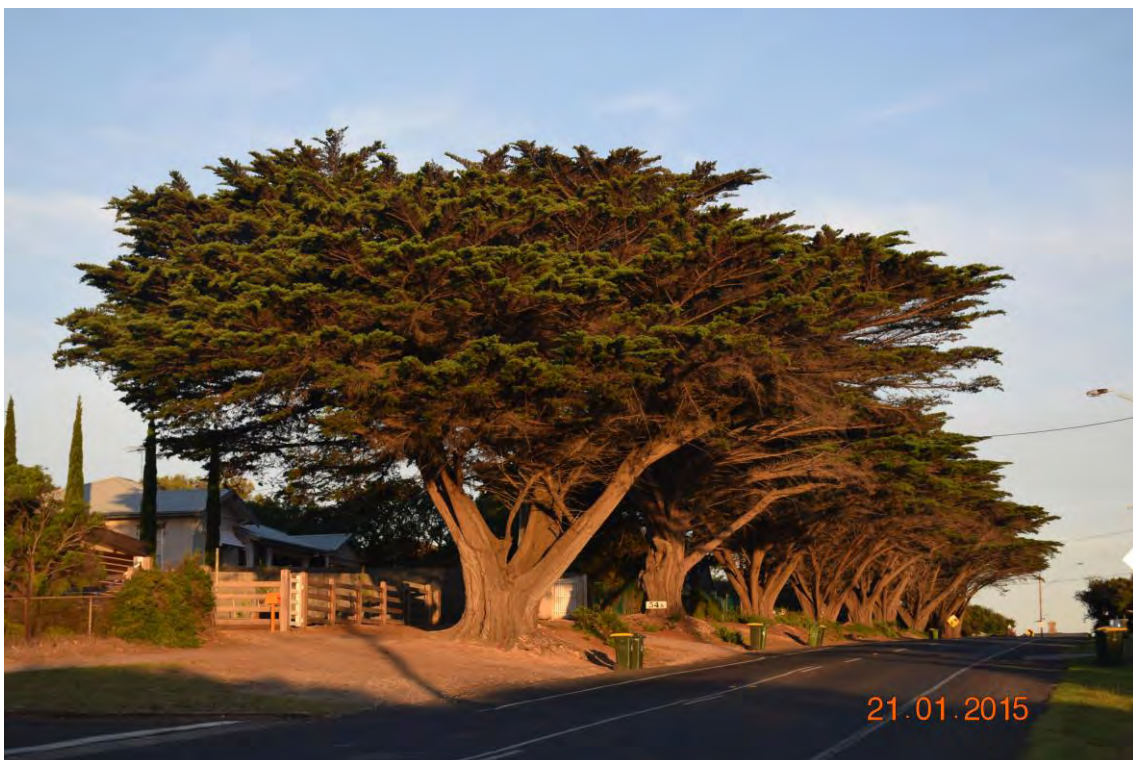
Figure 18: Trees 4-12 along Flinders Street, looking east towards Henry Street.
Tree 12 is in the foreground.

The majority of these trees are currently in fair health for their age and location in the landscape. There is a moderate level of deadwood in the crown which is typical for a tree of this age. The trees are showing signs of *Seiridium* infection (Seiridium Canker), with a thinning canopy and discoloration of foliage.

These trees are approaching the overmaturity phase and are expected to decline over the next 10 years. During this period, the trees should be inspected annually to assess safety and determine maintenance requirements.

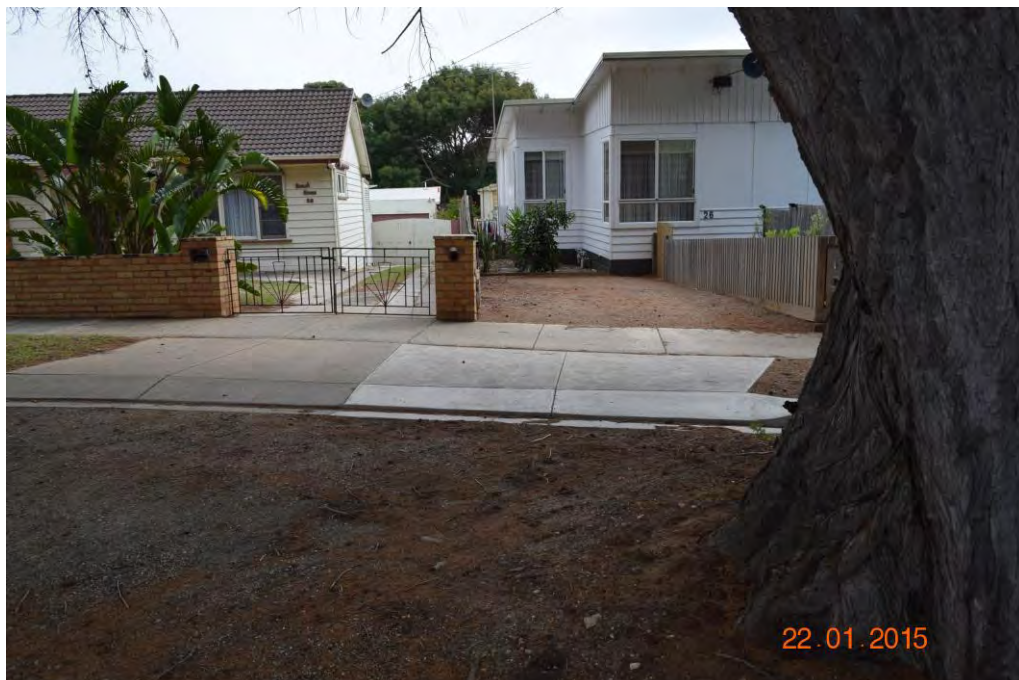
The majority of these trees are of poor structure due to root damage and soil compaction from the road construction, informal gravel parking areas under the canopy, the footpath and residential driveways (Figure 19). Major roots have been severed for grade changes, presumably in the course of road upgrades along this section of Flinders Street (Figure 20). There is evidence of moderate to large branch failure and the trees have been lopped to achieve property clearance.

Figure 19: Vehicular and pedestrian traffic has compacted soils around the root zone.

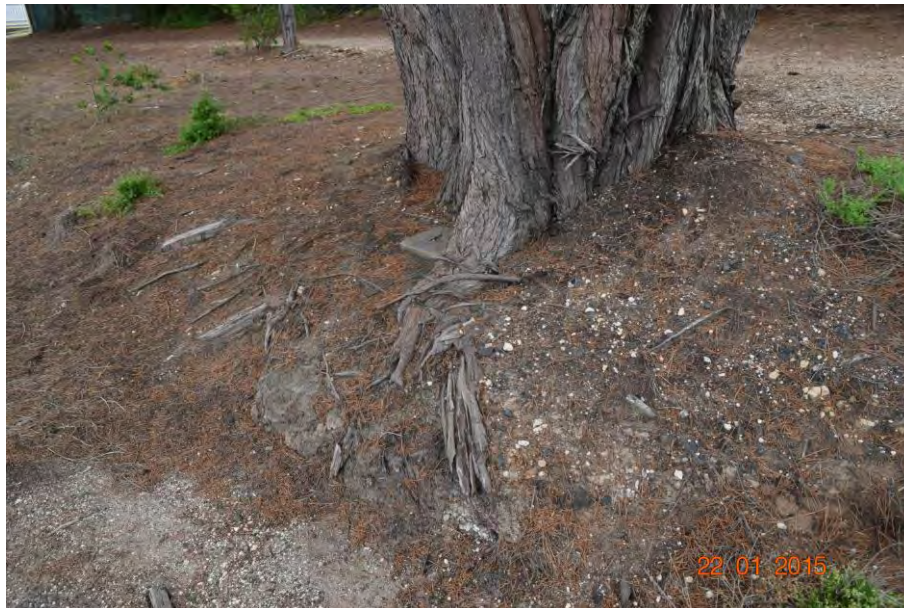
Figure 20: Major roots have been severed in the course of road works on Flinders Street.

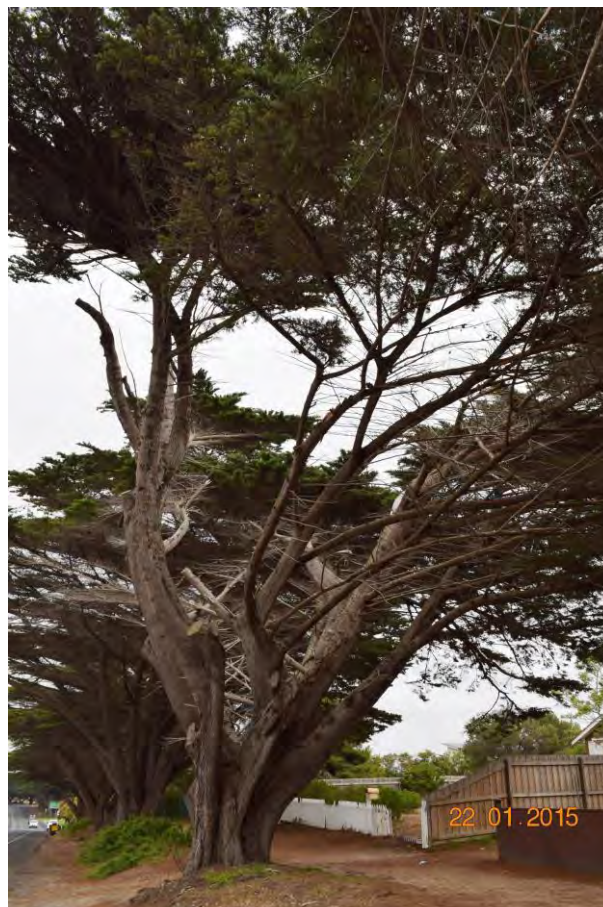
Individual branch removal is recommended for 2 trees with damaged limbs. Tree 7 has a ULE of less than 5 years and is recommended for removal within the next 2-4 years. Many large scaffold branches on Tree 7 have been removed or cut back, presumably due to branch failures or structural defects leaving the canopy quite open (Figure 21). There is substantial decay in the trunk.

Figure 21: Tree 7 has a ULE of 1-5 years and is recommended for a low priority removal.

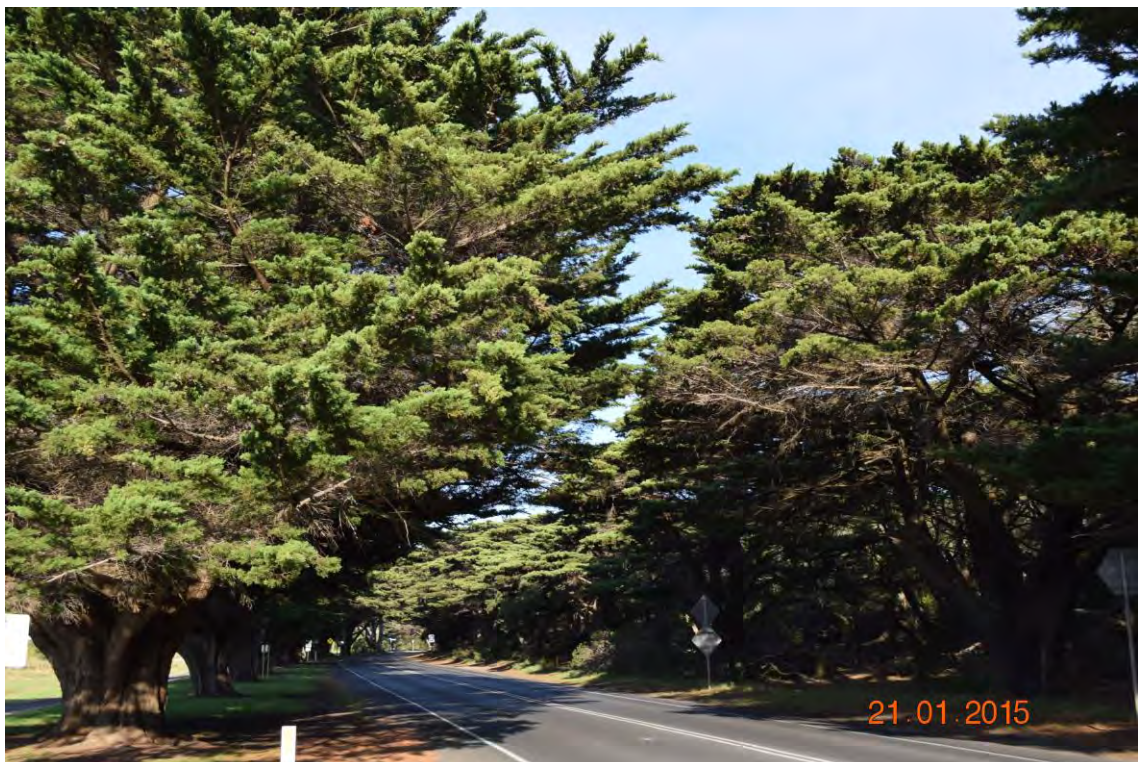
Figure 25: The original Avenue of Honour trees, looking east along the Bellarine Highway. Tree 29 is in the foreground on the LHS of the photo and Tree 34 is in the foreground on the RHS.

The majority of these trees are currently in fair health and of fair structure for their age. The trees are showing signs of *Seiridium* infection, with a thinning canopy and discoloration of foliage. There is moderate to heavy deadwood in the crowns which is typical for the species at this age.

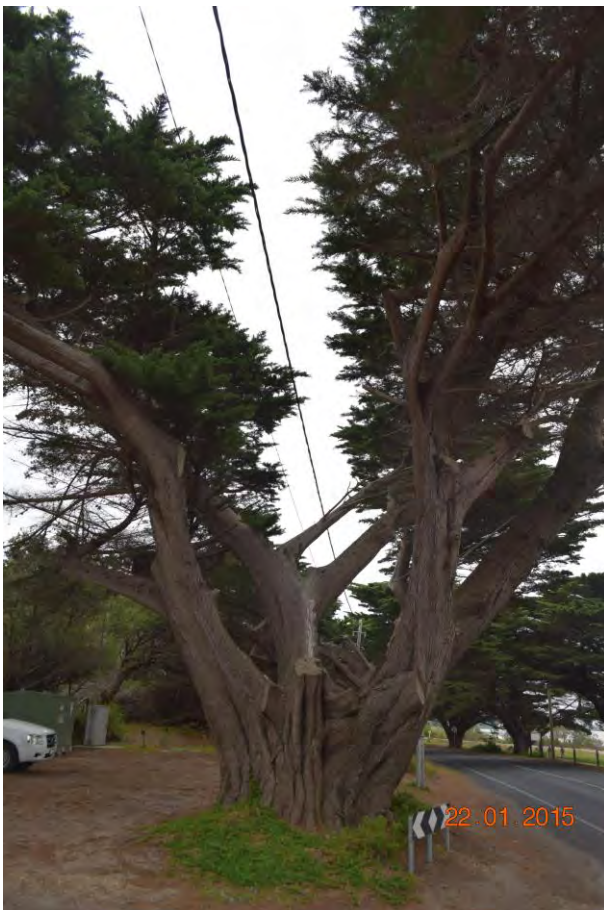
Trees on the northern side of the highway are subject to root zone soil compaction due to cars parking on the road verge. Approximately 40% of the Avenue of Honour trees have poor structure due to extensive pruning. The canopies have been heavily uplifted, resulting in large, extended and end-weighted limbs. Trees 42-44 have been pruned for power line clearance (Figure 26). There is evidence of moderate to large branch failure in many of the trees.

Figure 26: Tree 42 has been pruned for power line clearance.

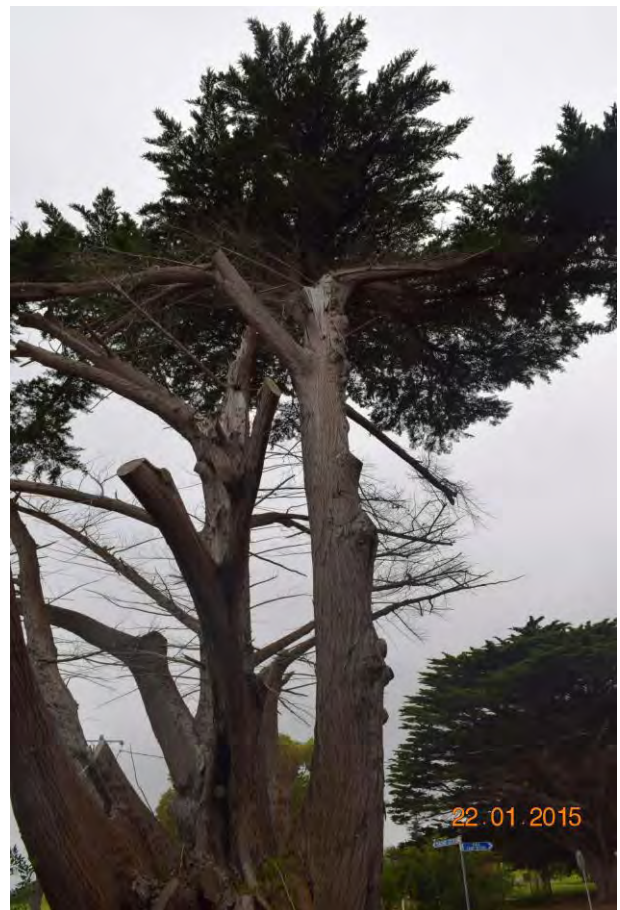
Individual branch removal is recommended for 2 trees with damaged limbs. Tree 19 has a ULE of less than 5 years and is recommended for removal within the next 2 years. Many large scaffold branches have been removed or pruned, presumably due to branch failures or structural defect, leaving the canopy quite open (Figure 27). There is substantial decay in the trunk of Tree 19.

Figure 27: Tree 19 is recommended for removal within the next 2 years.

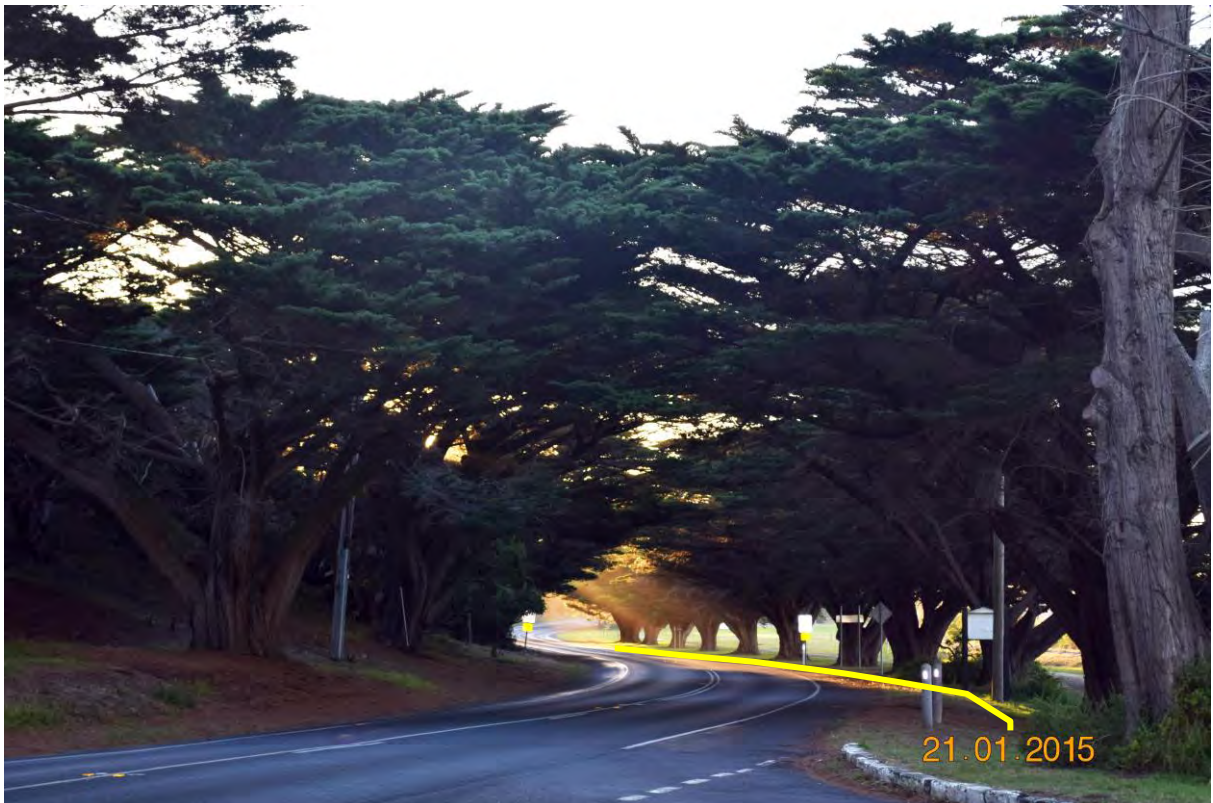
Figure 28: Applying mulch and excluding parking under the canopy of some of these trees will reduce soil compaction and reduce competition from weeds and grass.

Application of organic mulch helps retain moisture in the soil, moderates soil temperature and is beneficial to maintaining the soil microflora. In time it helps improve soil structure and promote the existence of worms and other soil organisms and promote root growth (Bastian 2009).

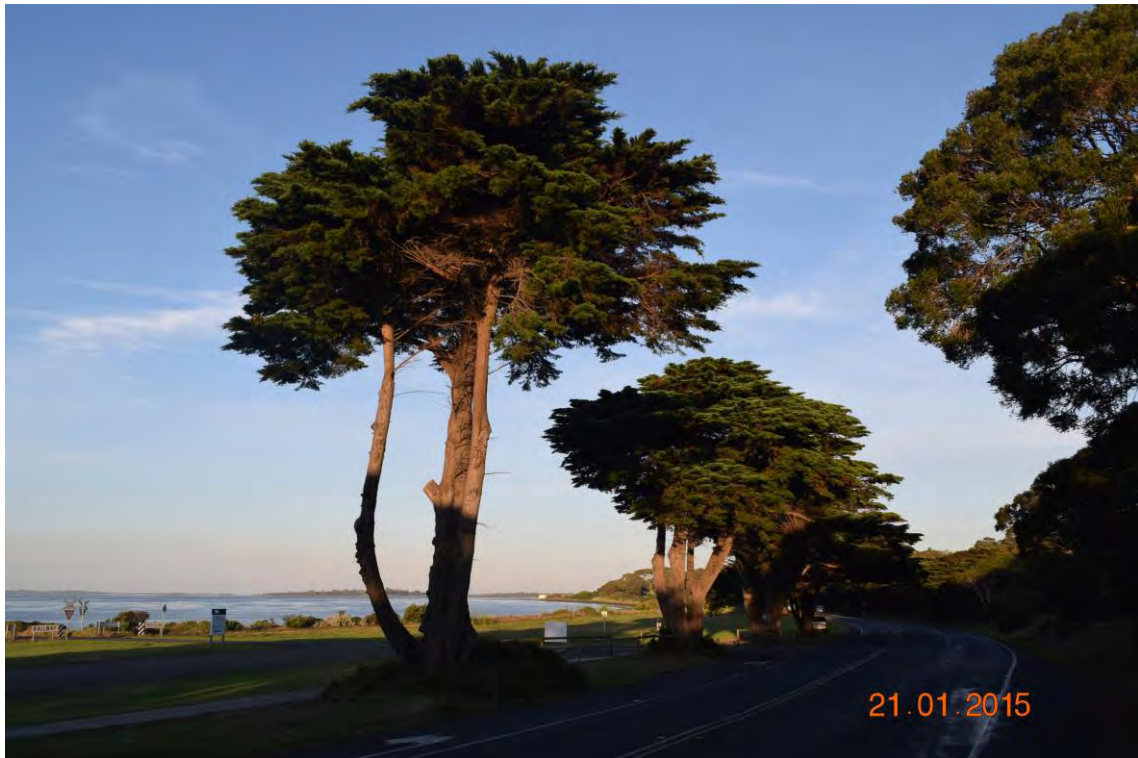
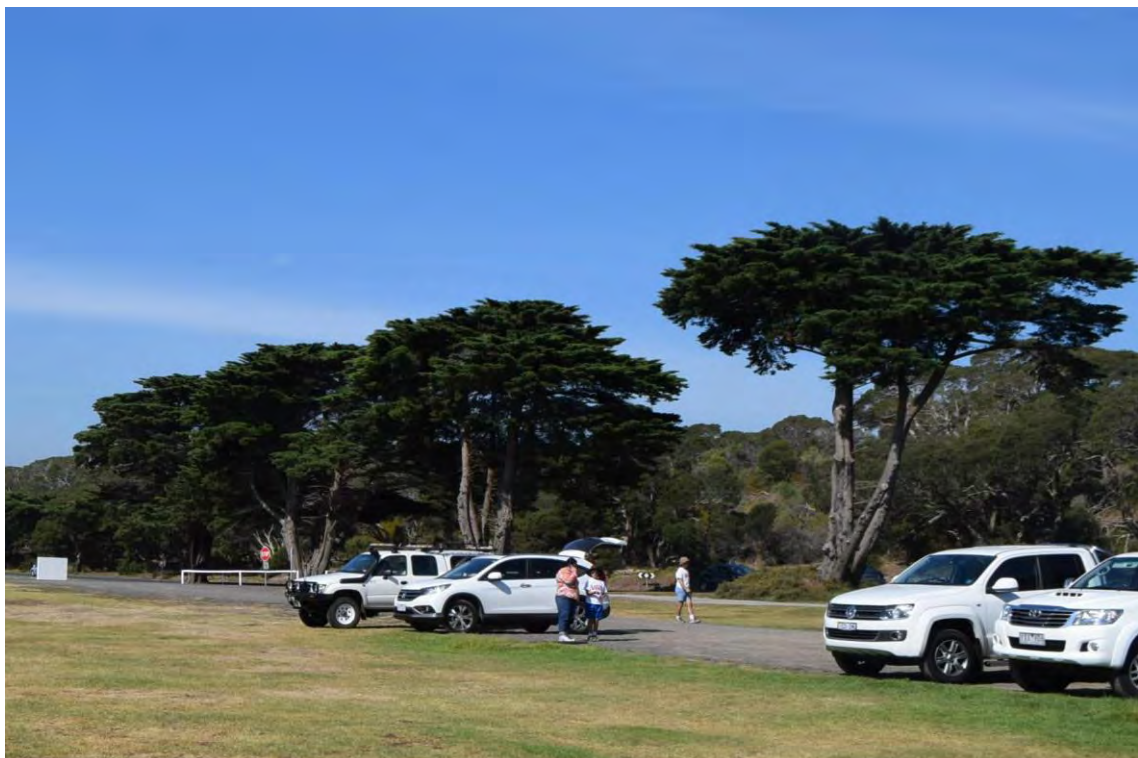
Figure 31: Trees 45-48, looking east along the Bellarine Highway. Tree 48 is in the foreground.

Figure 32: Trees 45-48, looking south east along the Bellarine Highway from the Marine Discovery Centre.

These trees are currently in fair health for their age and location in the landscape. The trees are showing signs of *Seiridium* infection, with a thinning canopy and discoloration of foliage. There is moderate deadwood in the crown which is typical for a tree of this age.

Tree health has been impacted by root zone soil compaction, from the Bellarine Highway on one side and the Bellarine rail trail (paved path) on the other. The trees are exposed to coastal winds from Swan Bay. 3 of the 4 trees have poor structure due to heavy canopy uplift pruning, presumably due to past branch failures or structural defects.

Hanging branch removal is recommended for 1 tree. Tree 48 has a ULE of less than 5 years and is recommended for removal within the next 2-4 years. The codominant stems, heavy trunk decay and lack of foliage on lower branches leave this tree more susceptible to failure under adverse weather conditions.

The trees should be inspected annually to assess safety and determine maintenance requirements.

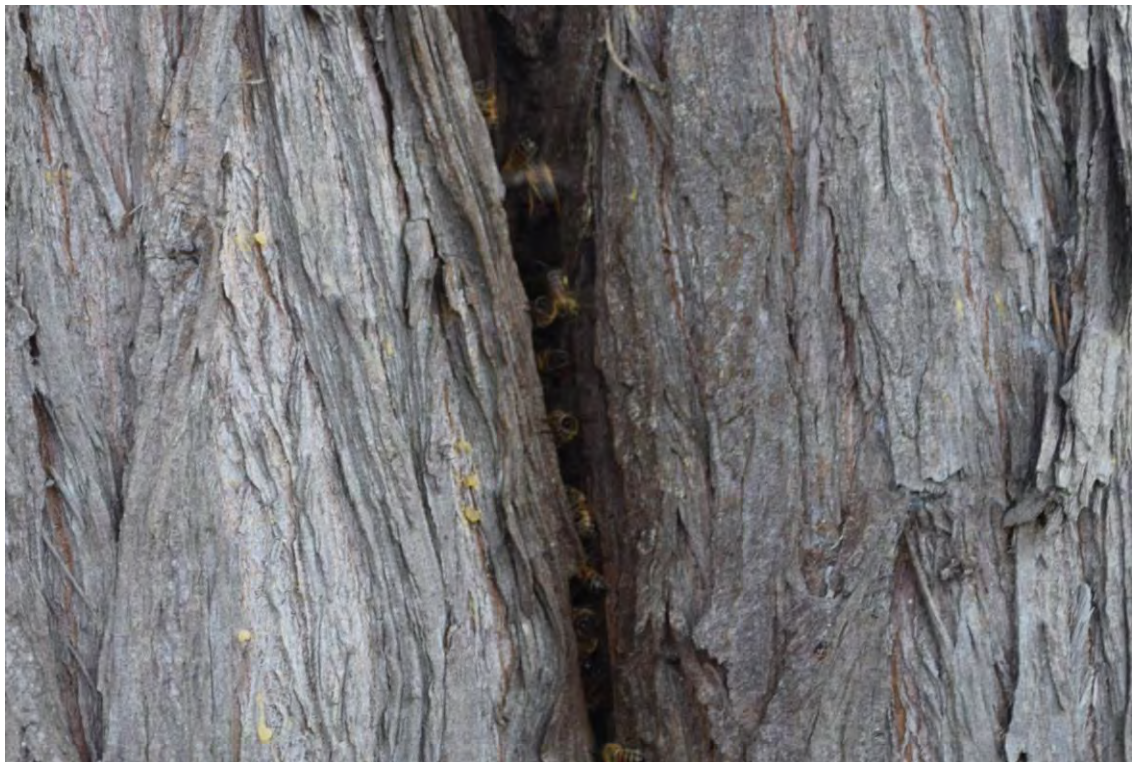
Figure 33: The presence of bees in the trunk of Tree 48 is indicative of an internal cavity from decay.

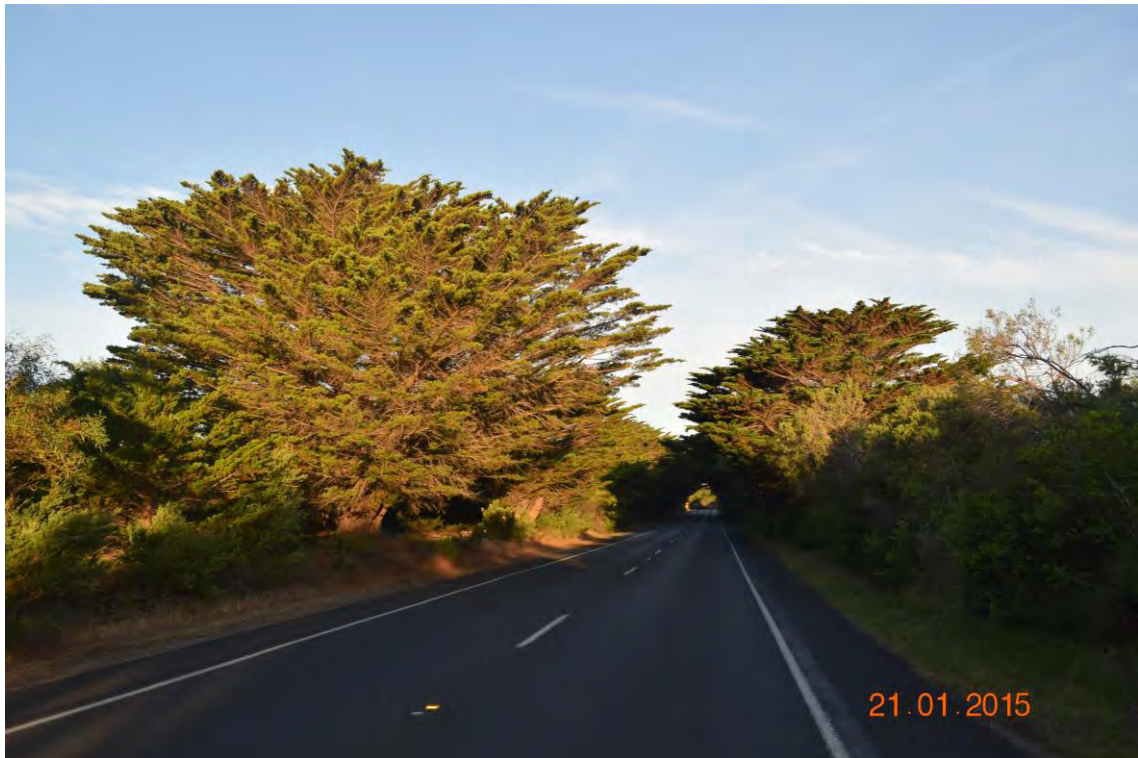
Most of these trees are in fair health, exhibiting an adequate canopy of foliage with minor deadwood present in the crown. Canopy discoloration is indicative of *Seiridium* spp. infection in these trees. The trees all have fair or good structure, generally with a well-balanced crown and branch unions showing only minor structural faults. Individual branch removal is recommended for 1 tree.

Figure 35: Trees 50-77, looking east along the Bellarine Highway.
Tree 66 is in the foreground on the LHS of the photo and Tree 67 in the RHS.

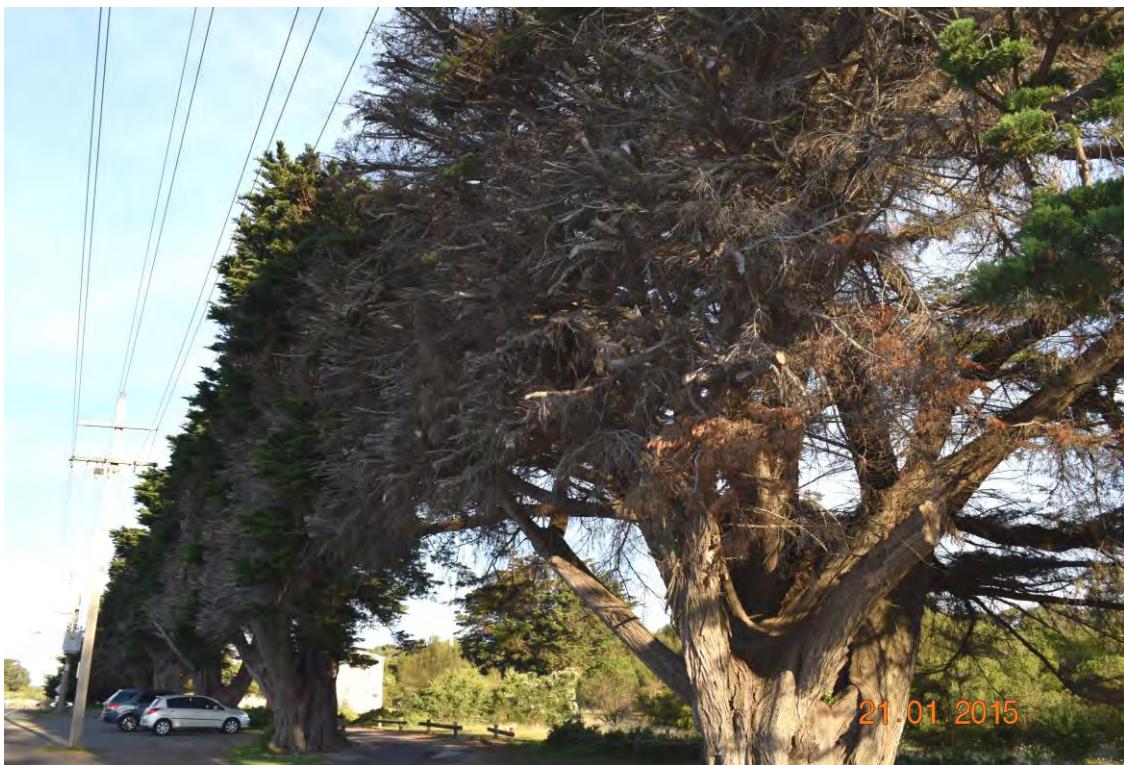
The majority of these trees are currently in fair health for their age and location in the landscape. Some trees are of poor health due to canopy lopping for high voltage power line clearance and in particular, Trees 100-104 have been heavily lopped resulting in excessive deadwood through the canopy (Figure 41). Monterey Cypress will not re-grow foliage from bare wood, and this has dramatically altered the aesthetics at the western end of the row.

Figure 41: High voltage power line clearance offsets has involved pruning the trees back to bare wood.

- Fit insulating covers on sections of conductor where vegetation is within the clearance space;
- Replace bare high voltage and/or low voltage conductors with high voltage or low voltage Aerial Bundle Cable (ABC);
- Underground installation;
- Relocate poles;
- Install offset cross arms.

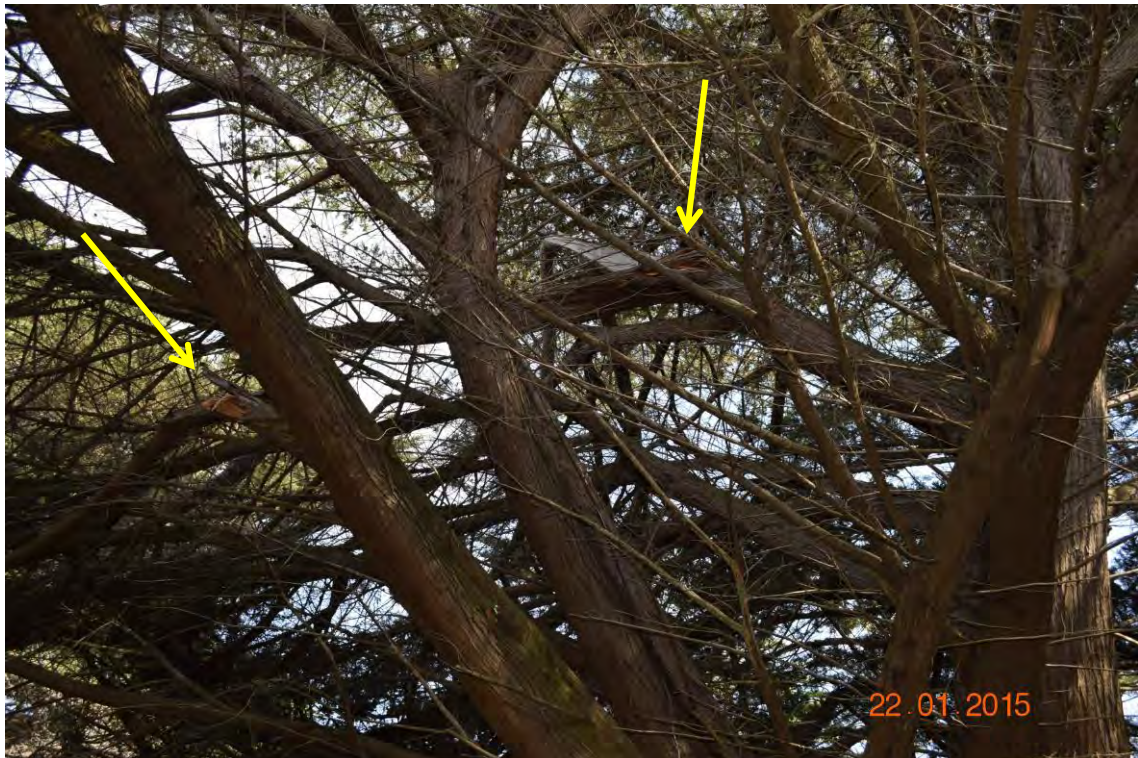
Figure 42: Many of the trees in this row have cracked or hanging branches above the shared path.

Risk reduction pruning of extended, end weighted limbs over the shared path and removal of broken and hanging branches over the path and parking areas is recommended (Figure 42). Trees 83, 94 and 104 have major structural defects including active trunk splits and/or major canopy splits and these trees are recommended for removal (Figure 43).

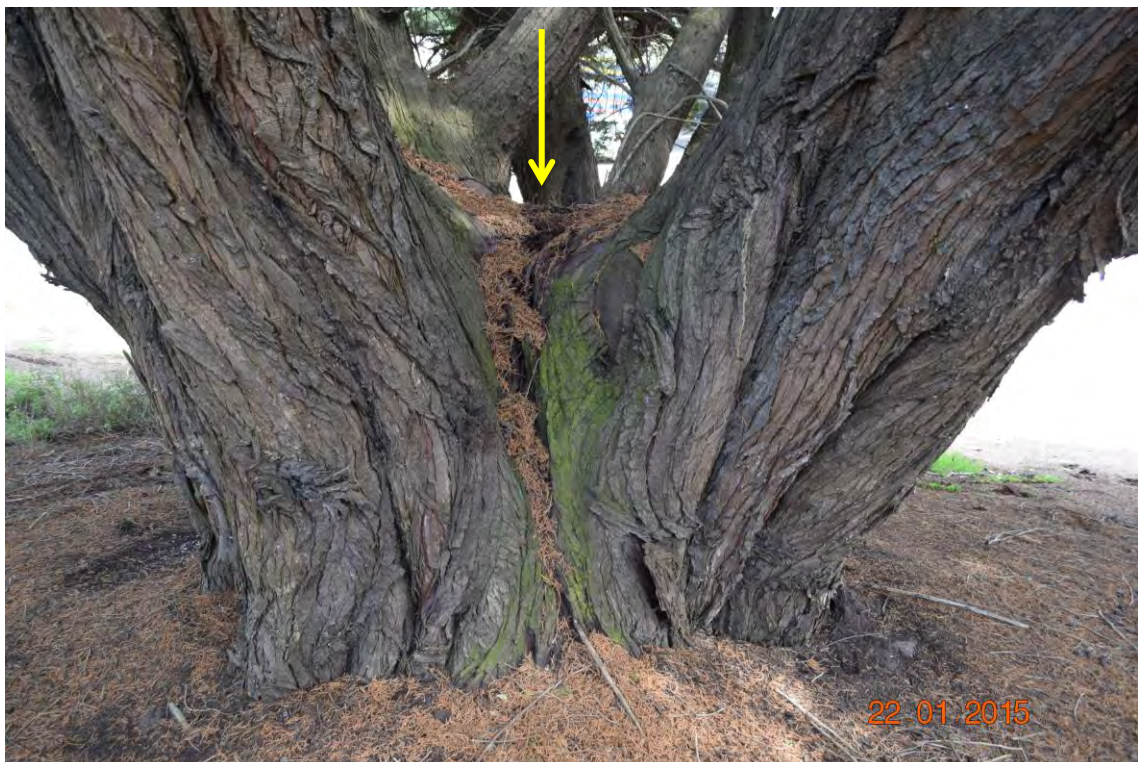
Figure 43: Tree 83 has an active split of the codominant trunks.
This tree is recommended for removal.

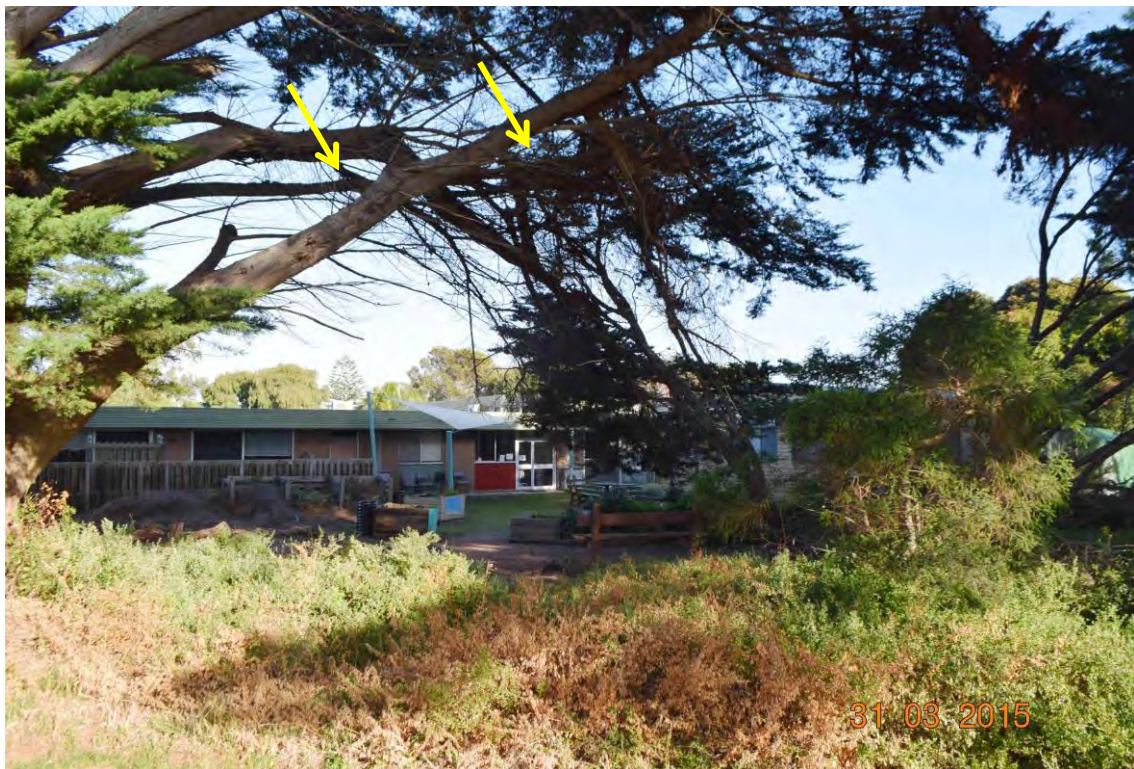
In general, these trees are of fair health and structure and appear typical examples of the species at maturity. All of these trees contain a moderate amount of deadwood in the canopy and there is evidence of small and moderate sized branch failures. Broken branch removal and risk reduction is recommended for one tree with defective branches above a park bench and an informal gravel path.

Figure 47: Tree 107 has broken and extended limbs above a park bench.

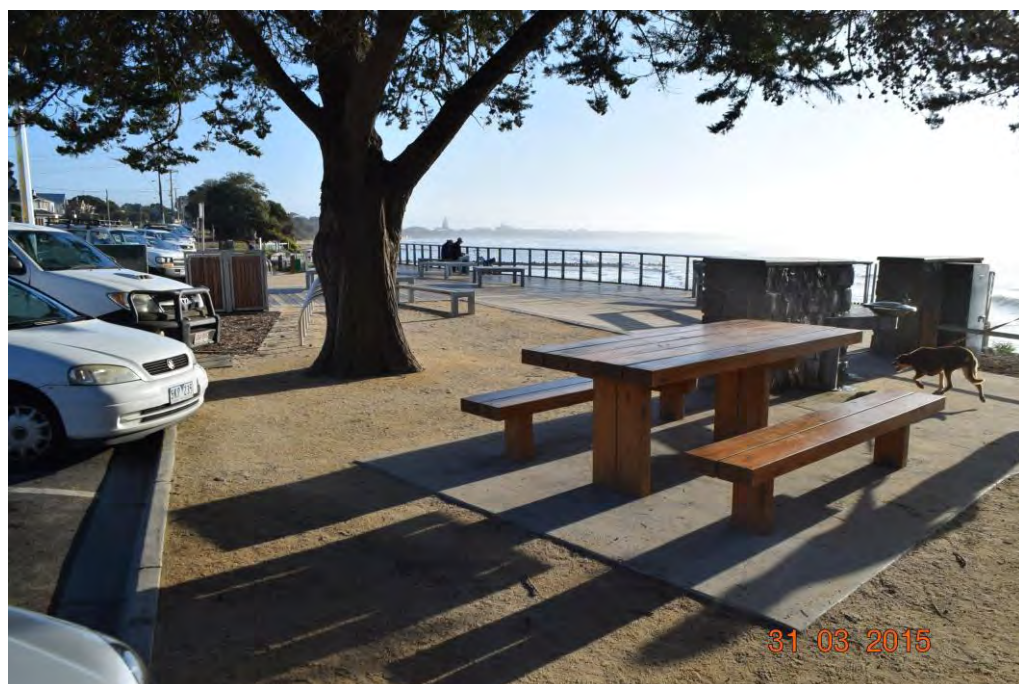
Figure 51: High pedestrian and vehicle traffic around Trees 111 (shown) and 112 has compacted soils.

These trees are in fair health and have fair structure, both being typical examples of the species at maturity. The canopy of both trees is thinning and this is most likely due to soil compaction in the root zone, with heavy vehicle and pedestrian traffic around both of the trees (Figure 51).

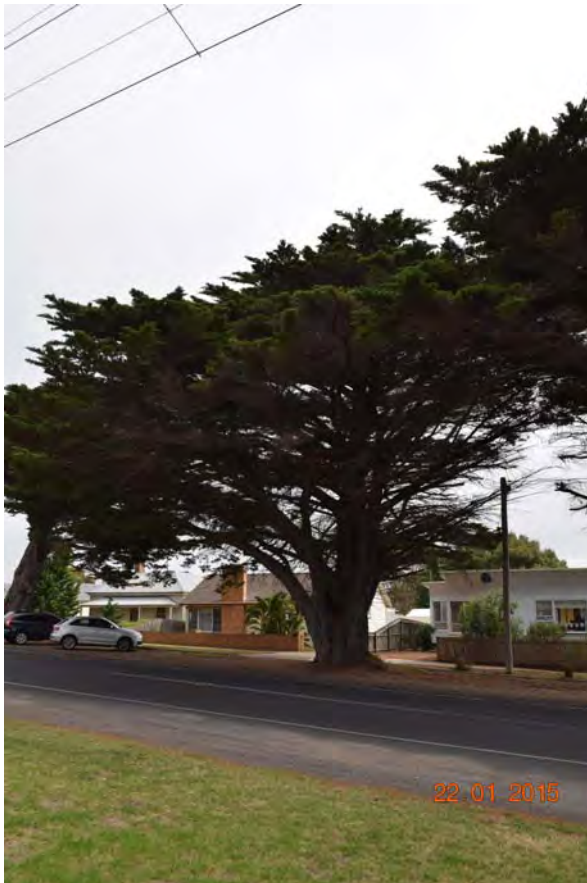
Location: Flinders St
Easting: 294459.67
Northing: 5761568.25
Estimated year planted: 1945
Estimated Age: 70

Recommended Works: Individual branch removal
Priority: Moderate
Inspection Regime: Annual
Adjacent Infrastructure: Flinders St, Concrete driveways, Concrete footpath
Comments: Remove damaged branch over road

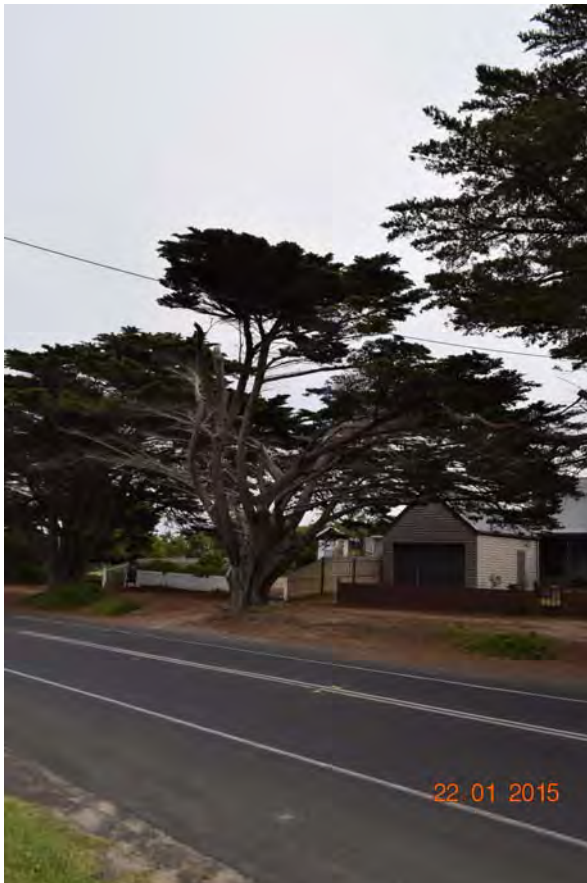
Location: Flinders St
Easting: 294295.71
Northing: 5761619.07
Estimated year planted: 1945
Estimated Age: 70

Recommended Works: Removal
Priority: Low
Inspection Regime: Annual
Adjacent Infrastructure: Flinders St, Gravel driveway, Gravel path
Comments:

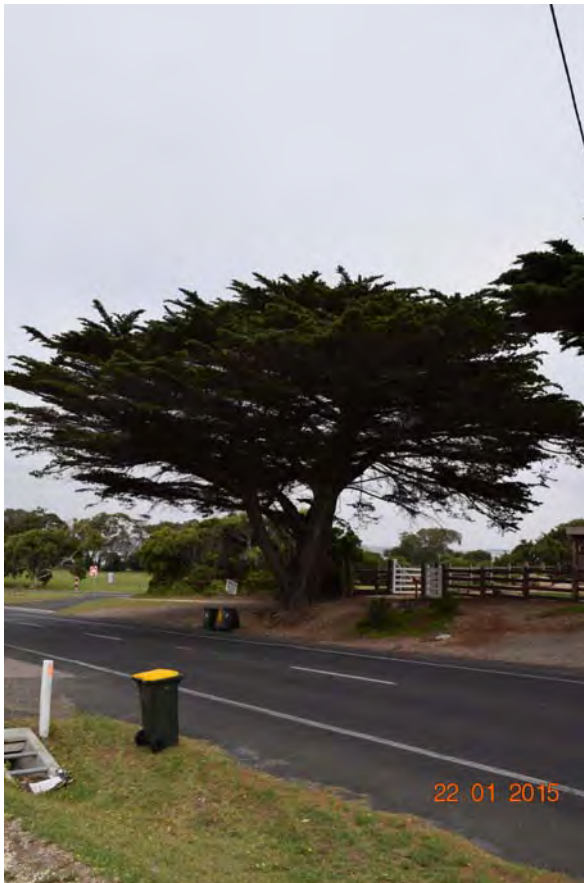
Location: Flinders St
Easting: 294194.59
Northing: 5761614.35
Estimated year planted: 1945
Estimated Age: 70

Recommended Works: Individual branch removal
Priority: Moderate
Inspection Regime: Annual
Adjacent Infrastructure: Flinders St, Gravel driveway, Gravel path
Comments: Remove damaged branch above driveway

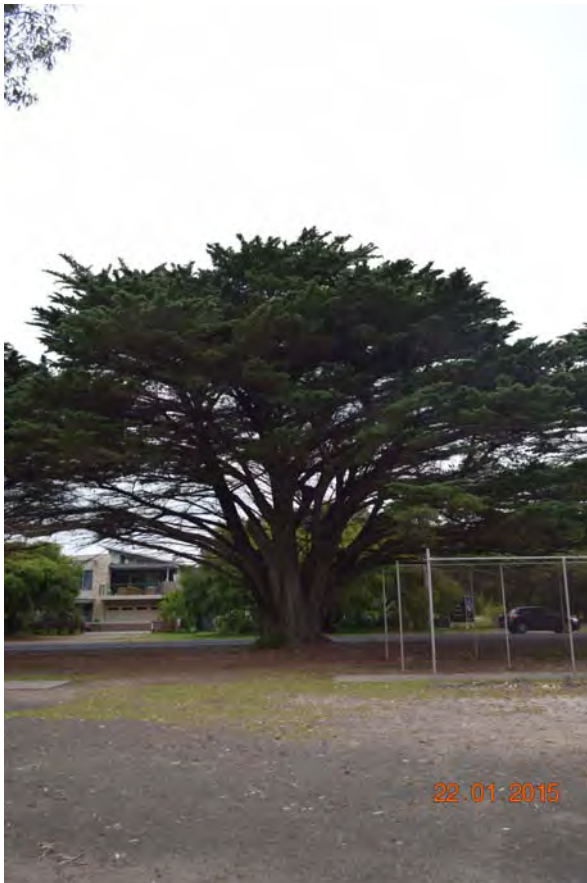
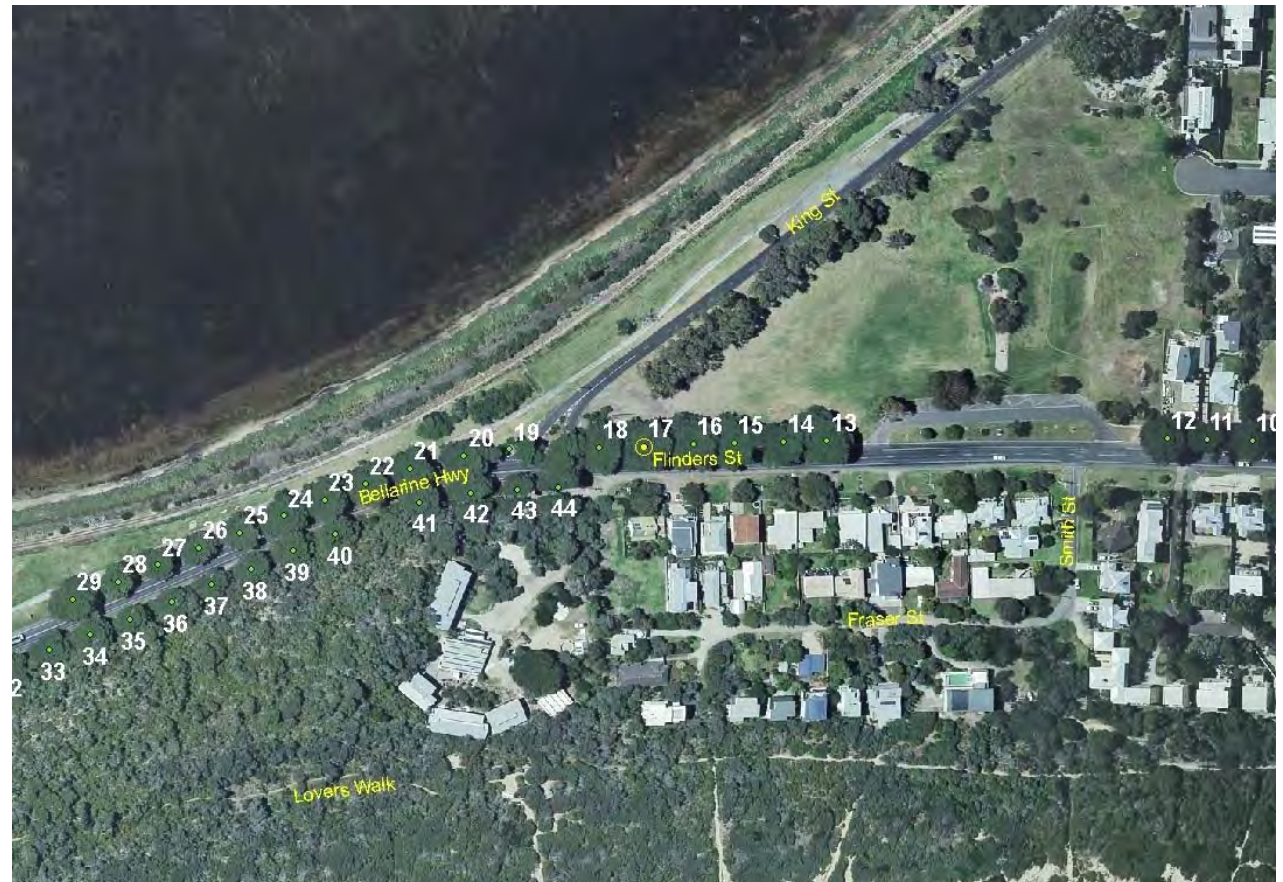
Recommended Works: No works
Priority: None
Inspection Regime: Annual
Adjacent Infrastructure: Bellarine Hwy, Informal roadside parking, Batting cage
Comments: Small hanging branch, no target

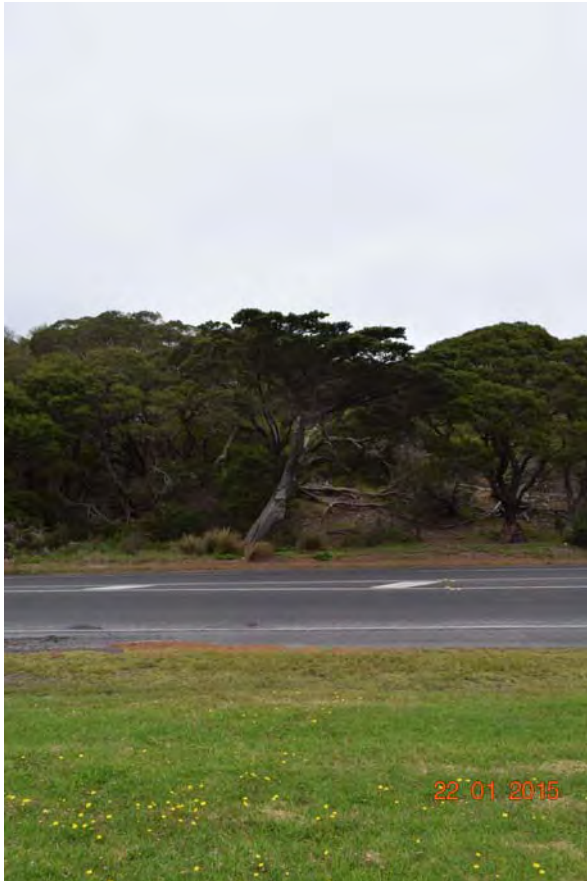
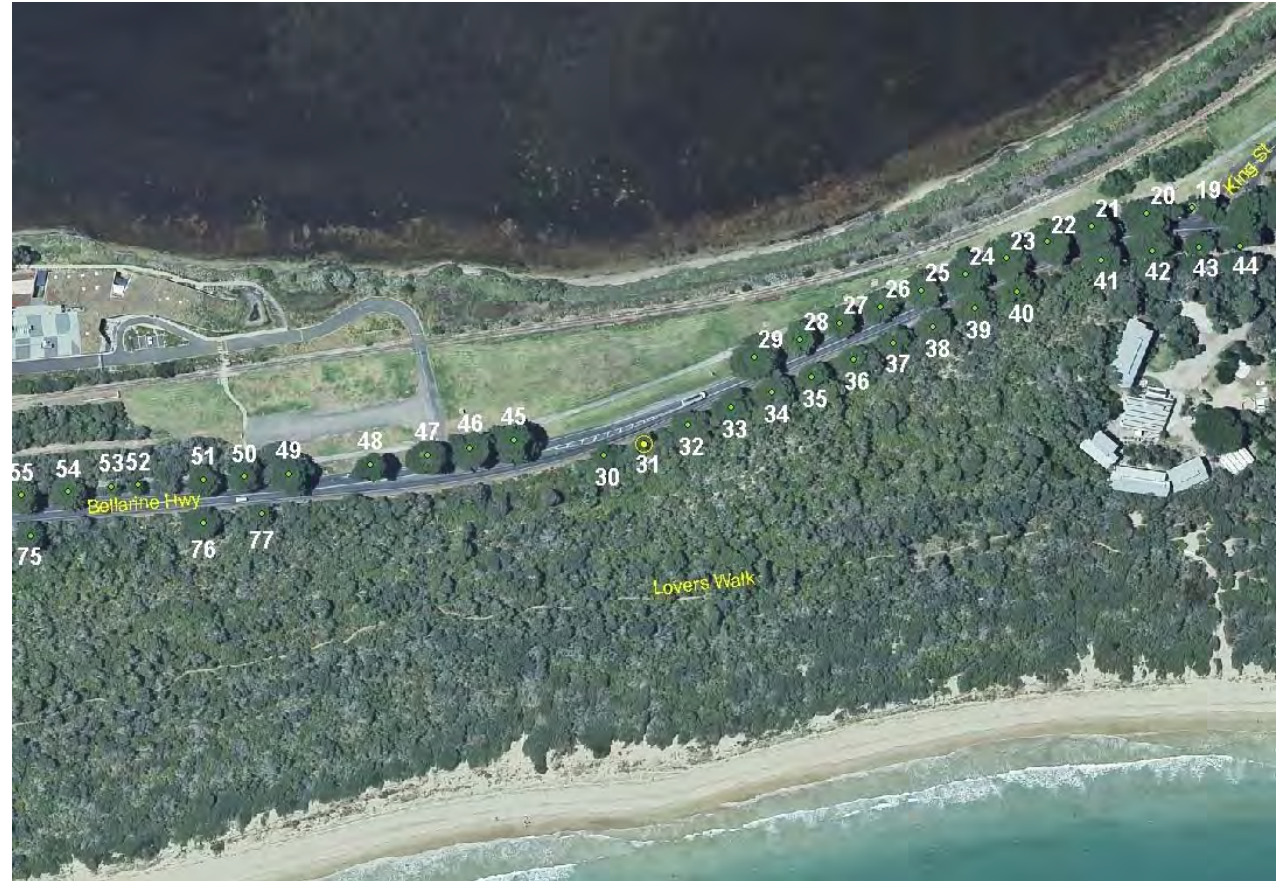
Recommended Works: No works
Priority: None
Inspection Regime: Annual
Adjacent Infrastructure: Bellarine Hwy, Coastal Moonah Woodland
Comments: Heavily uplited

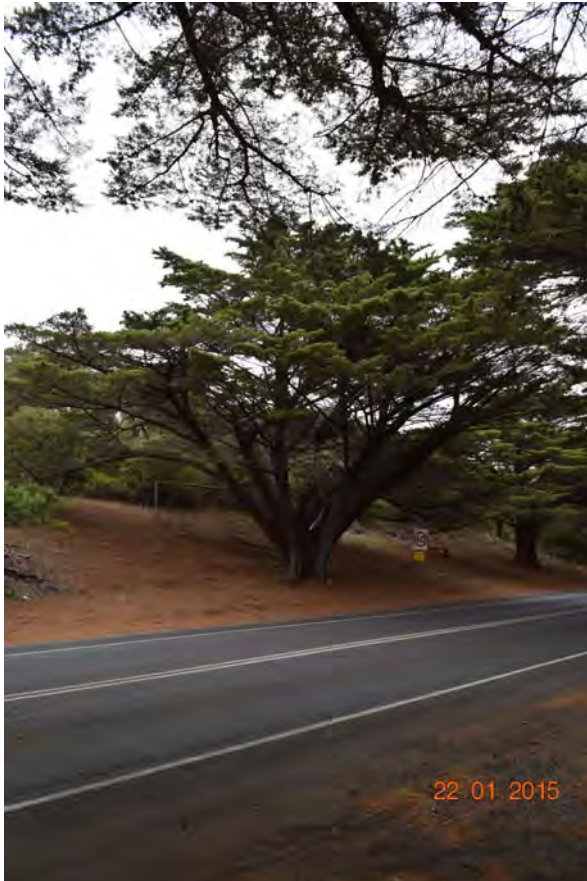
Recommended Works: Risk reduction pruning
Priority: Moderate
Inspection Regime: Annual
Adjacent Infrastructure: Bellarine Hwy, Coastal Moonah Woodland
Comments: Reduce extended limbs over road

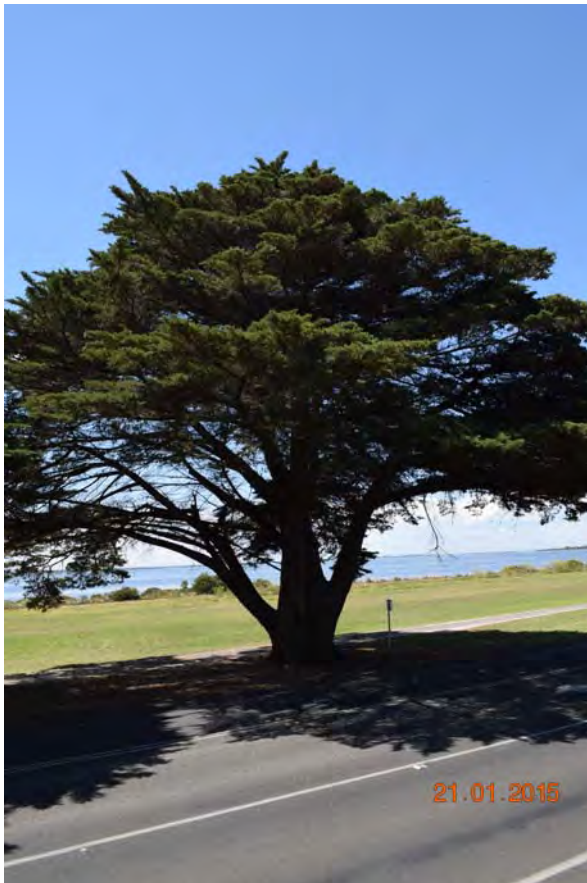
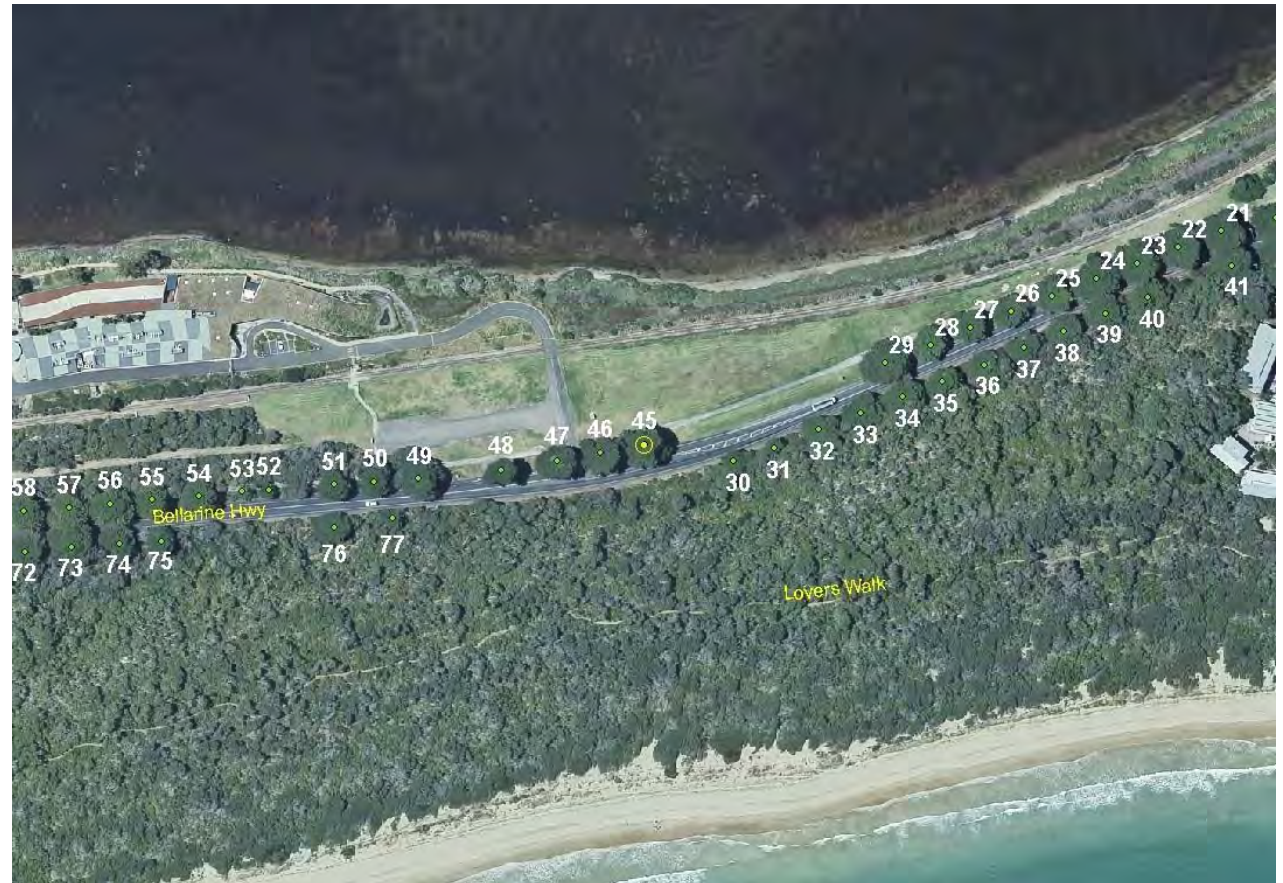
Recommended Works: Broken and hanging branch removal
Priority: Moderate
Inspection Regime: Annual
Adjacent Infrastructure: Surfaced path, Lawn, Bellarine Hwy
Comments:
