Avenue of Honour Tree Management and Replacement Plan

Homewood Consulting Pty Ltd

May 2015

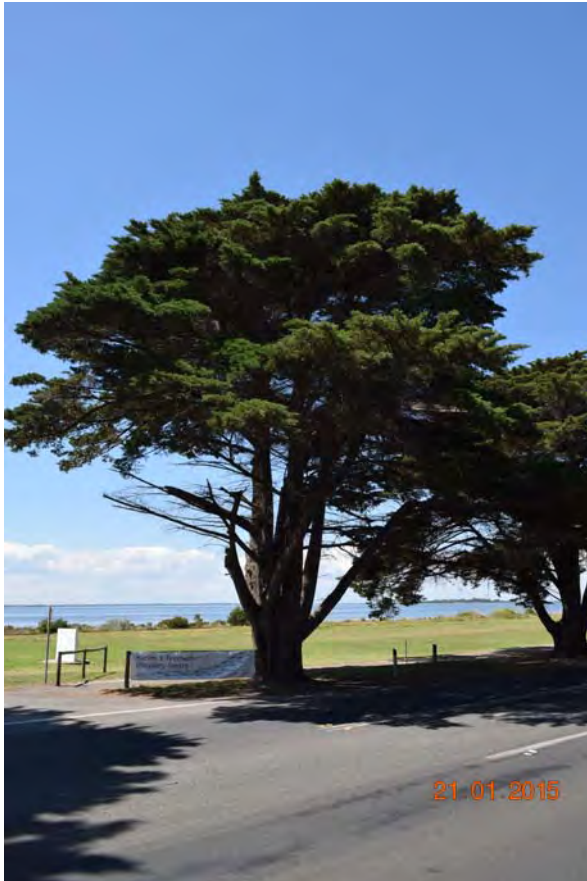
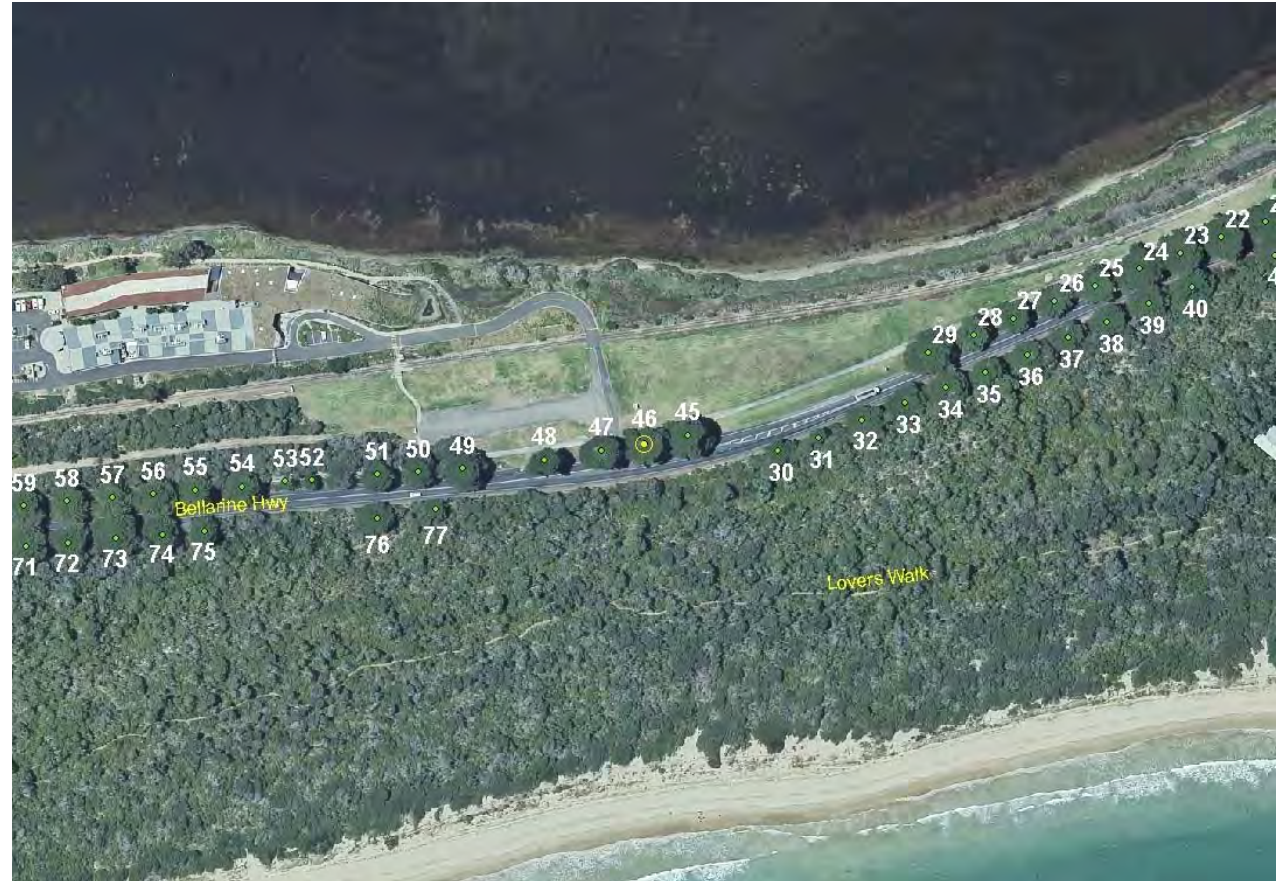
Recommended Works: No works
Priority: None
Inspection Regime: Annual
Adjacent Infrastructure: Surfaced path, Lawn, Bellarine Hwy, Marine Discovery access
Comments: Heavily uplifted

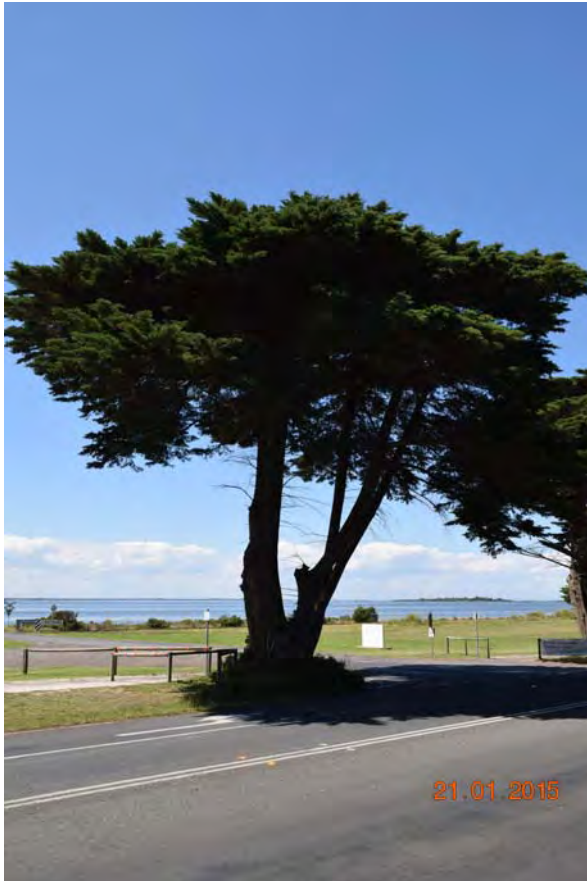
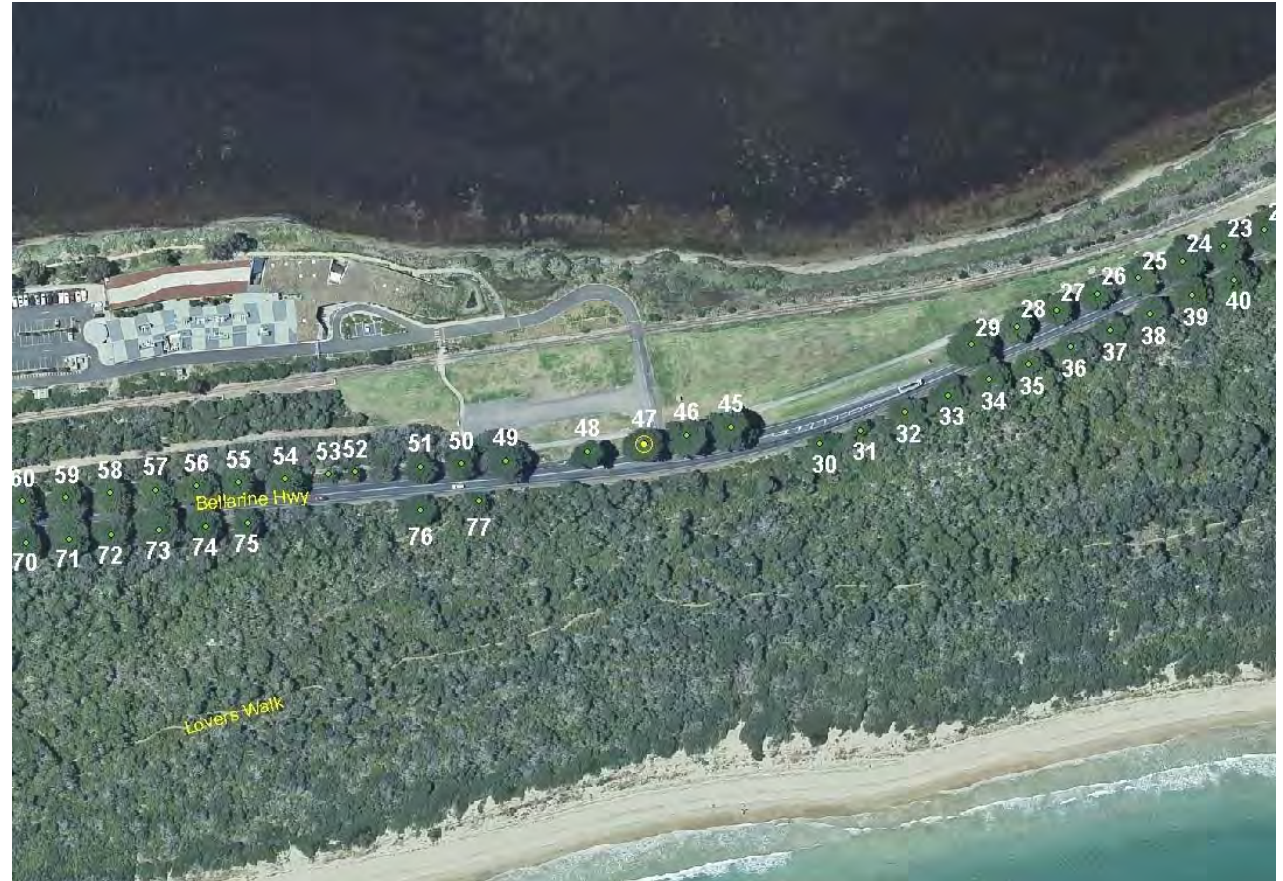
Recommended Works: No works
Priority: None
Inspection Regime: Annual
Adjacent Infrastructure: Surfaced path, Lawn, Bellarine Hwy, Marine Discovery access
Comments: Heavily uplifted

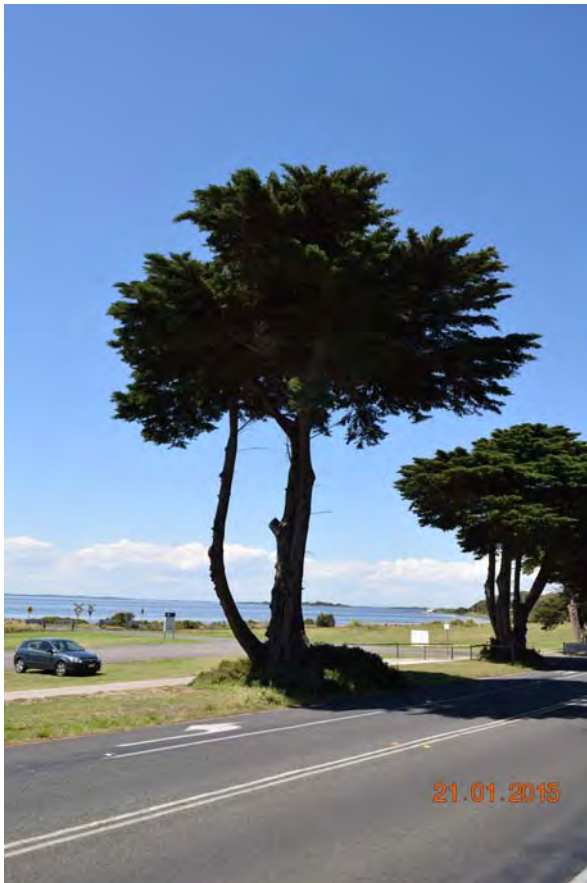
Recommended Works: Removal
Priority: Low
Inspection Regime: Annual
Adjacent Infrastructure: Surfaced path, Lawn, Bellarine Hwy
Comments: Heavily uplifted, Bee hive in trunk

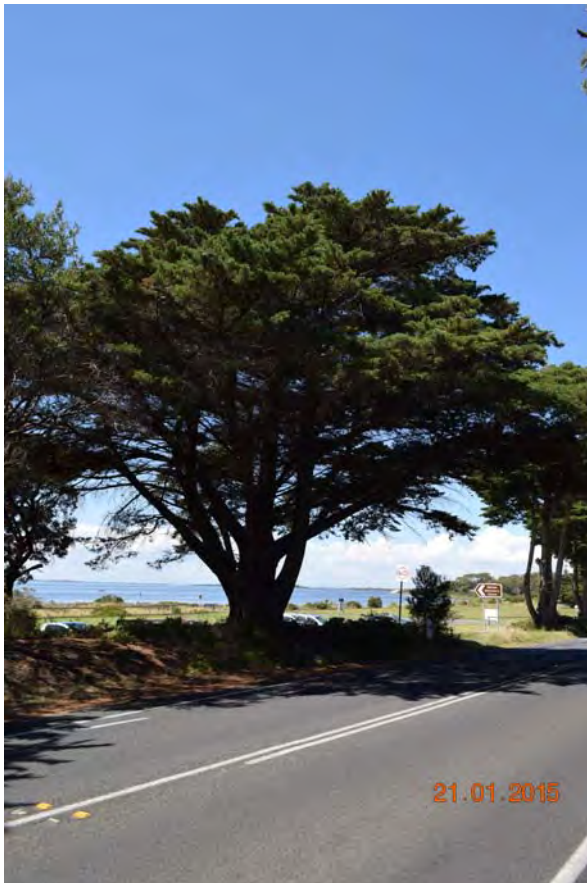
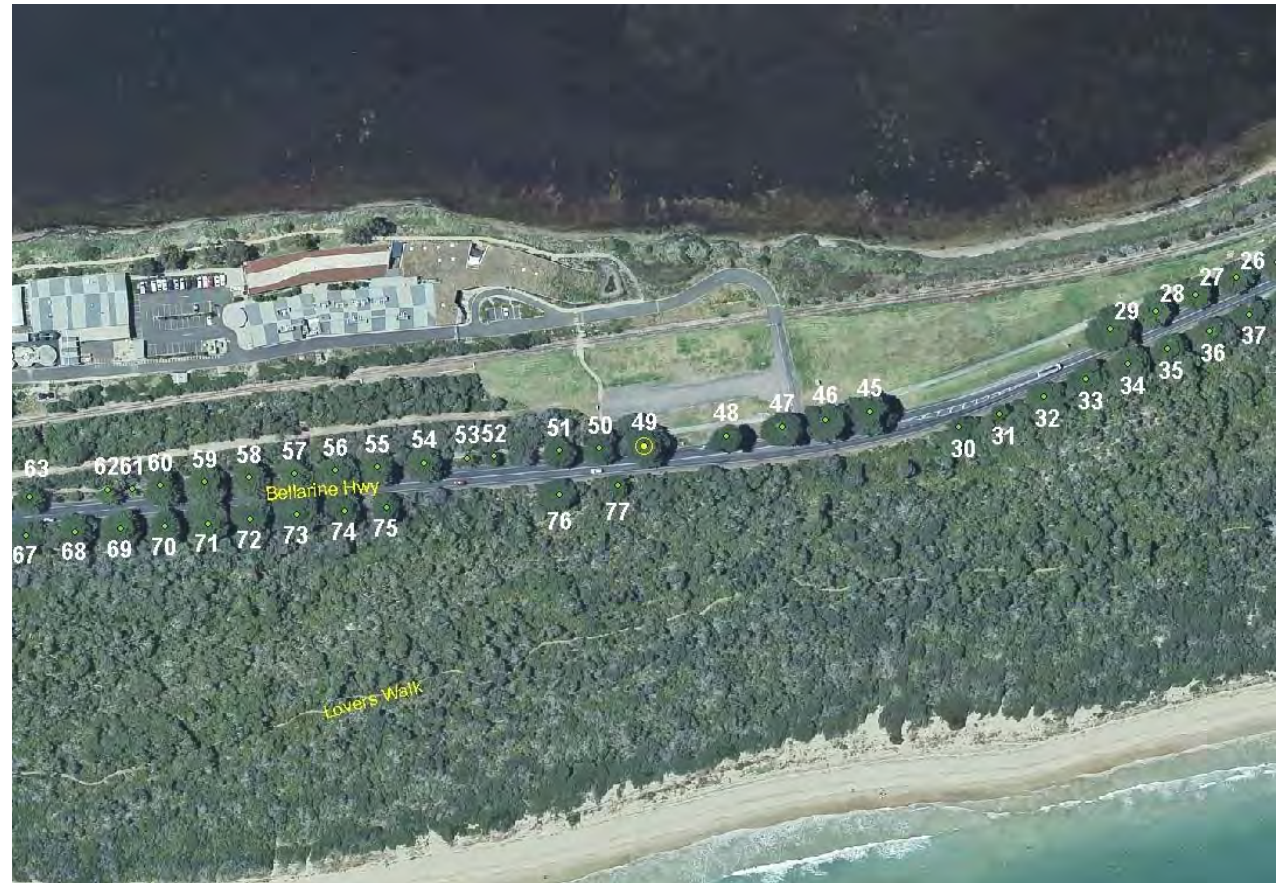
Recommended Works: No works
Priority: None
Inspection Regime: 3-5 years
Adjacent Infrastructure: Bitumen path, Bellarine Hwy, Coastal Moonah Woodland
Comments: Branch above road hit by vehicle

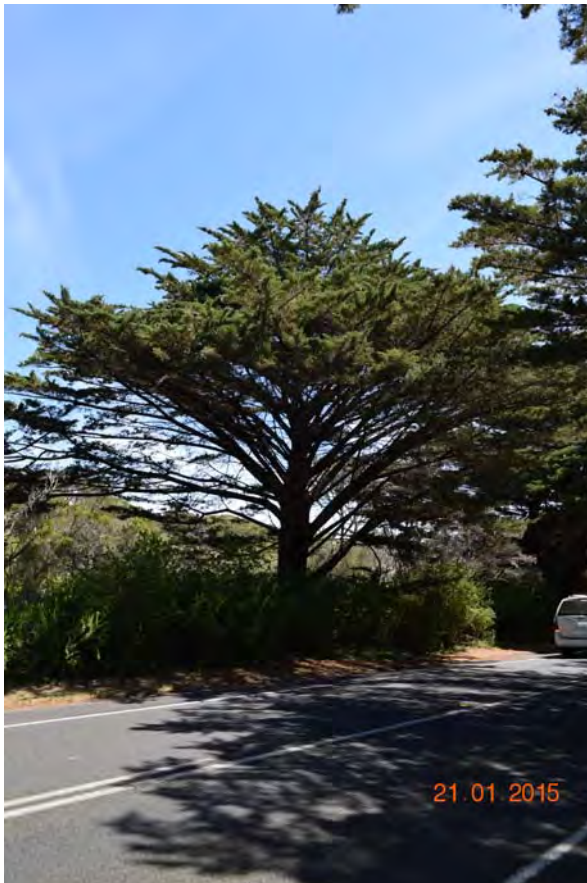
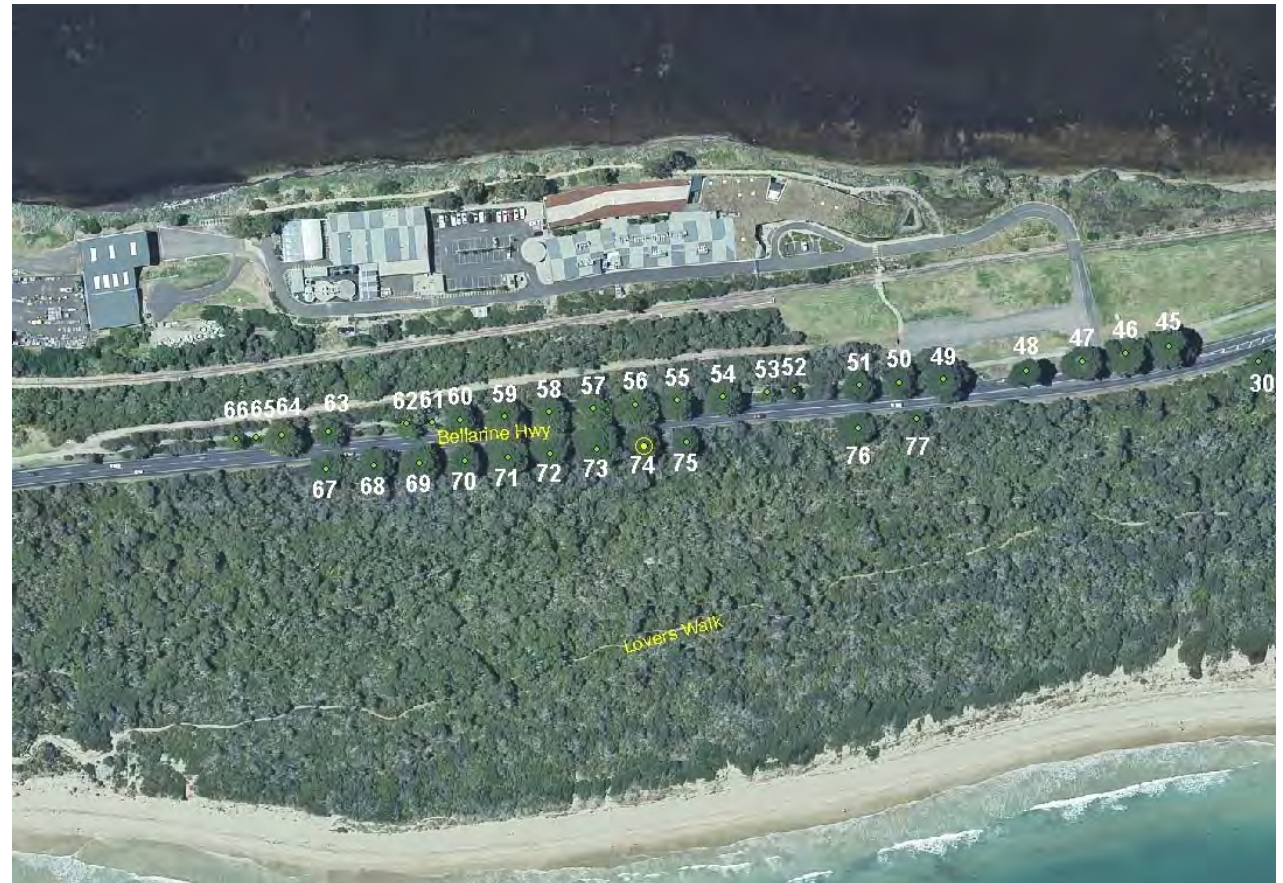
Location: The Narrows - western extent
Easting: 293347.01
Northing: 5761461.31
Estimated year planted: 1965-75
Estimated Age: 40-50

Recommended Works: No works
Priority: None
Inspection Regime: 3-5 years
Adjacent Infrastructure: Bellarine Hwy, Coastal Moonah Woodland
Comments: DBH estimated

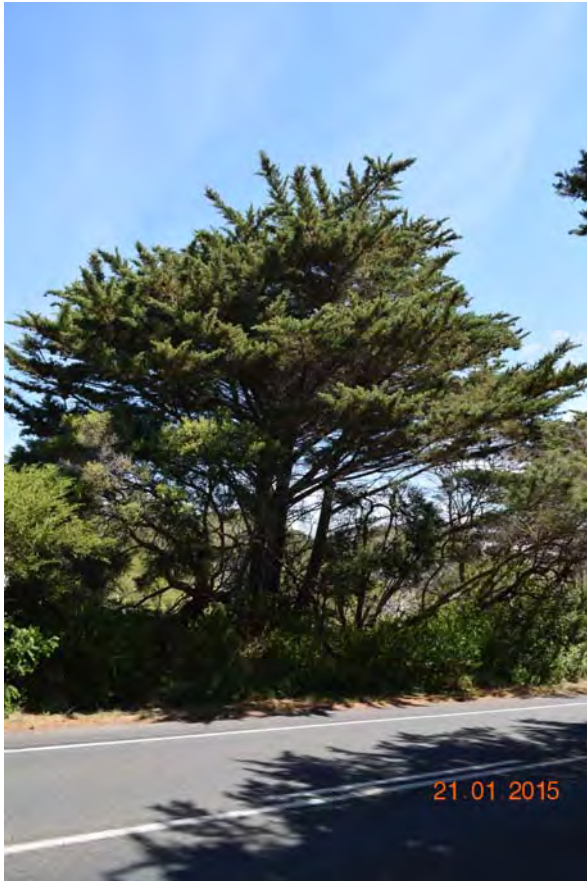
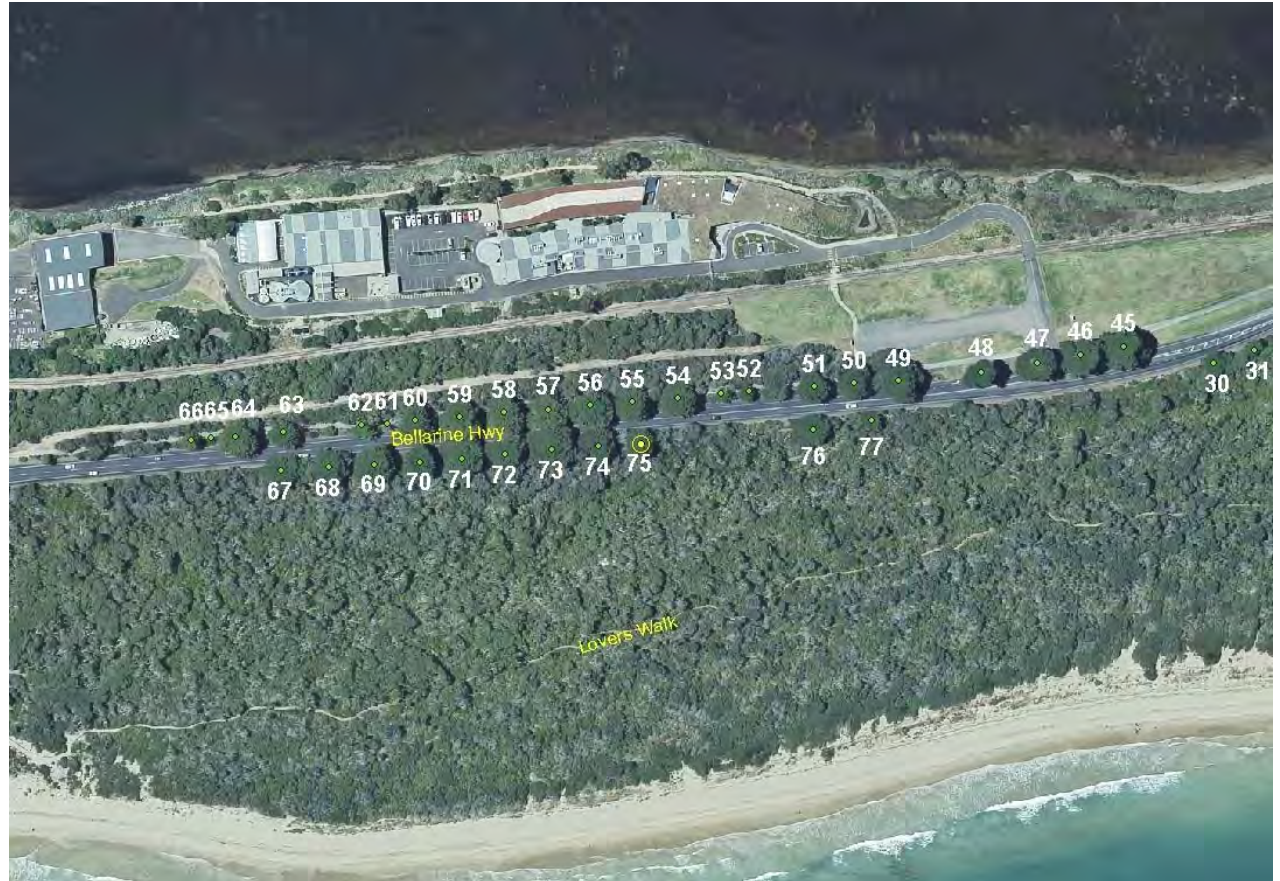
Location: The Narrows - western extent
Easting: 293363.64
Northing: 5761460.41
Estimated year planted: 1965-75
Estimated Age: 40-50

Recommended Works: No works
Priority: None
Inspection Regime: 3-5 years
Adjacent Infrastructure: Bellarine Hwy, Coastal Moonah Woodland
Comments: DBH estimated

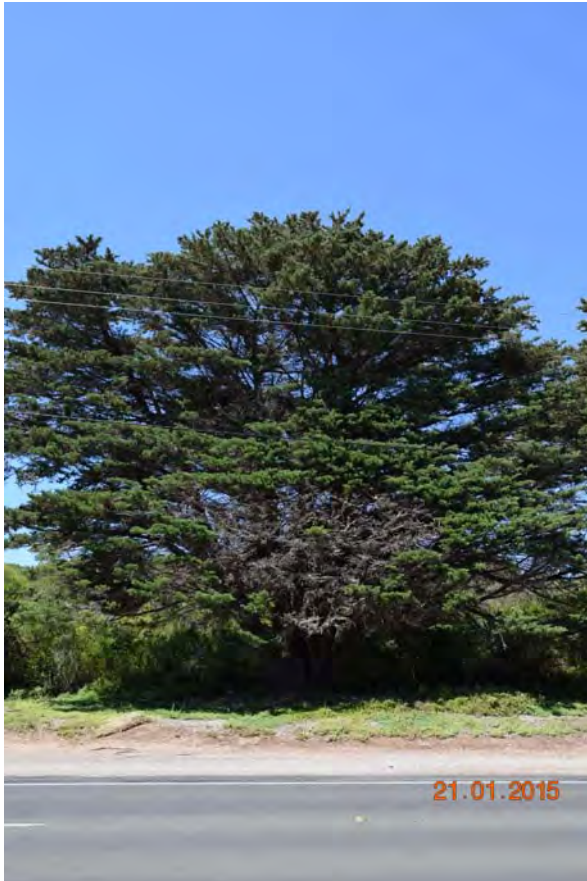
Recommended Works: Broken and hanging branch removal
Priority: High
Inspection Regime: Annual
Adjacent Infrastructure: High Voltage powerlines, Bitumen footpath
Comments: Broken branch above path

A number of trees assessed have hanging branches, that is unattached, cut or broken branches caught in the canopy (Australian Standards, 2007). Hanging branches can pose a substantial hazard and even branches as thin as 50mm in diameter can be considered serious if they have a long, clear route of fall (Lonsdale 1999). If a branch has snapped or cracked across the grain, any hanging or dead attached portion which could place people or property at risk should be removed (Lonsdale 1999).

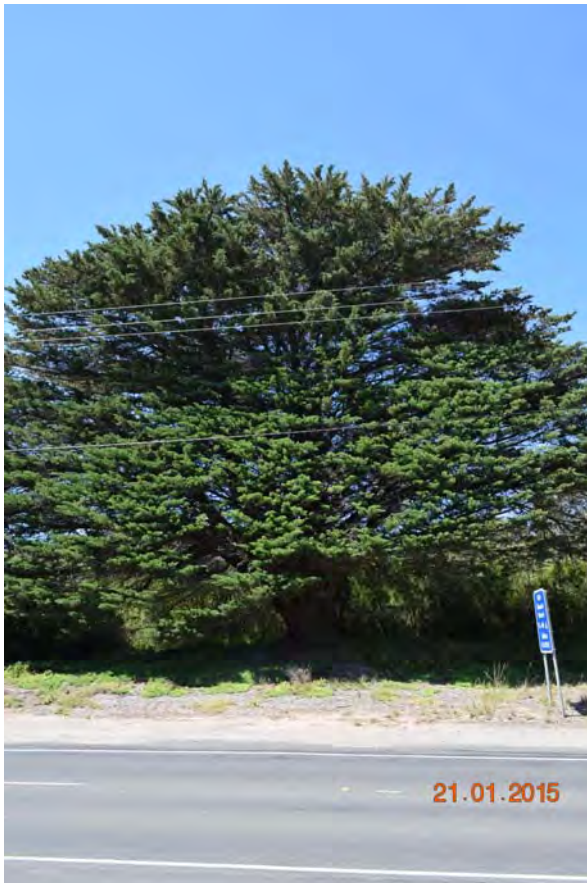
Recommended Works: Broken and hanging branch removal
Priority: High
Inspection Regime: Annual
Adjacent Infrastructure: High Voltage powerlines, Bitumen footpath
Comments: Multiple hanging branches above path

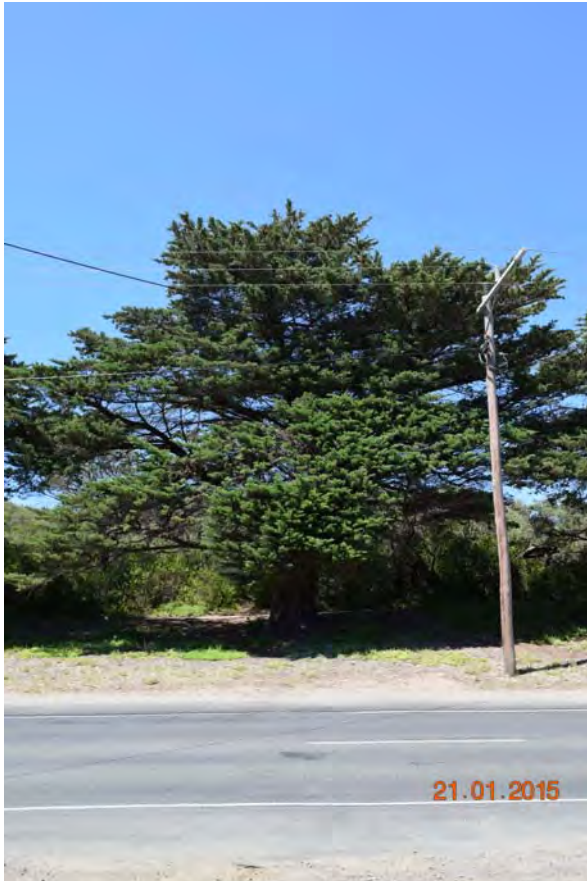
Recommended Works: Broken and hanging branch removal
Priority: High
Inspection Regime: Annual
Adjacent Infrastructure: High Voltage powerlines, Bitumen footpath
Comments: Broken branch above path

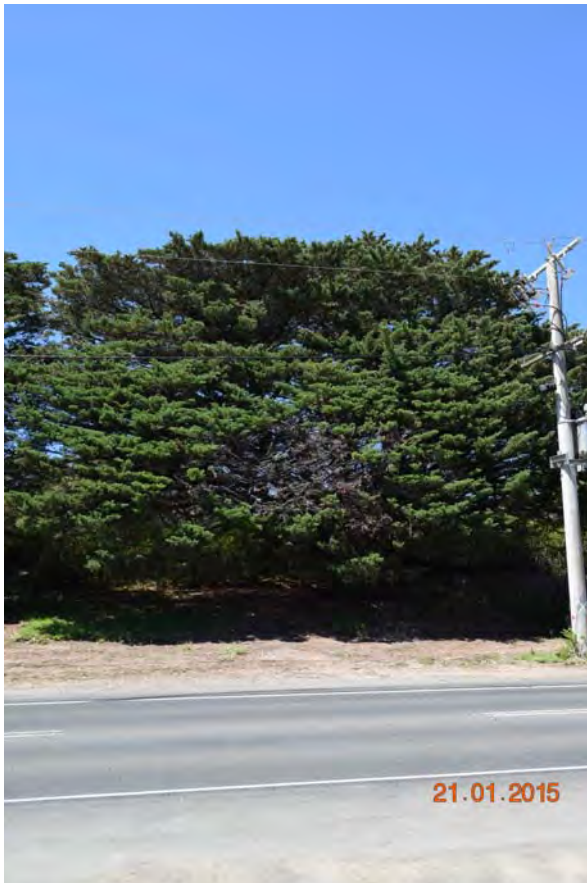
Recommended Works: Removal
Priority: Moderate
Inspection Regime: Annual
Adjacent Infrastructure: High Voltage powerlines, Bitumen footpath
Comments: Active split between trunks

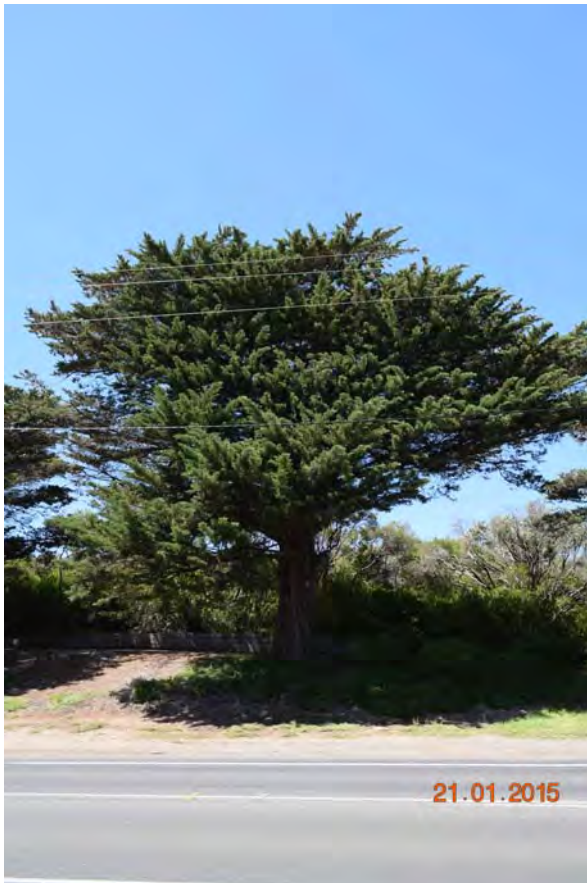
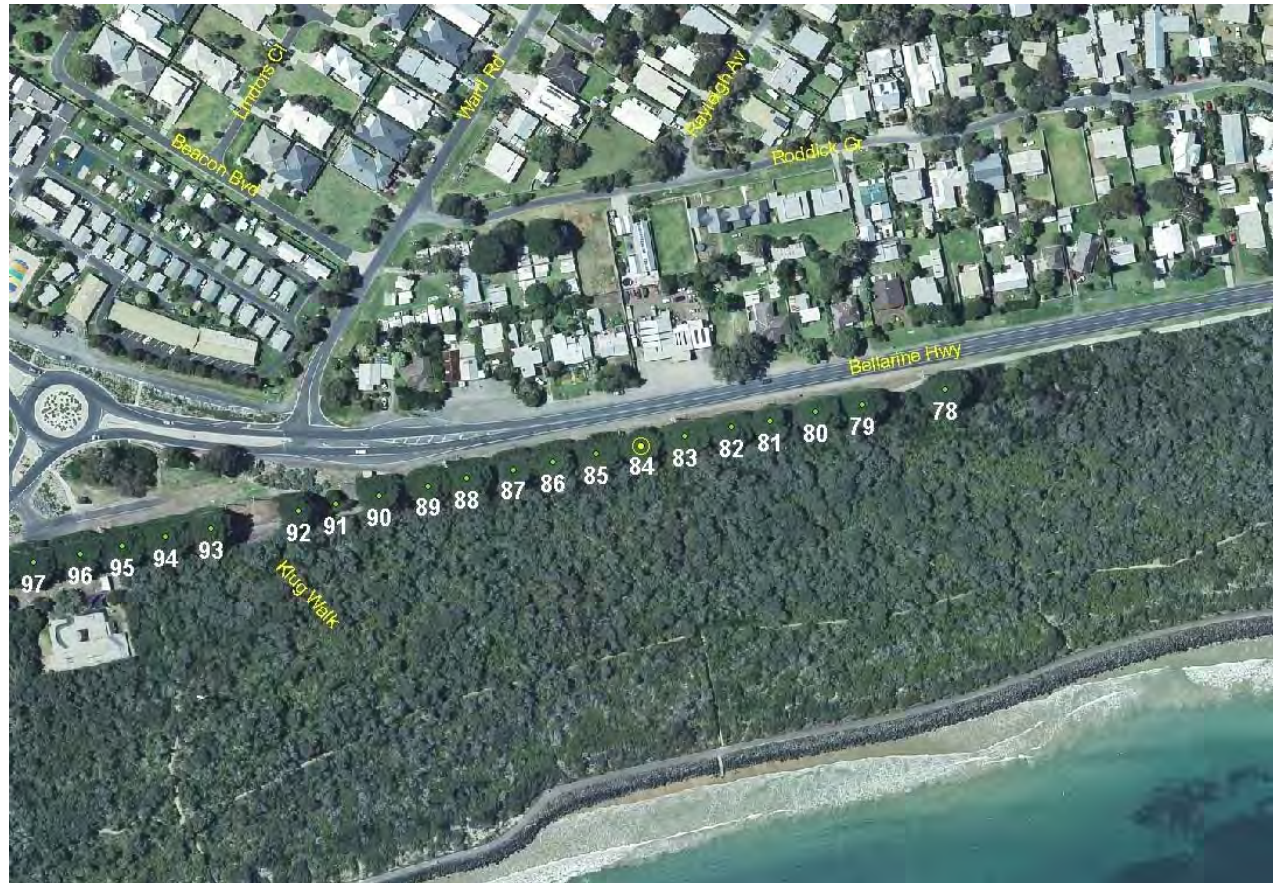
Recommended Works: Broken and hanging branch removal
Priority: High
Inspection Regime: Annual
Adjacent Infrastructure: High Voltage powerlines, Bitumen footpath
Comments: Hanging branch above path

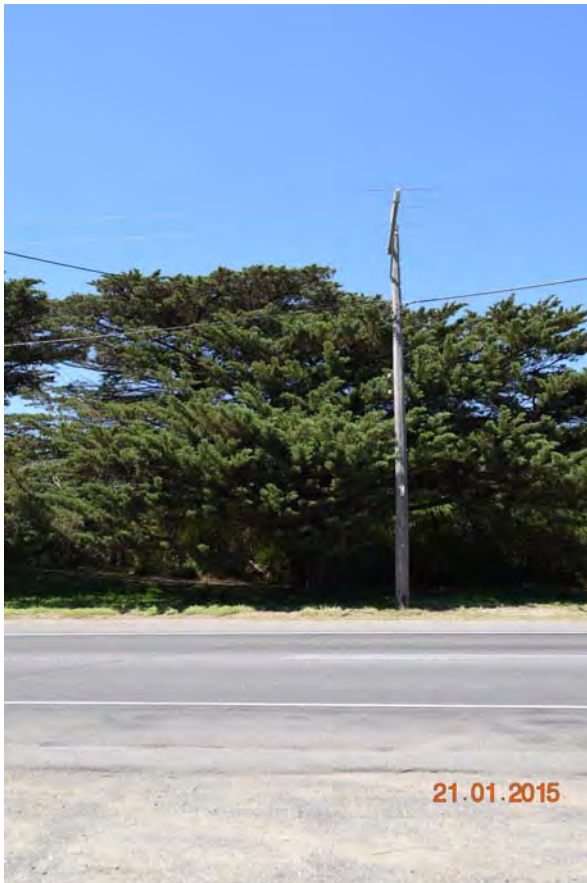
Recommended Works: Risk reduction pruning
Priority: Moderate
Inspection Regime: Annual
Adjacent Infrastructure: High Voltage powerlines, Bitumen footpath
Comments: Reduce extended limbs over path

Canopy, branch or stem reduction pruning of overextended limbs can reduce the possibility of failure. The aim is the selective pruning of long and extended branches starting in the 3rd order branching, back to a shorter, more compact growing point. This reduces the overall weight, length and leverage on the branch union.

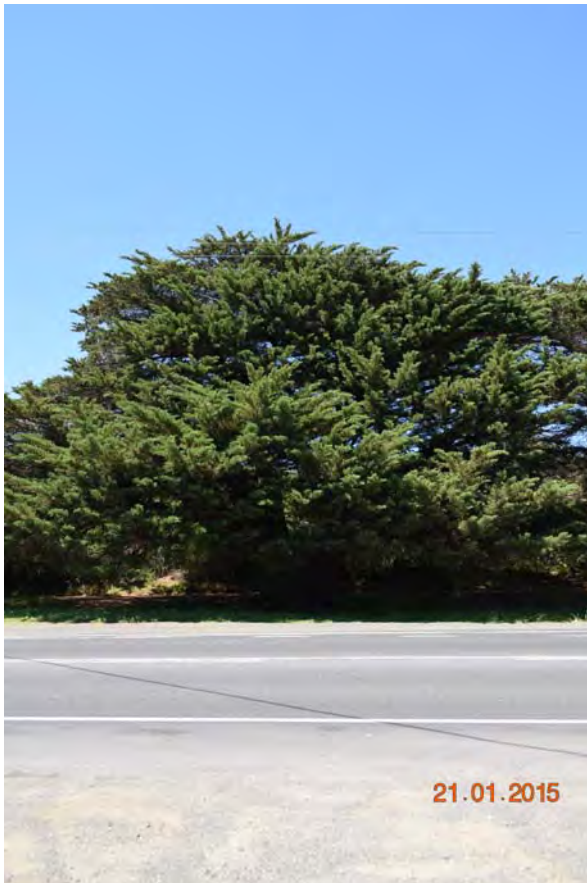
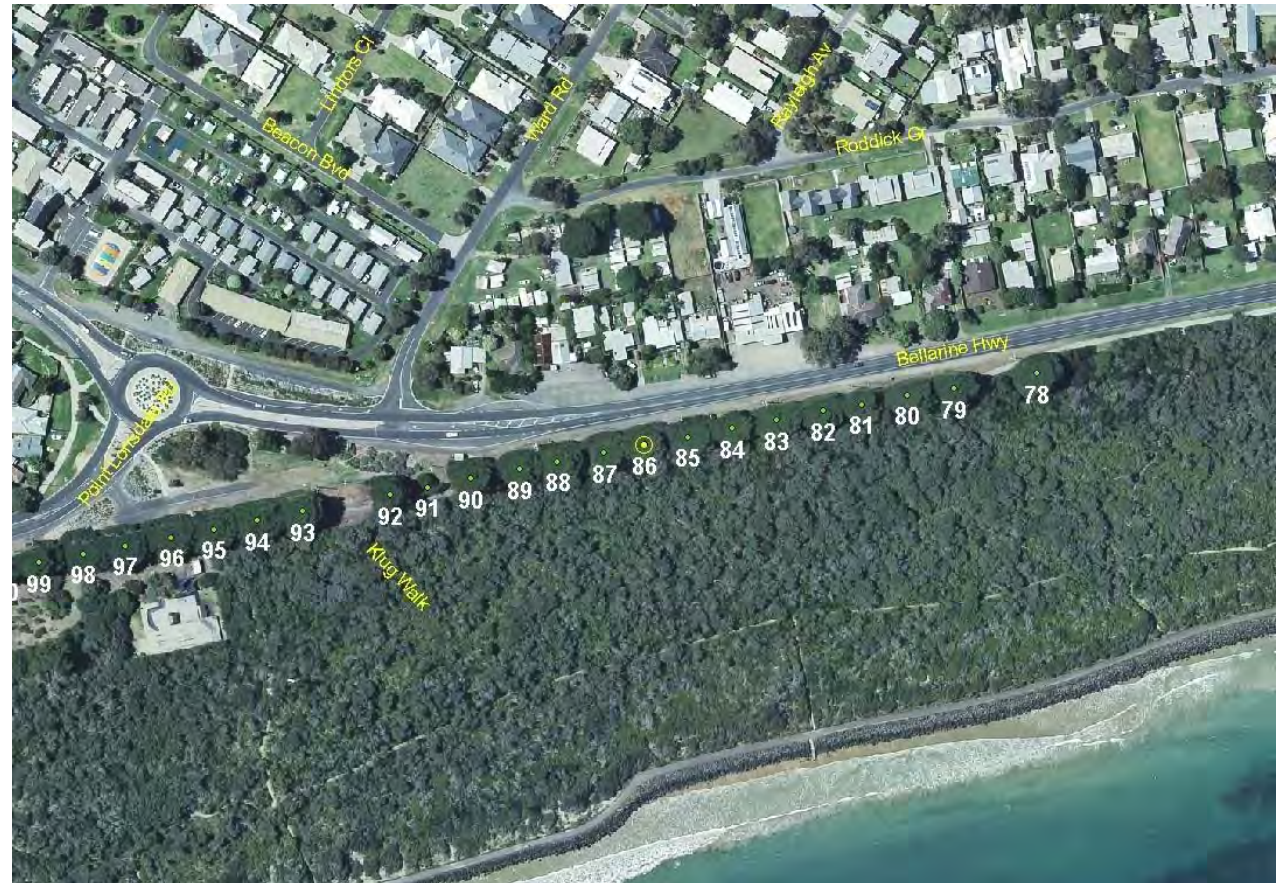
Recommended Works: Broken and hanging branch removal
Priority: High
Inspection Regime: Annual
Adjacent Infrastructure: High Voltage powerlines, Bitumen footpath
Comments: Hazard beam split in limb above path

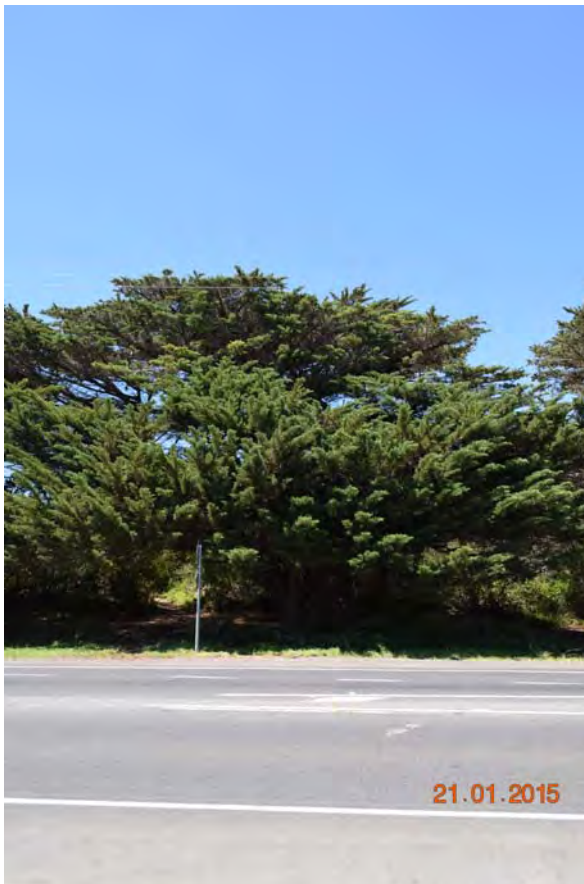
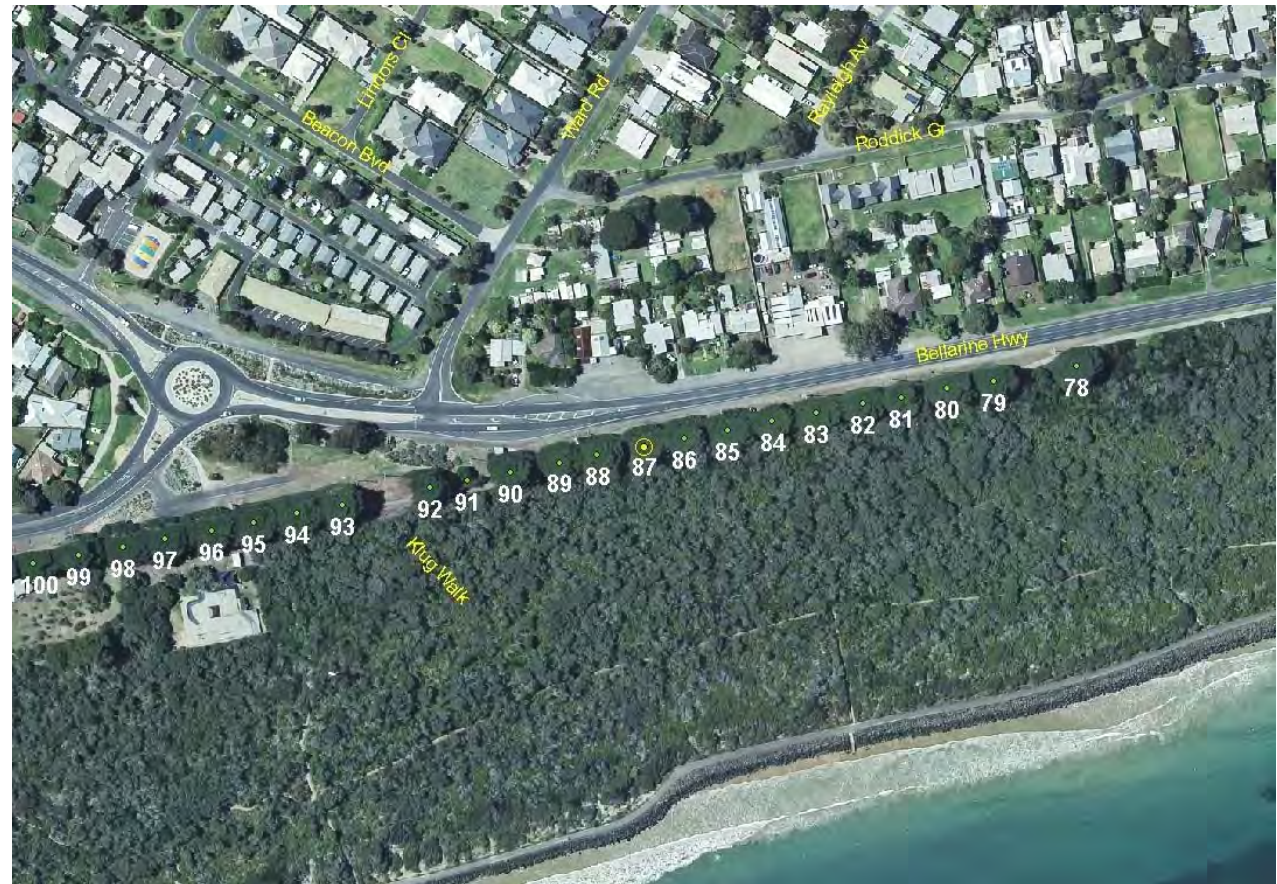
Recommended Works: Broken and hanging branch removal
Priority: High
Inspection Regime: Annual
Adjacent Infrastructure: High Voltage powerlines, Bitumen footpath
Comments: Cracked and hanging branches above path

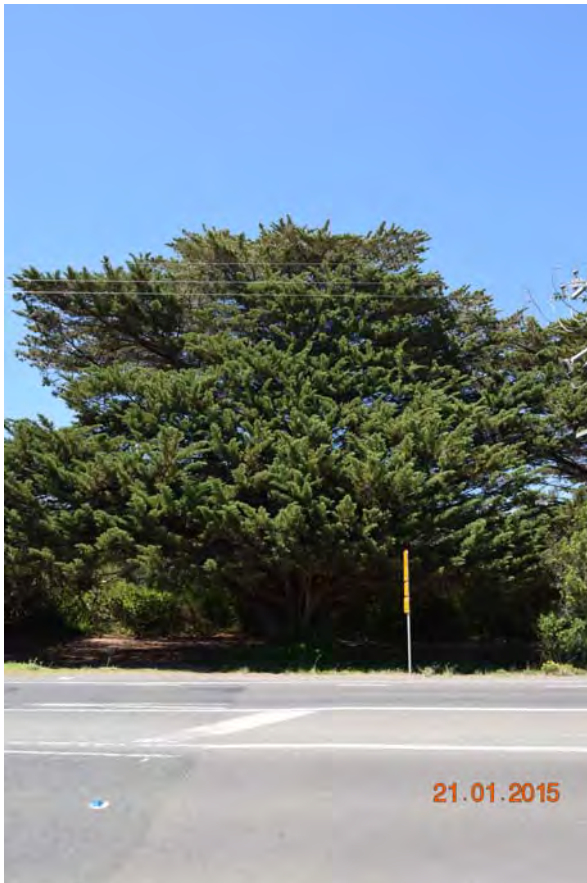
Recommended Works: Risk reduction pruning, Broken and hanging branch removal
Priority: Moderate
Inspection Regime: Annual
Adjacent Infrastructure: High Voltage powerlines, Bitumen footpath
Comments: Reduce extended limbs over path, small hanging branch above path

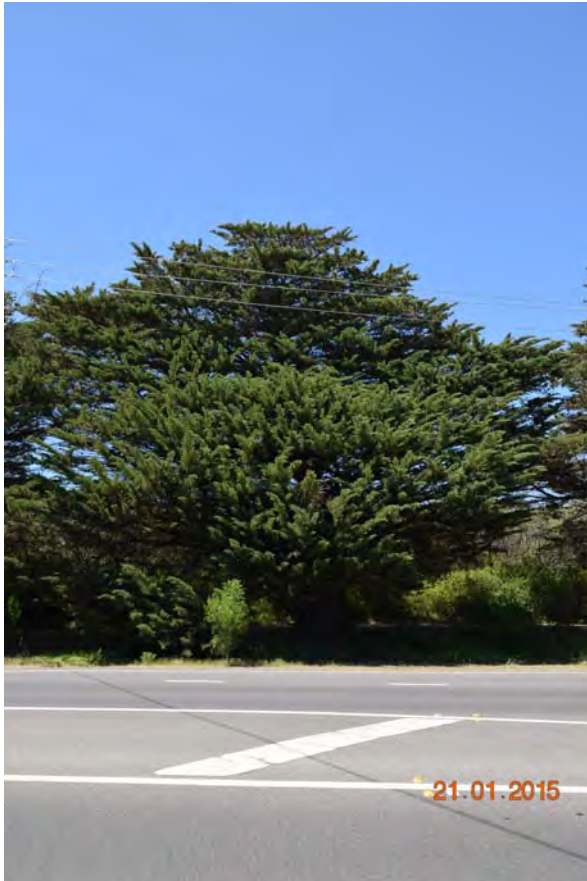
Recommended Works: Risk reduction pruning
Priority: Moderate
Inspection Regime: Annual
Adjacent Infrastructure: High Voltage powerlines, Bitumen footpath
Comments: Reduce extended limbs over path

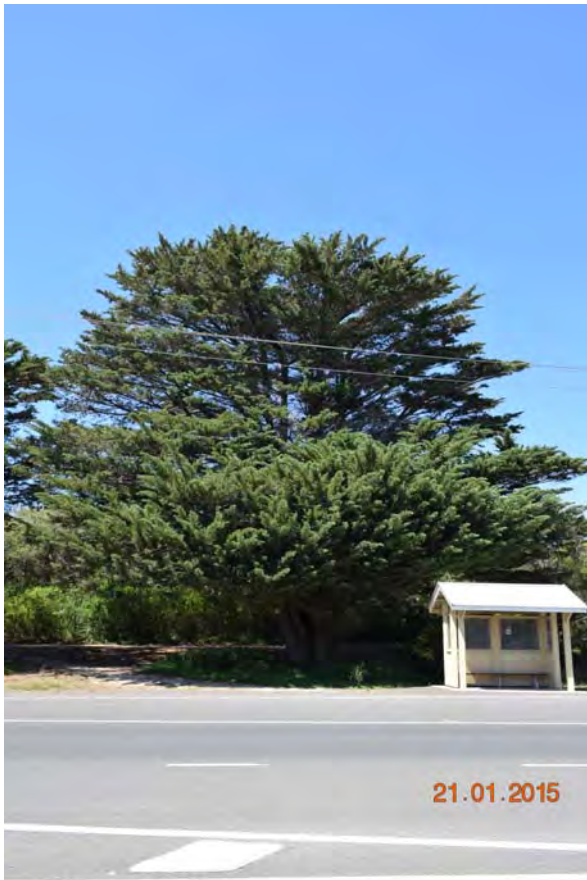
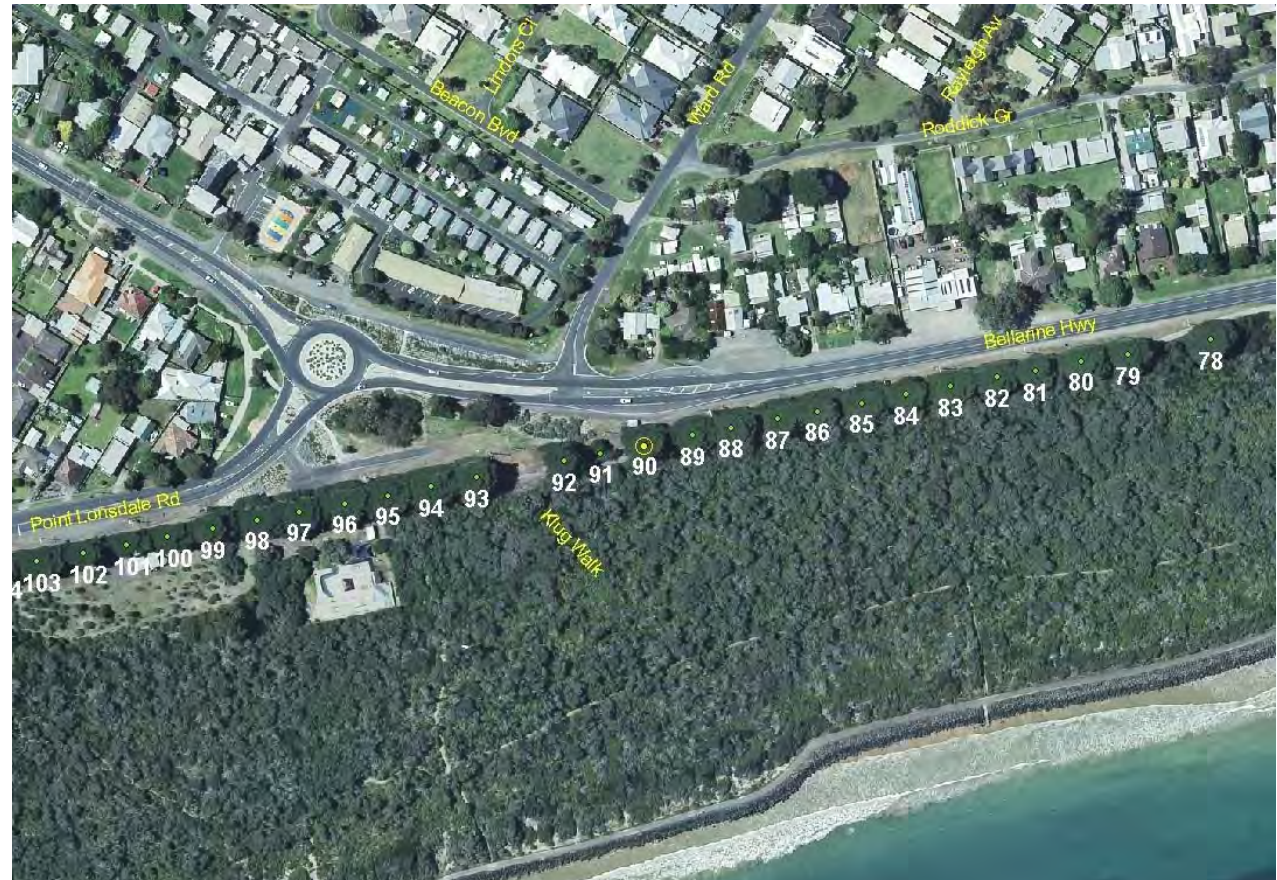
Recommended Works: Risk reduction pruning
Priority: Moderate
Inspection Regime: Annual
Adjacent Infrastructure: High Voltage powerlines, Bitumen footpath, Bus stop
Comments: Reduce extended limbs over path

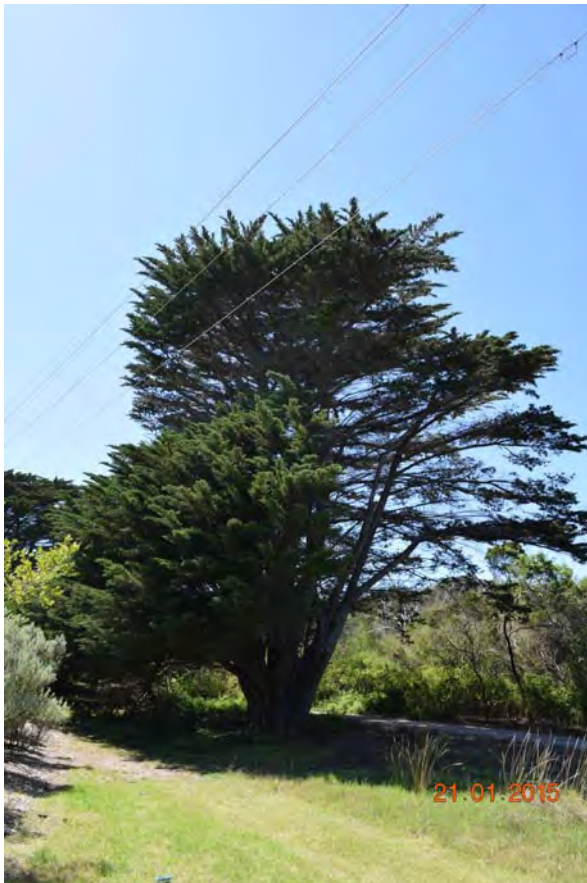
Recommended Works: Risk reduction pruning
Priority: High
Inspection Regime: Annual
Adjacent Infrastructure: High Voltage powerlines, Bitumen footpath
Comments: Shear crack in trunk leaning towards path

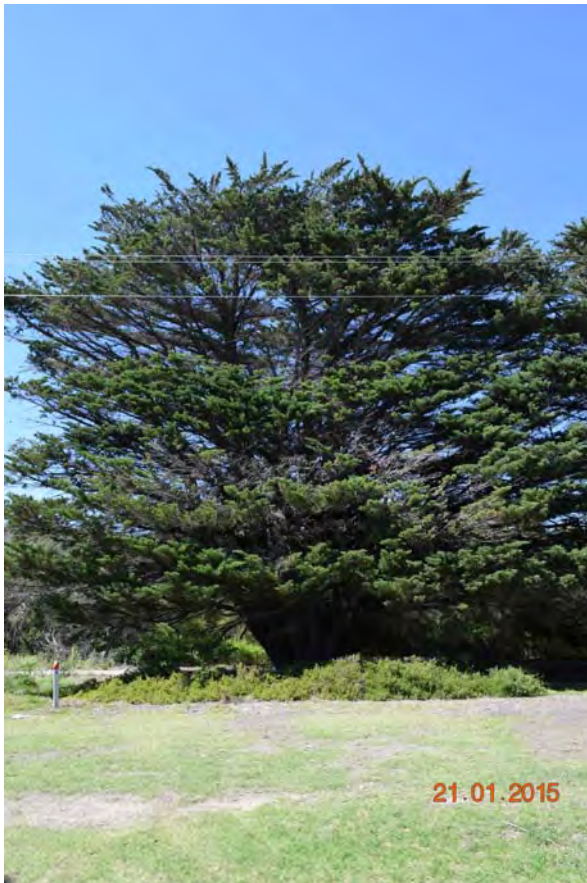
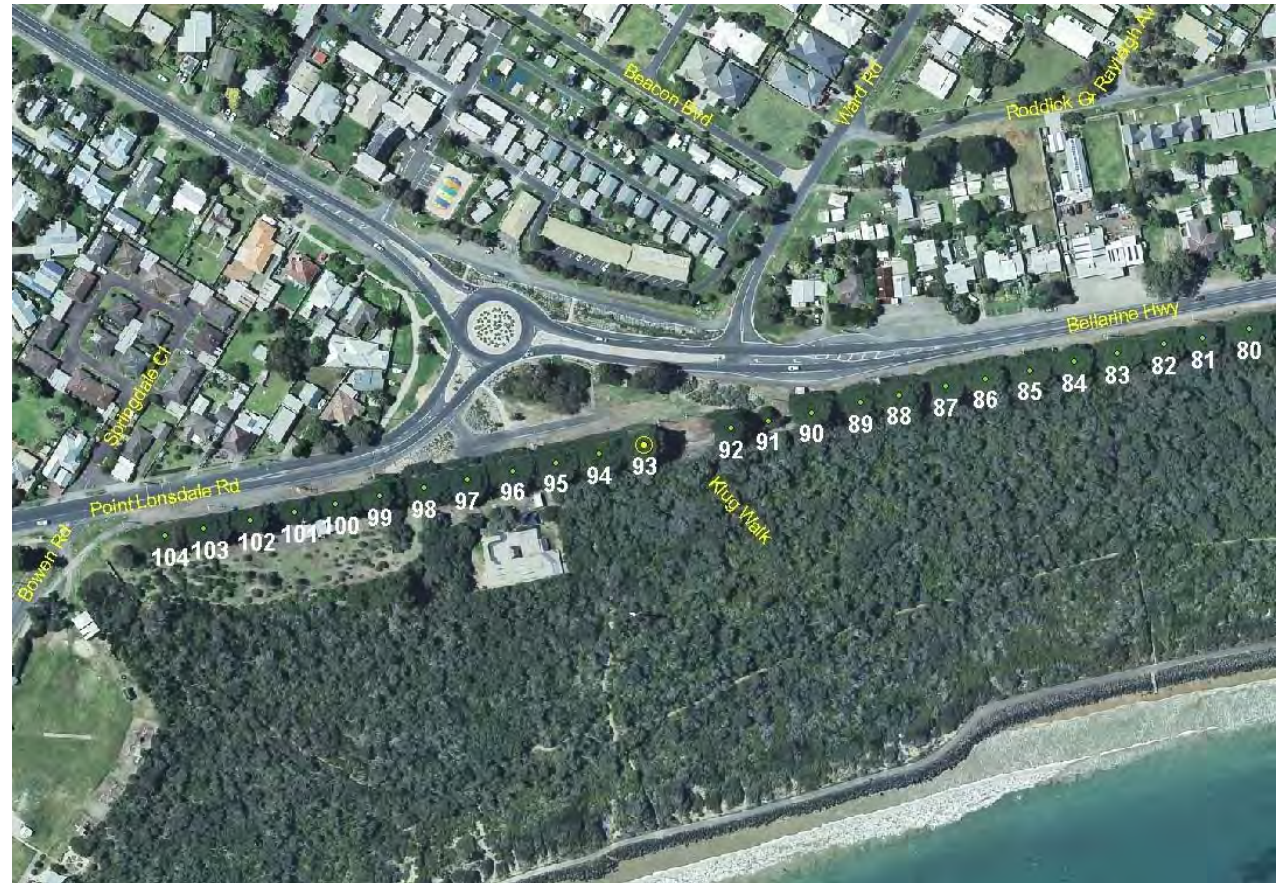
Recommended Works: No works
Priority: None
Inspection Regime: Annual
Adjacent Infrastructure: High Voltage powerlines, Gravel carpark, Bitumen path
Comments: Heavily lopped resulting in excessive deadwood
