Avenue of Honour Tree Management and Replacement Plan

Homewood Consulting Pty Ltd

May 2015

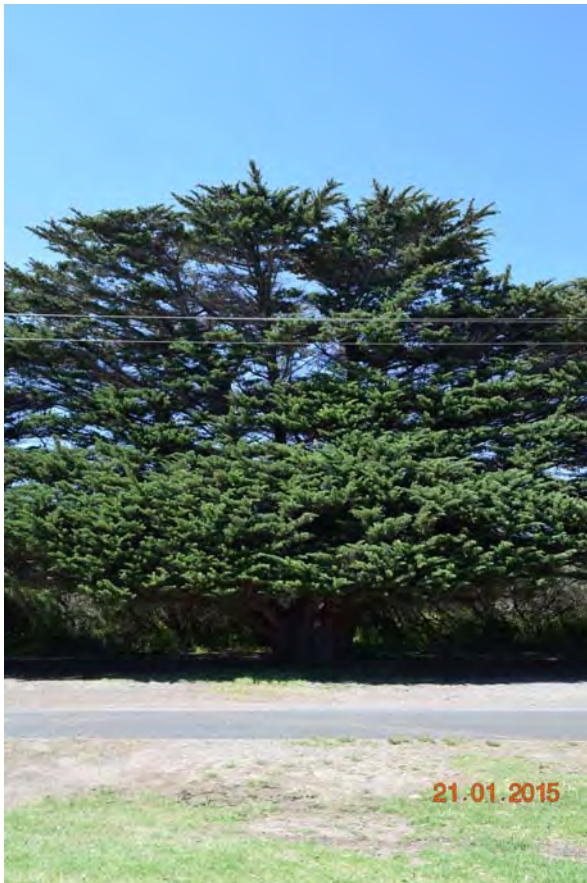
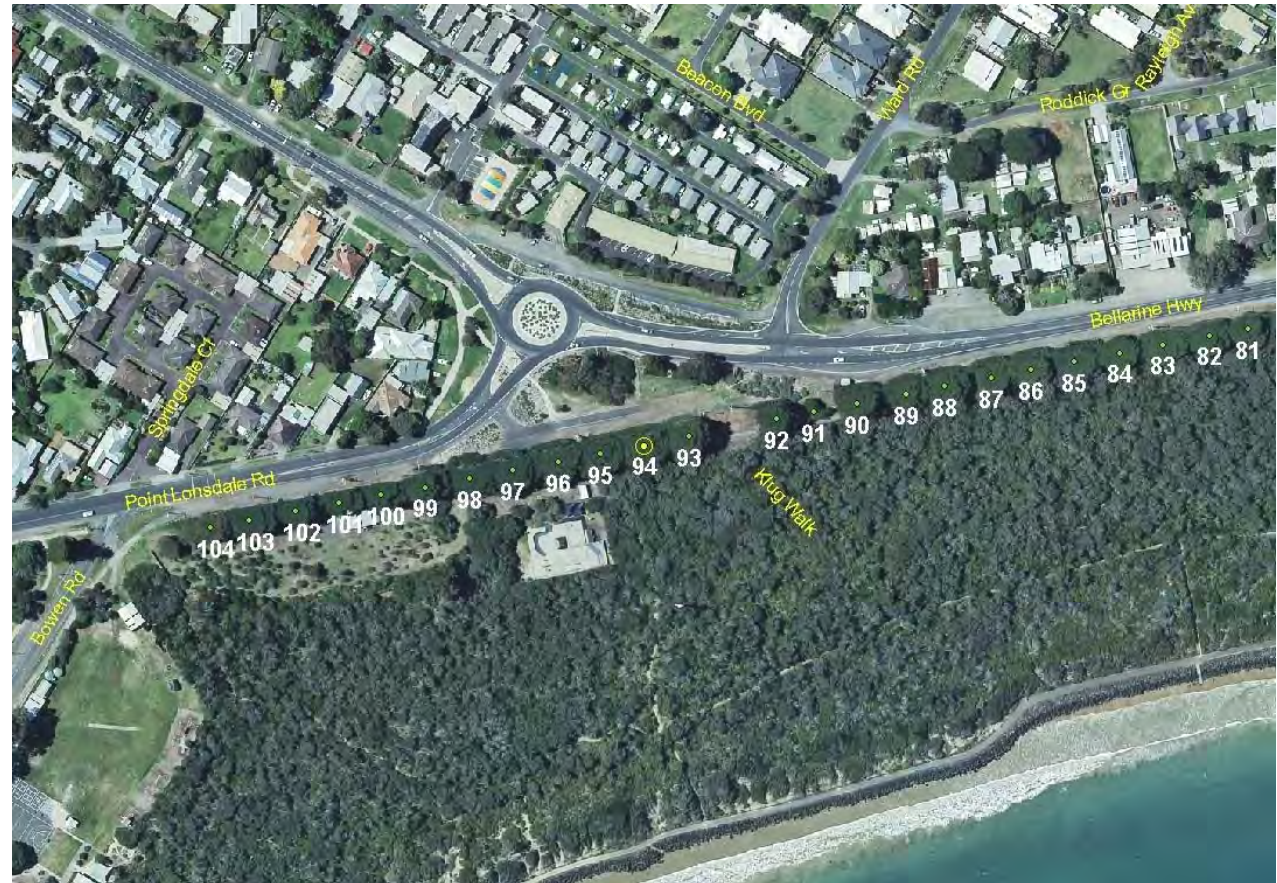
Recommended Works: Removal
Priority: Moderate
Inspection Regime: Annual
Adjacent Infrastructure: High Voltage powerlines, Gravel carpark, Bitumen path
Comments: Active split between trunks

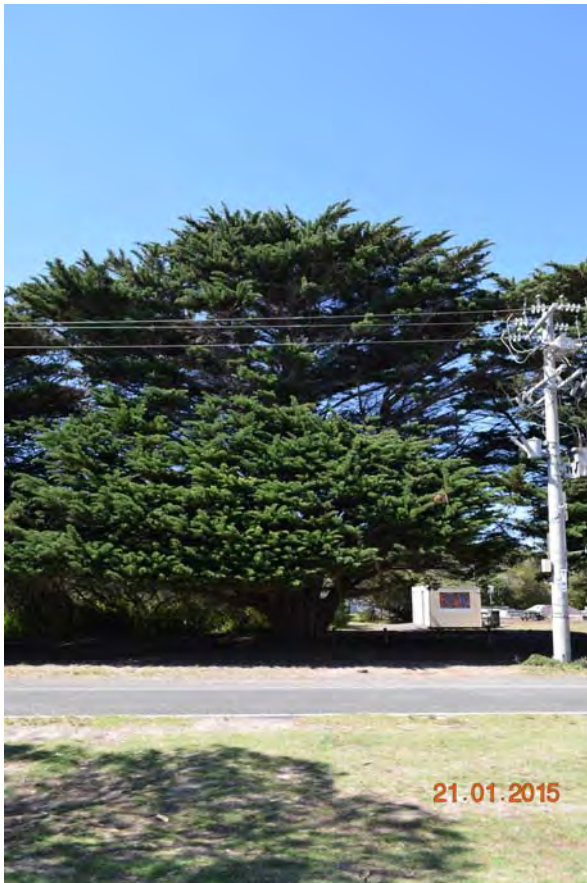
Recommended Works: Deadwood removal, Risk reduction pruning
Priority: Moderate
Inspection Regime: Annual
Adjacent Infrastructure: High Voltage powerlines, Gravel carpark, Bitumen path
Comments: Reduce extended limbs over path

Canopy, branch or stem reduction pruning of overextended limbs can reduce the possibility of failure. The aim is the selective pruning of long and extended branches starting in the 3rd order branching, back to a shorter, more compact growing point. This reduces the overall weight, length and leverage on the branch union.

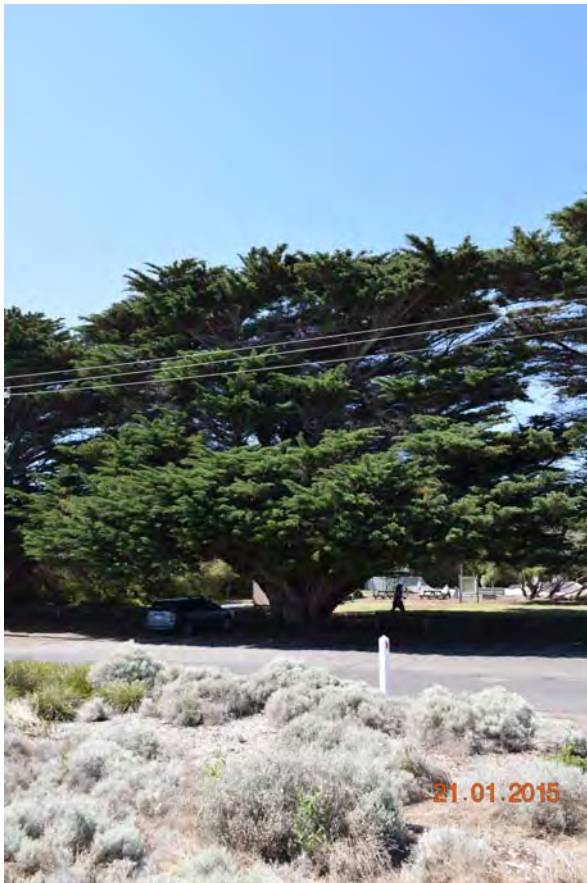
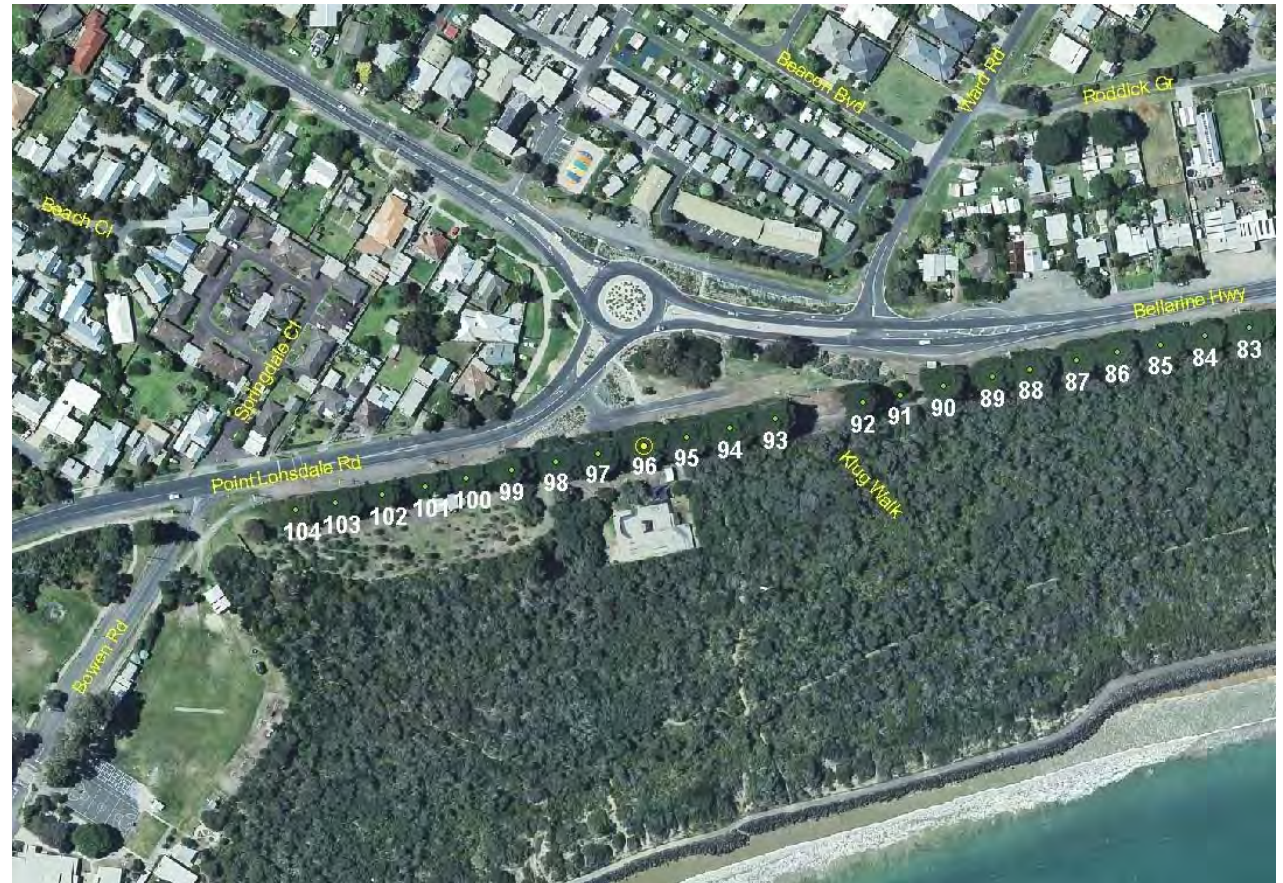
Recommended Works: Deadwood removal, Broken and hanging branch removal, Risk reduction pruning
Priority: Moderate
Inspection Regime: Annual
Adjacent Infrastructure: High Voltage powerlines, Gravel carpark, Bitumen path
Comments: Reduce extended limbs over path

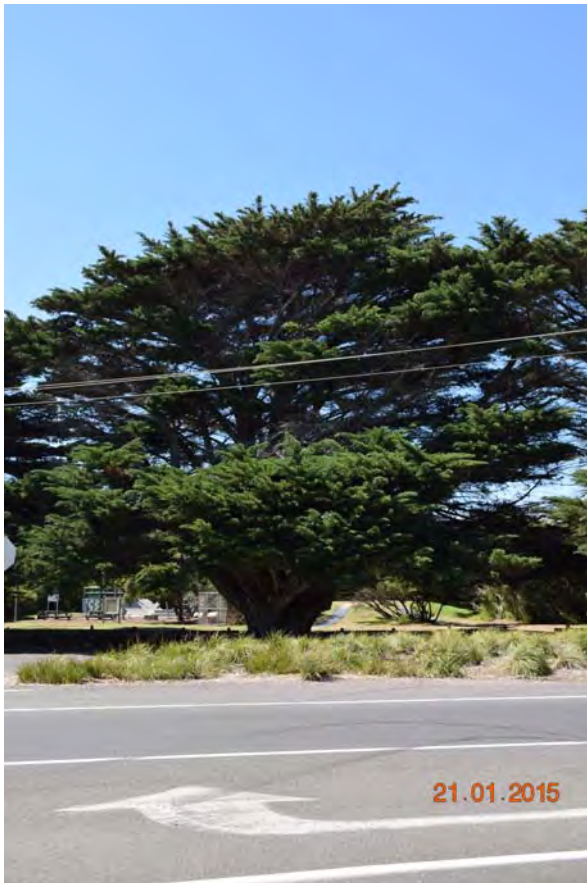
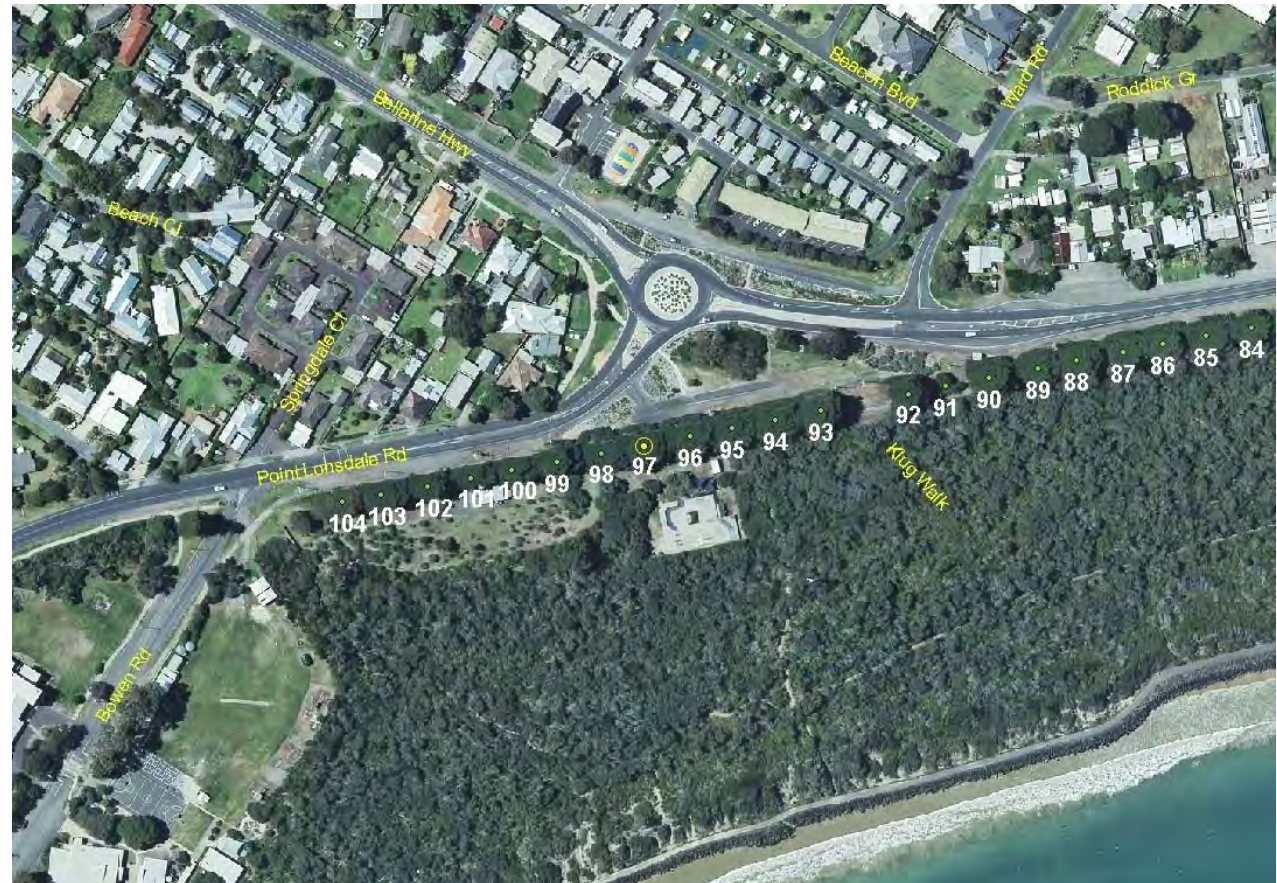
Recommended Works: Deadwood removal, Broken and hanging branch removal, Risk reduction pruning
Priority: High
Inspection Regime: Annual
Adjacent Infrastructure: High Voltage powerlines, Gravel carpark, Bitumen path
Comments: Reduce extended limbs over path, Hanging branch above path

A number of trees assessed have hanging branches, that is unattached, cut or broken branches caught in the canopy (Australian Standards, 2007). Hanging branches can pose a substantial hazard and even branches as thin as 50mm in diameter can be considered serious if they have a long, clear route of fall (Lonsdale 1999). If a branch has snapped or cracked across the grain, any hanging or dead attached portion which could place people or property at risk should be removed (Lonsdale 1999).

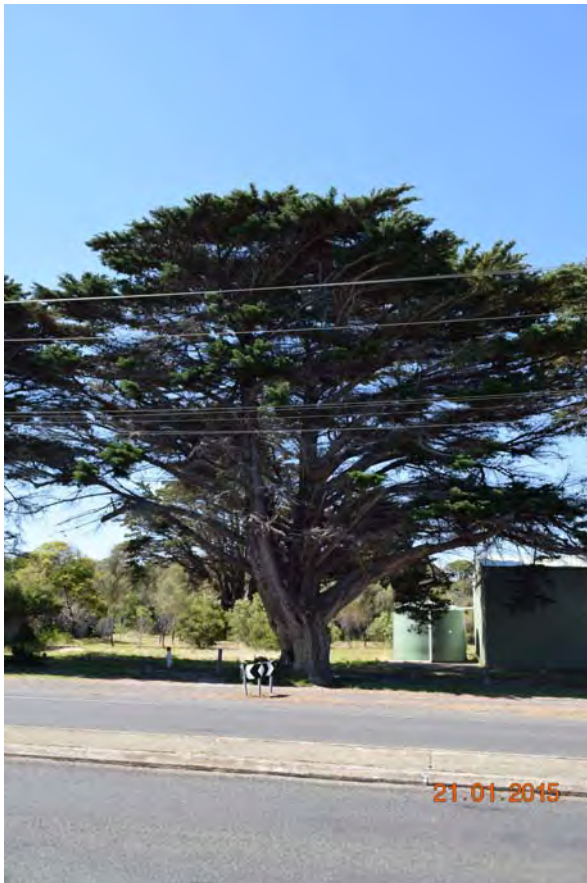
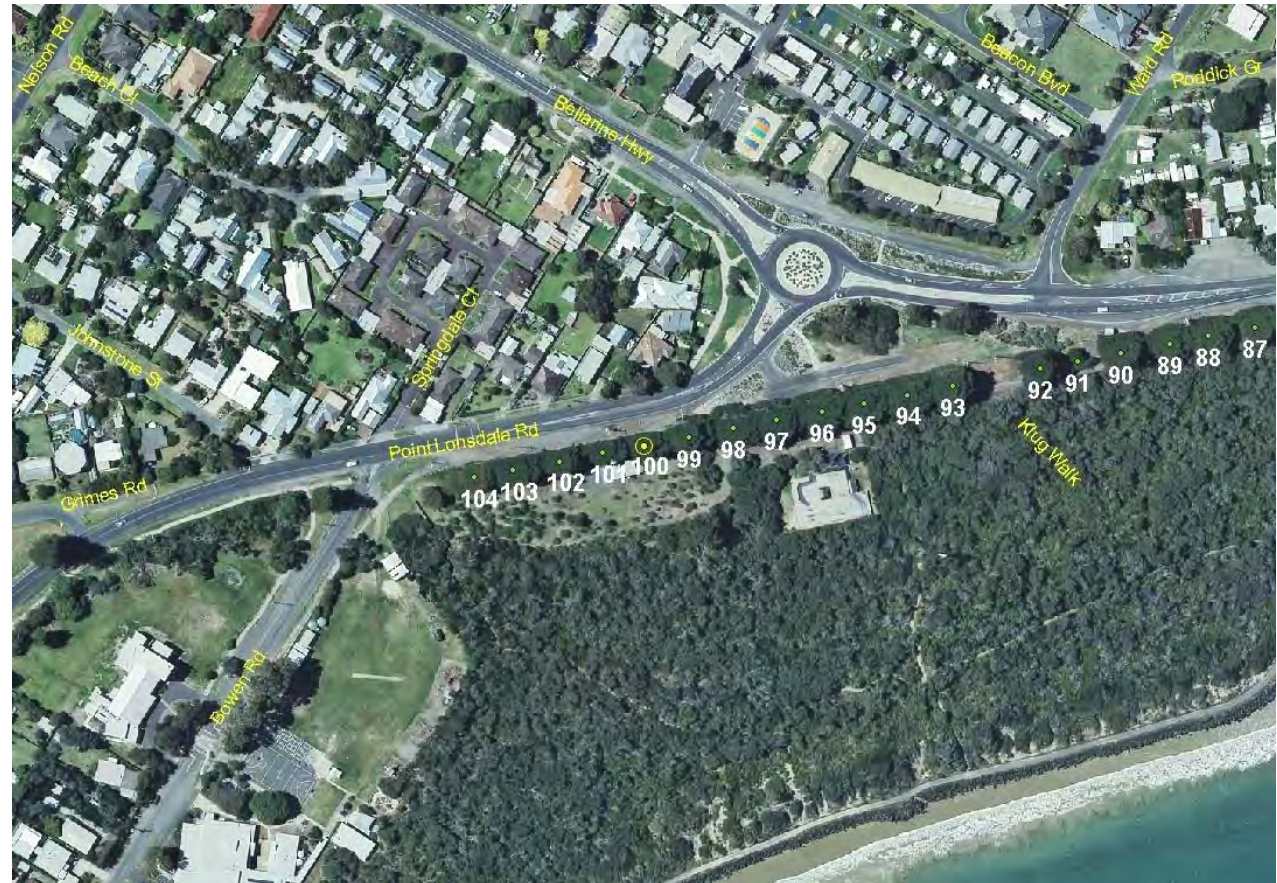
Recommended Works: Broken and hanging branch removal
Priority: Moderate
Inspection Regime: Annual
Adjacent Infrastructure: High Voltage powerlines, Gravel carpark, Bitumen track (path + CFA access)
Comments: Hanging branches over path

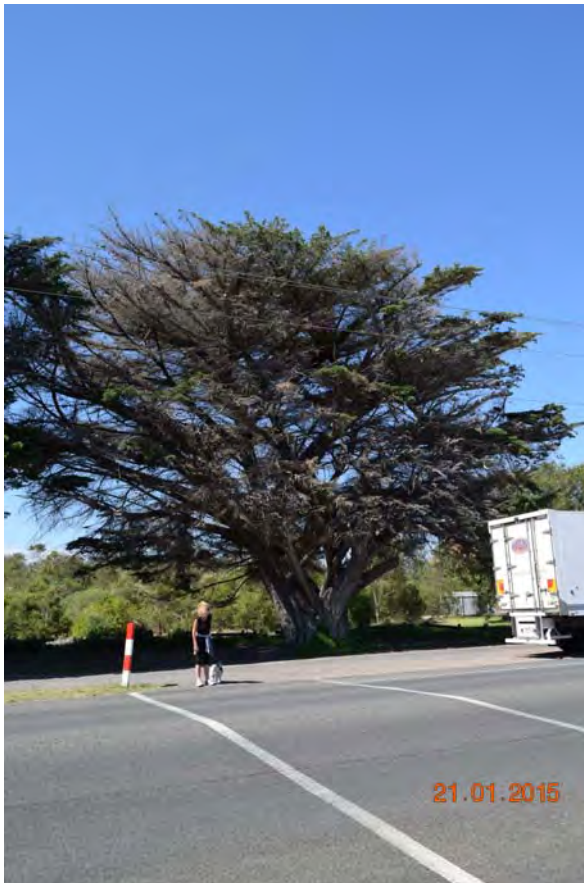
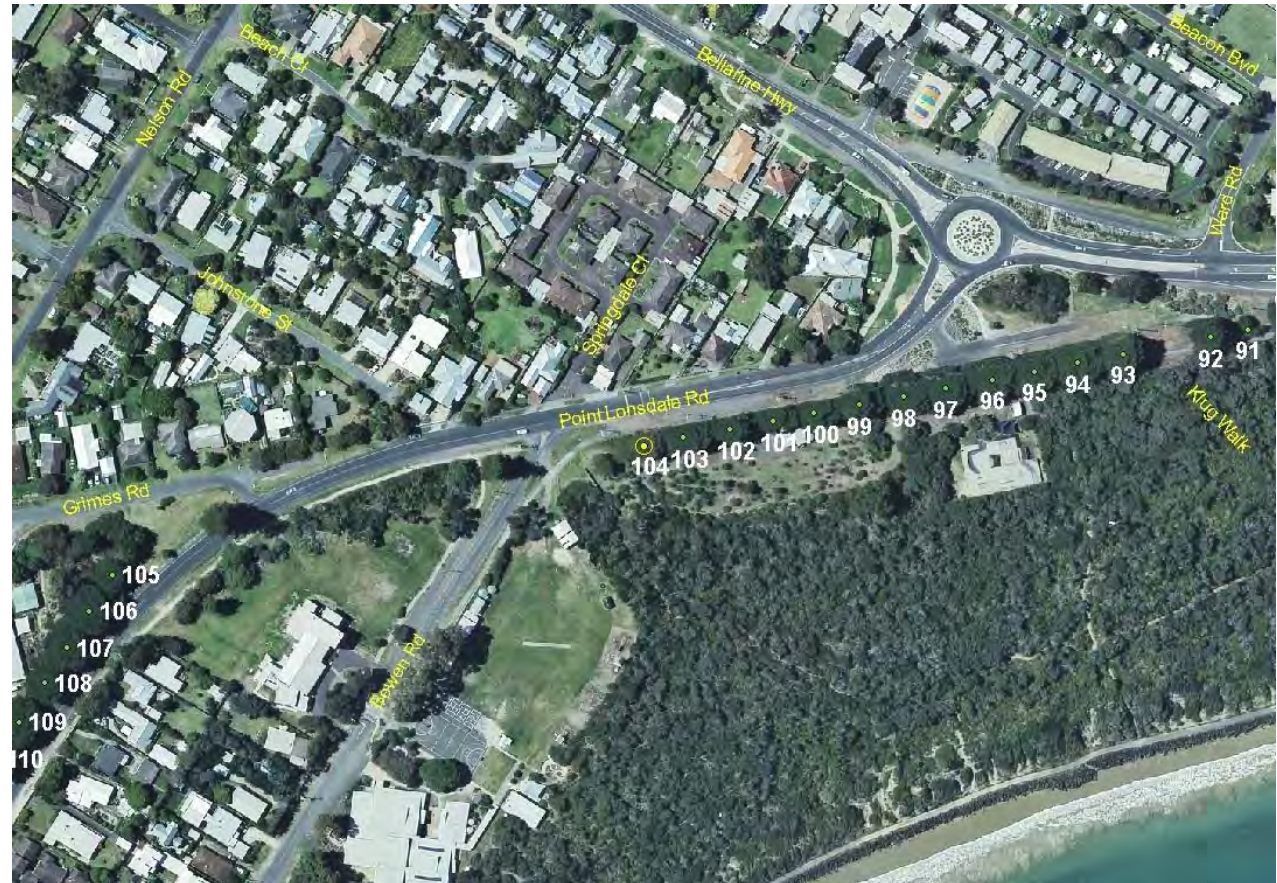
Location: The Springs
Easting: 292041.28
Northing: 5761242.26
Estimated year planted: 1950-60
Estimated Age: 55-65

Recommended Works: Removal
Priority: High
Inspection Regime: Annual
Adjacent Infrastructure: High Voltage powerlines, Gravel carpark, Bitumen track (path + CFA access)
Comments: Large active split in canopy above parking area, Heavily lopped resulting in excessive deadwood

Tree No.	Canopy Dimensions	DBH (cm)	Health	Structure	ULE	Location	Recommended Works	Works Priority
104	11m x 17m	219	Poor	Poor	0 years	The Springs	Removal	High
107	12m x 19m	187	Fair	Fair	10-20 years	Bellarine Community Health	Risk reduction pruning, Broken/hanging branch removal	High

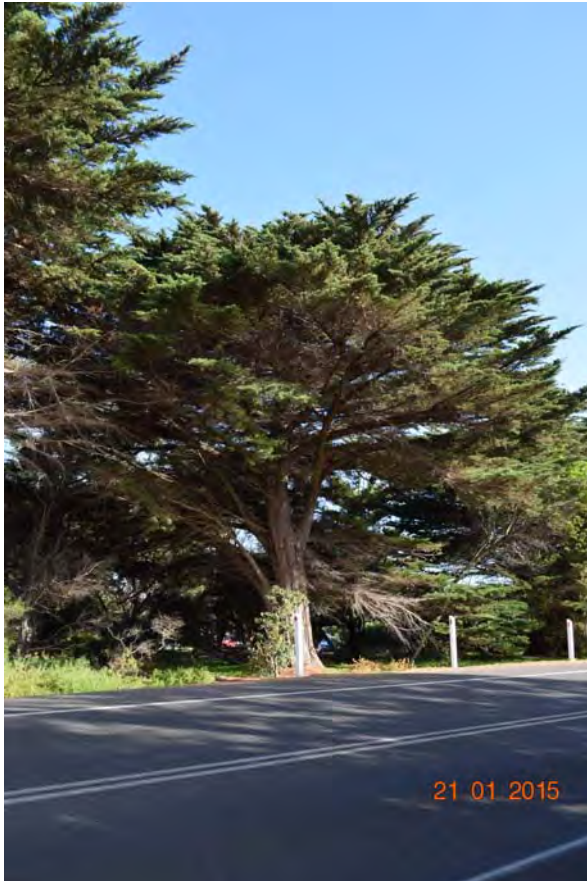
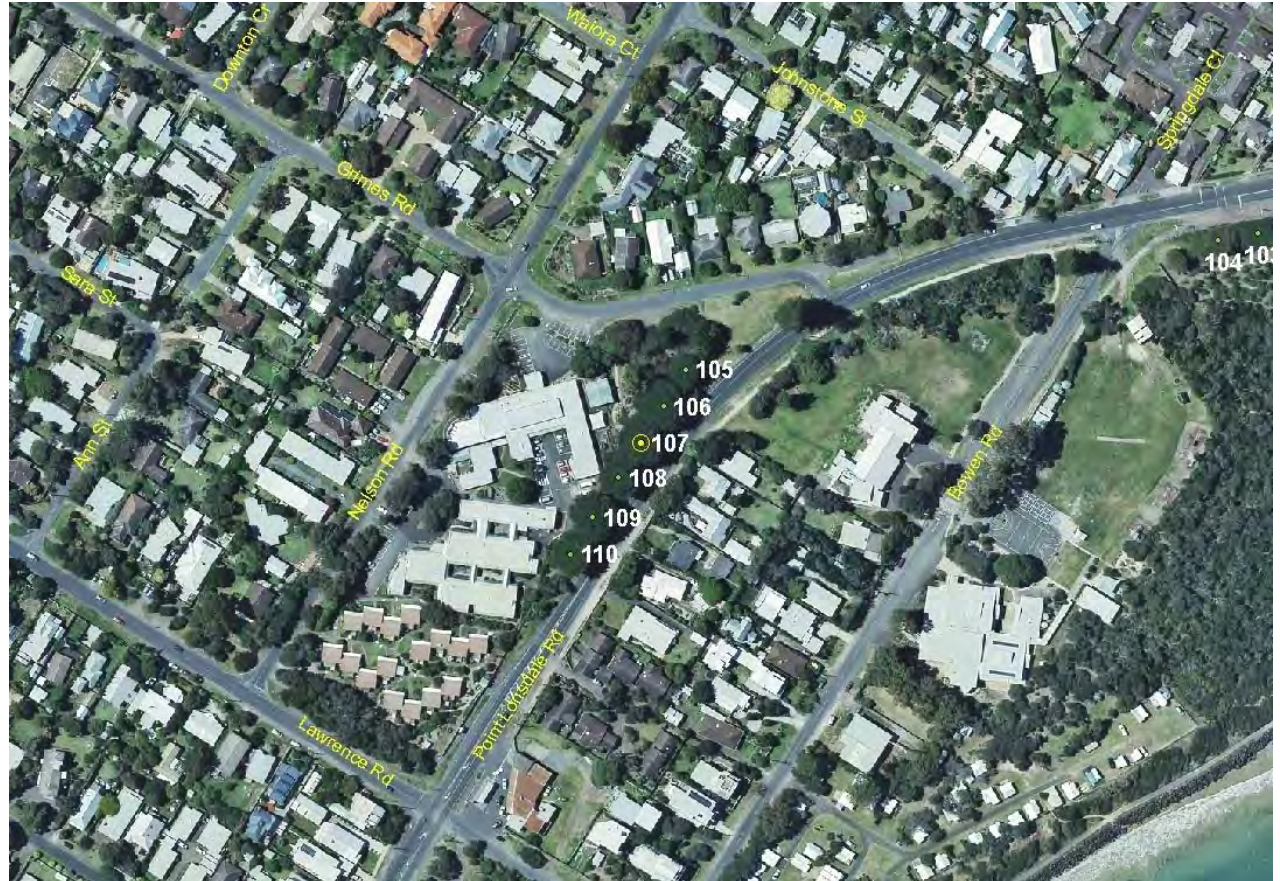
Location: Bellarine Community Health
Easting: 291789.18
Northing: 5761141.64
Estimated year planted: Unknown
Estimated Age:

Recommended Works: Risk reduction pruning, Broken and hanging branch removal
Priority: High
Inspection Regime: 3-5 years
Adjacent Infrastructure: Informal Gravel paths, Park bench
Comments: Cracked branch above park bench

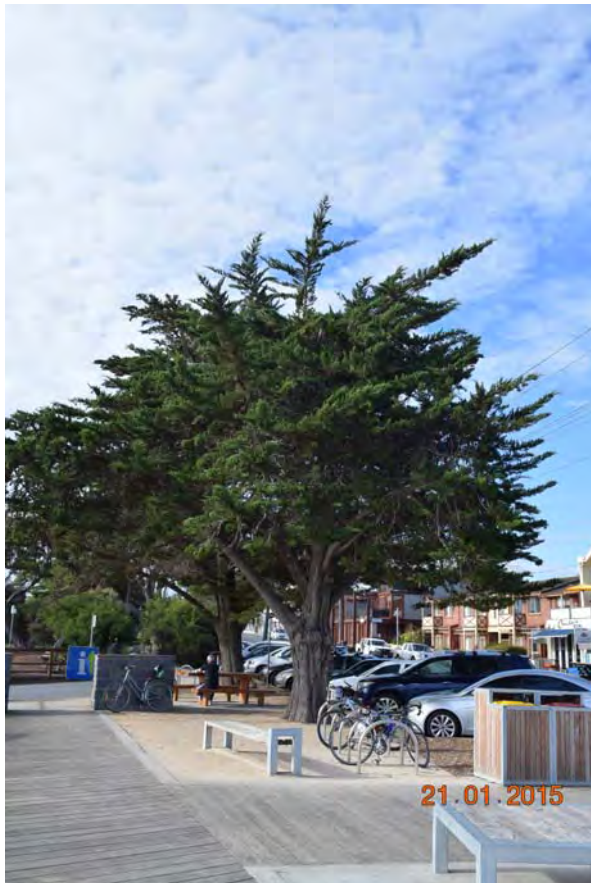
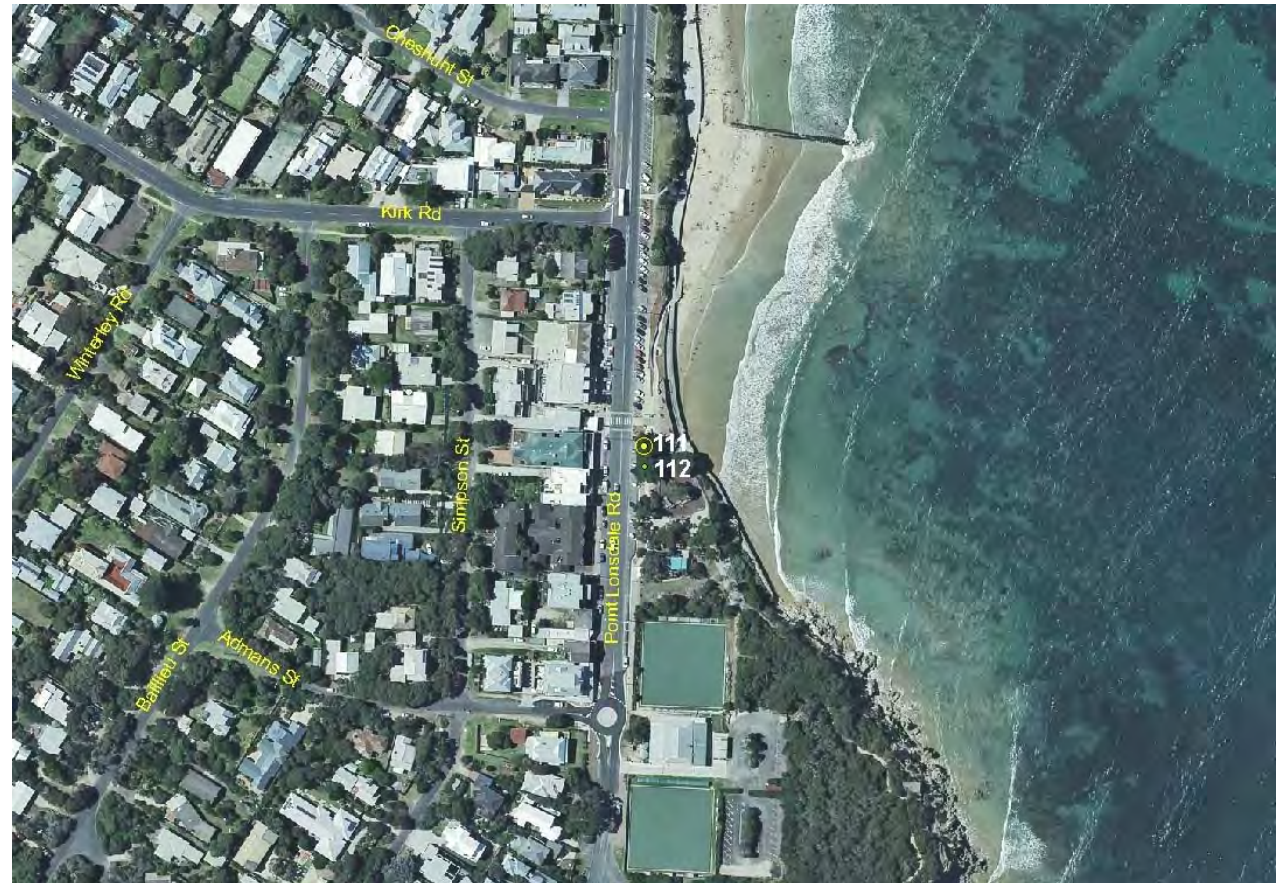
Comments: Thinning canopy

Recommended Works: No works

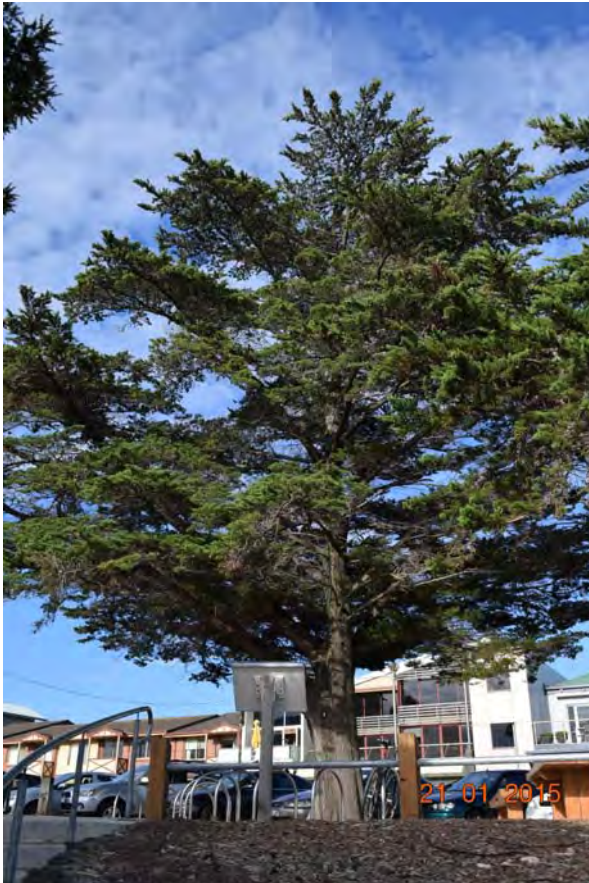
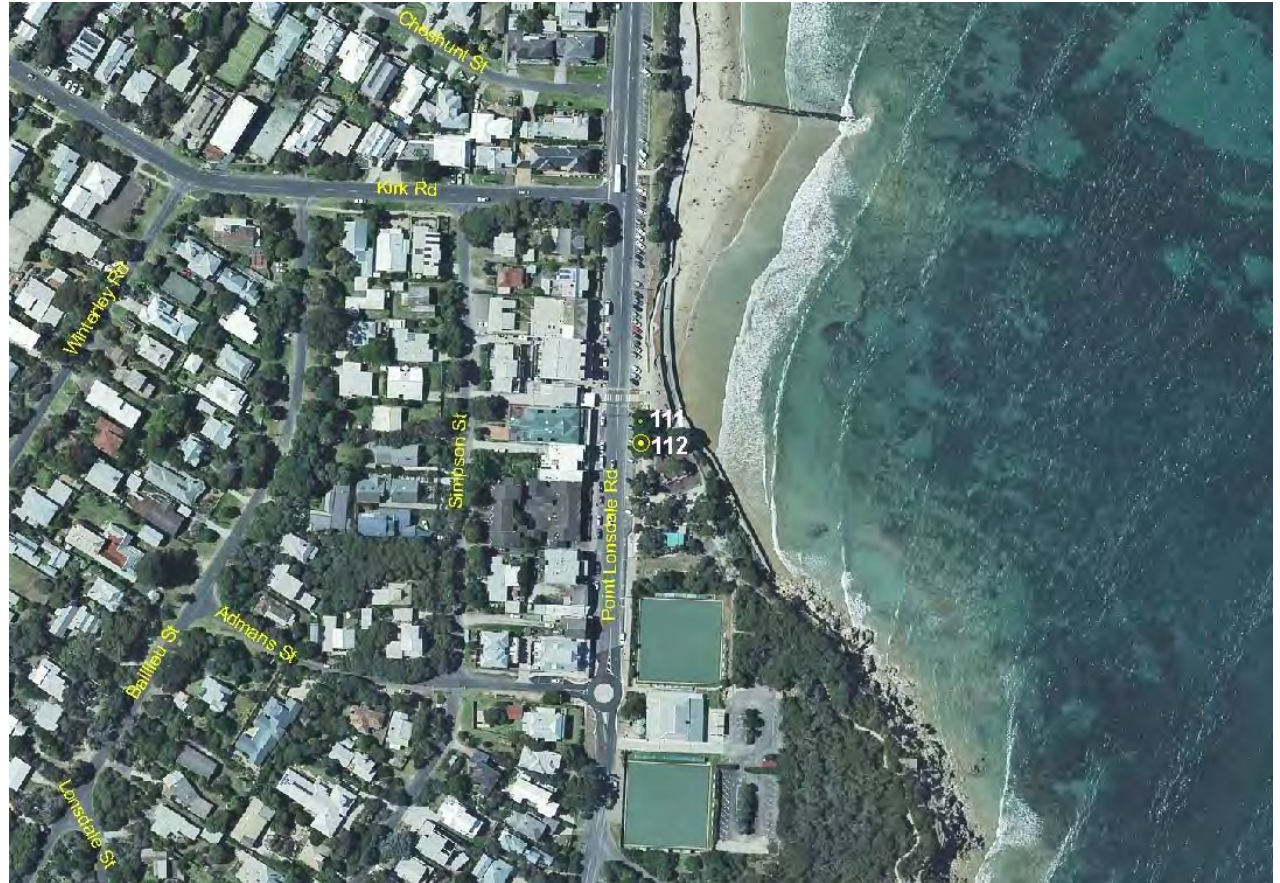
Comments: Thinning canopy

Recommended Works: No works
