Avenue of Honour Tree Management and Replacement Plan: Executive Summary

Homewood Consulting Pty Ltd

August 2015

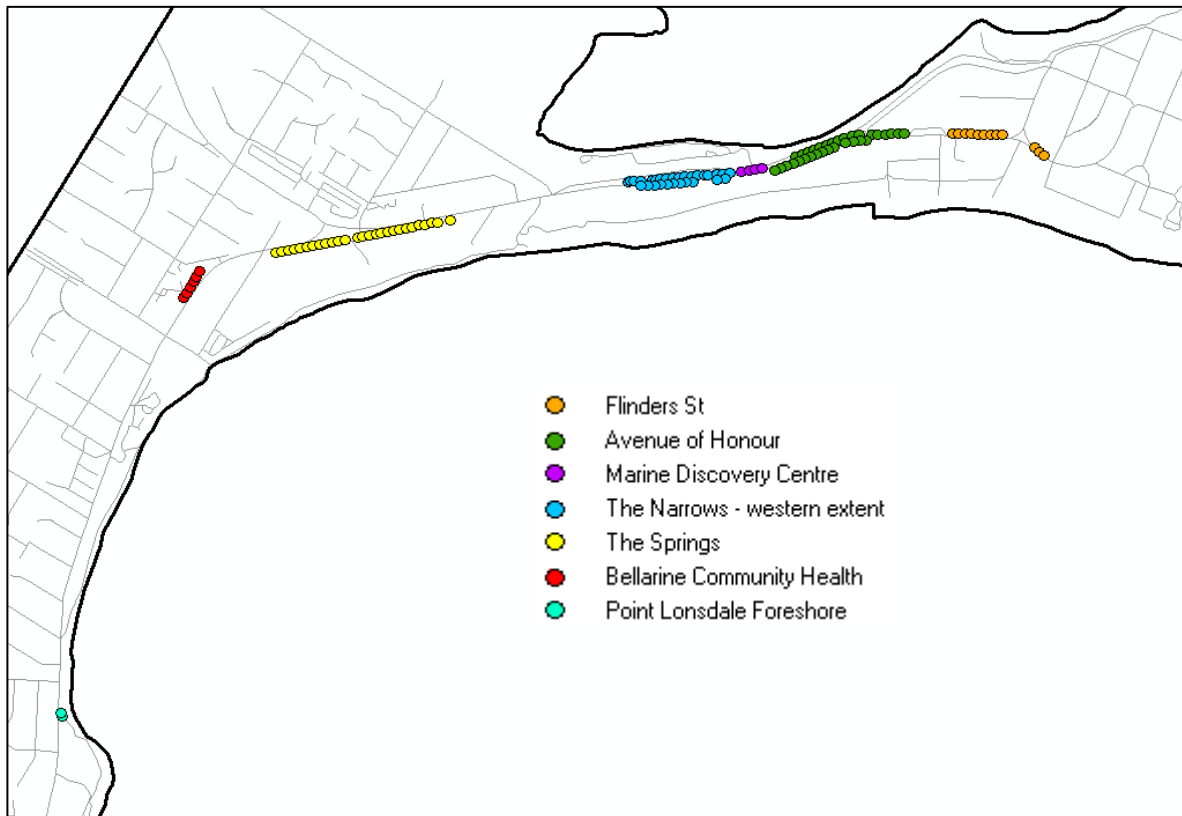
The location of the assessed trees and management units within the Borough of Queenscliffe.

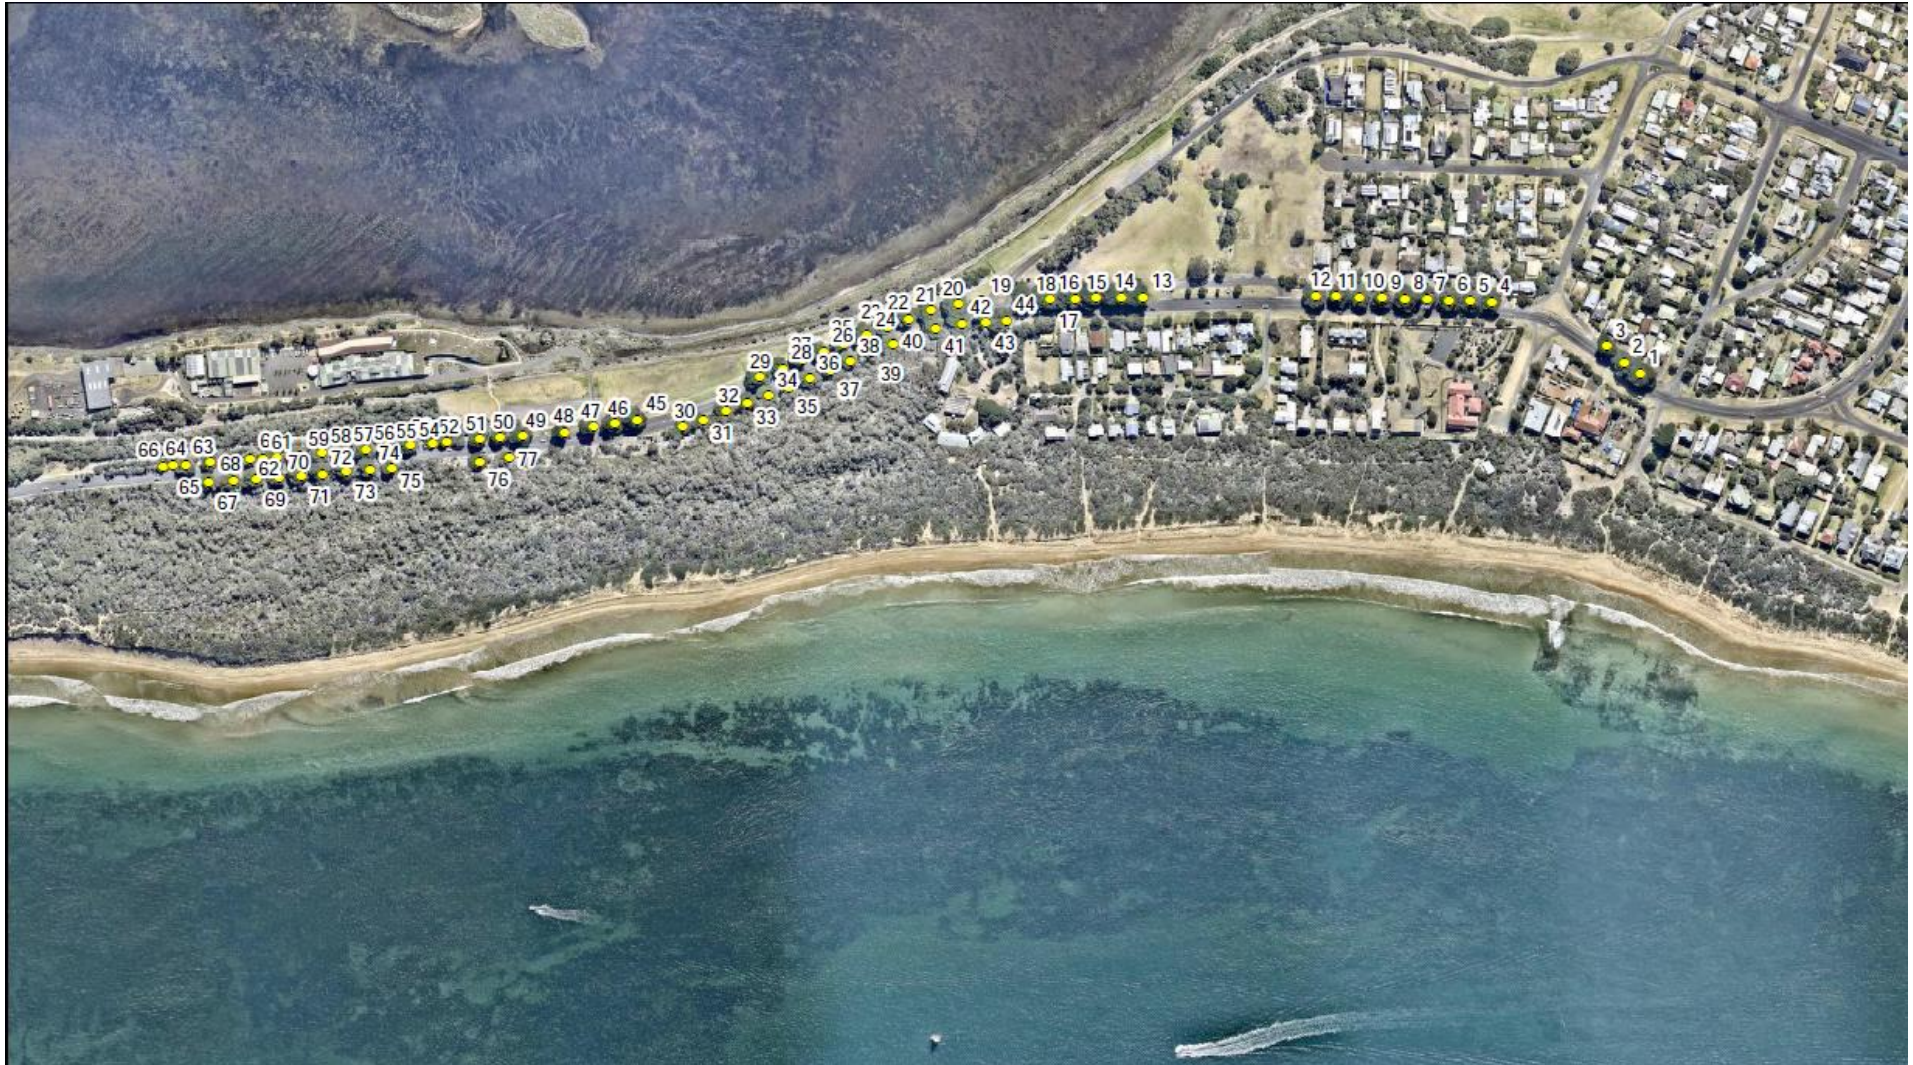
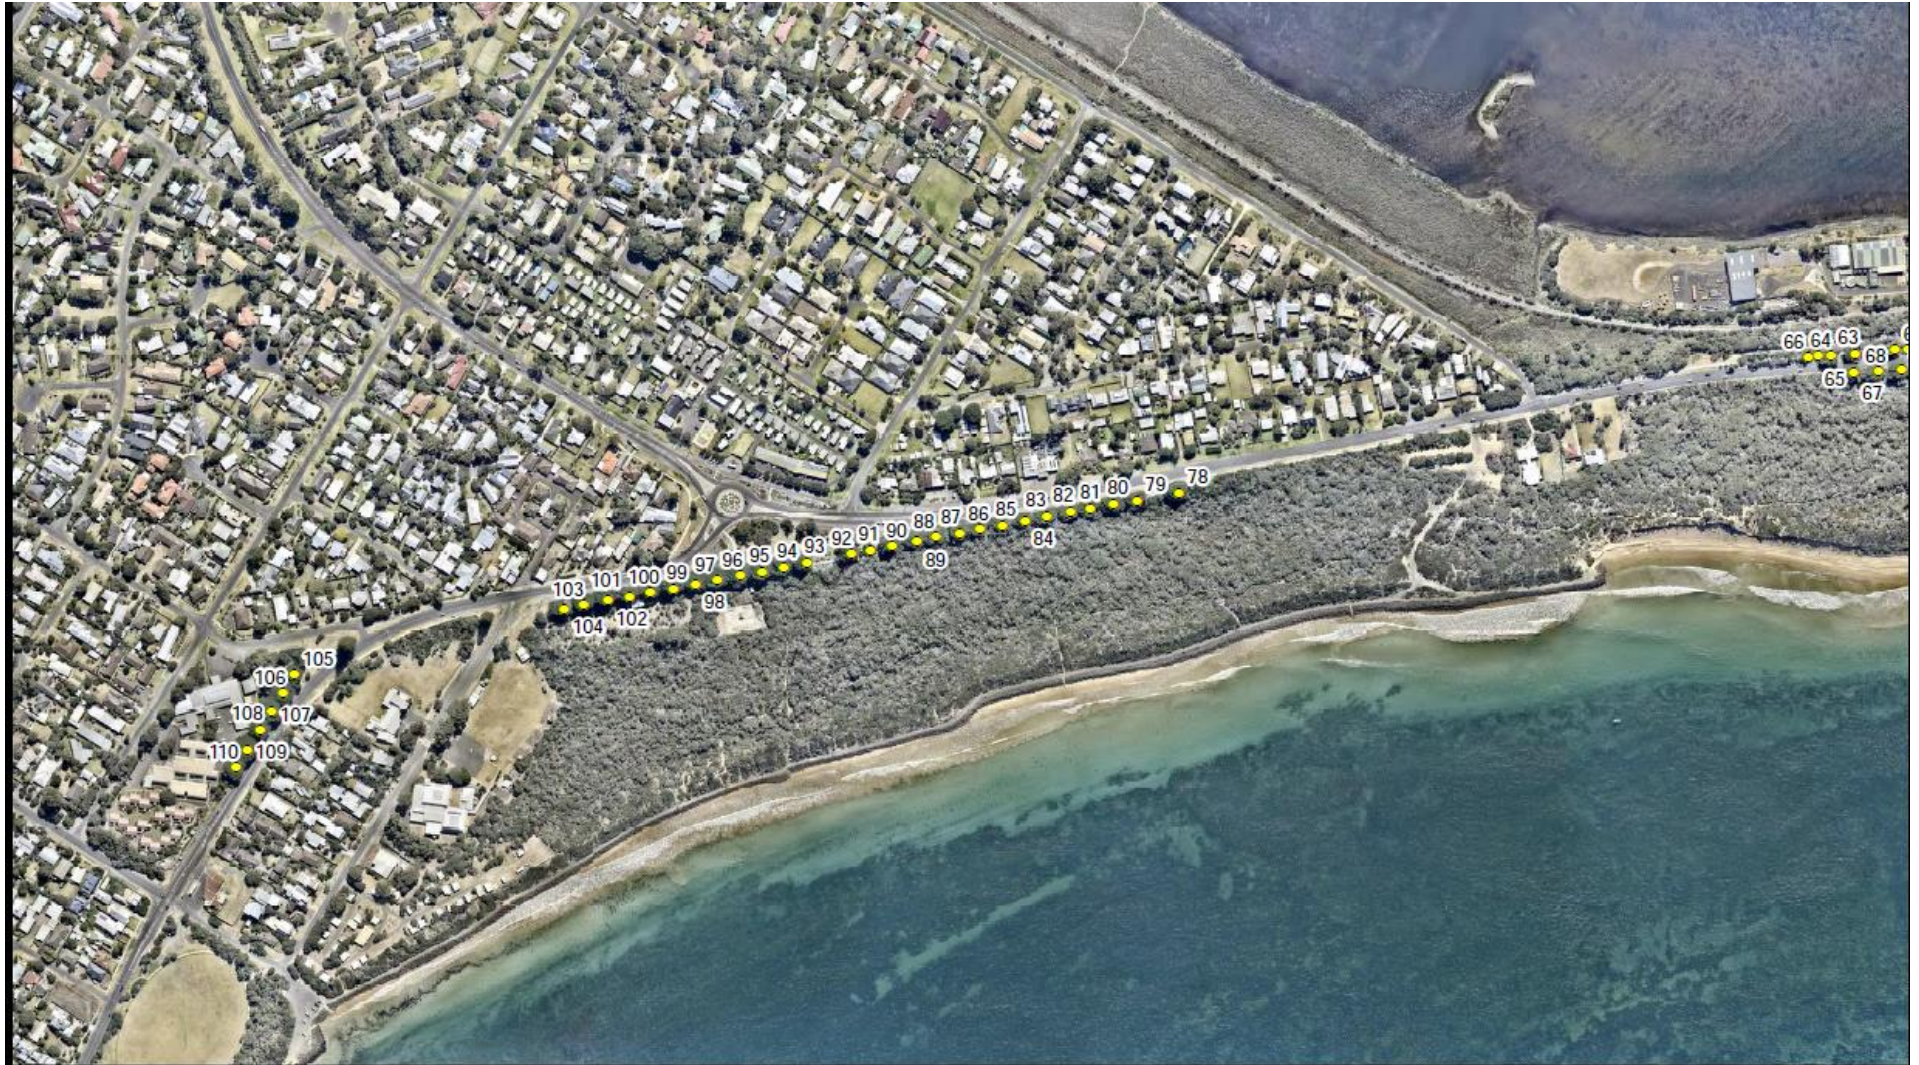
Two maps are included before the table indicating location of trees by number.

Tree No.	Canopy Dimensions	DBH (cm)	Health	Structure	ULE	Location	Recommended Works	Works Priority
2	12m x 18m	193	Fair	Poor	5-10 years	Flinders Street	Individual branch removal	Moderate
7	13m x 18m	153	Fair	Poor	1-5 years	Flinders Street	Removal	Low
12	11m x 18m	185	Fair	Poor	10-20 years	Flinders Street	Individual branch removal	Moderate
19	13m x 20m	219	Fair	Poor	1-5 years	Avenue of Honour	Removal	Low
20	11m x 15m	186	Fair	Fair	10-20 years	Avenue of Honour	Exclude target, Mulch required	High
21	10m x 15m	151	Fair	Fair	10-20 years	Avenue of Honour	Exclude target, Mulch required	High
22	11m x 15m	166	Fair	Fair	10-20 years	Avenue of Honour	Exclude target, Mulch required	High
23	10m x 16m	168	Fair	Fair	10-20 years	Avenue of Honour	Exclude target, Mulch required	High
24	9m x 18m	153	Fair	Fair	10-20 years	Avenue of Honour	Exclude target, Mulch required	High
25	9m x 14m	136	Fair	Fair	10-20 years	Avenue of Honour	Exclude target, Mulch required	High

26	9m x 14m	108	Fair	Fair	10-20 years	Avenue of Honour	Exclude target, Mulch required	High
27	9m x 15m	122	Fair	Fair	10-20 years	Avenue of Honour	Exclude target, Mulch required	High
28	9m x 13m	133	Fair	Fair	10-20 years	Avenue of Honour	Exclude target, Mulch required	High
29	11m x 19m	197	Fair	Fair	10-20 years	Avenue of Honour	Exclude target, Mulch required, Individual branch removal	High
40	11m x 19m	192	Fair	Poor	5-10 years	Avenue of Honour	Risk reduction pruning	Moderate
45	13m x 18m	174	Fair	Fair	5-10 years	Marine Discovery Centre	Broken/hanging branch removal	Moderate
48	13m x 12m	169	Fair	Poor	1-5 years	Marine Discovery Centre	Removal	Low
57	11m x 16m	137	Fair	Fair	20-40 years	The Narrows - western extent	Individual branch removal	Moderate
65	4m x 8m	22	Fair	Fair	20-40 years	The Narrows - western extent	Remove rope/tie from trunk	Moderate
79	11m x 17m	185	Fair	Fair	10-20 years	The Springs	Broken/hanging branch removal	High
